Middle Head, Mosman

Former 10 Terminal Regiment Barracks Buildings & Laundry

HERITAGE IMPACT ASSESSMENT

Date: 16th November 2020

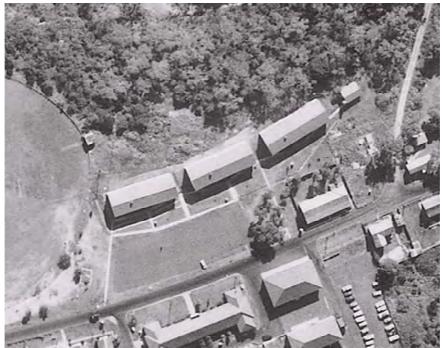
Image: 1961 aerial showing the former Ten Terminal Regiment barracks buildings, laundry and adjacent parade ground. Source: Harbour Trust

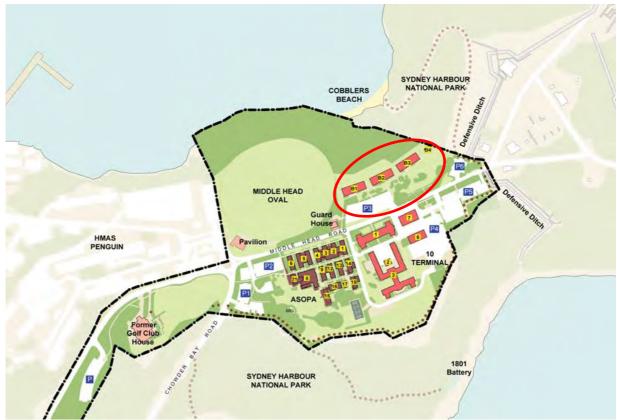
Figure 1. 3: Extract from *Middle Head Management Plan* showing the location of the four subject buildings (circled in red) within the Ten Terminal Regiment Precinct. Source: Figure 1, *Middle Head Management Plan* 2007

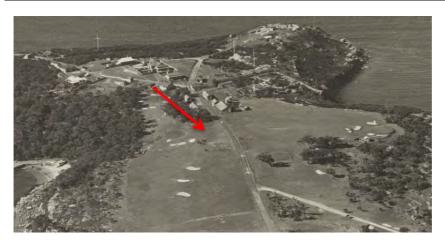
Figure 2. 5: Detail from 1930s aerial view of Middle Head and the Mosman golf course. The future location of the subject buildings is indicated with an arrow. Source: SLNSW, PXW 889

Aerial photographs from the 1930s of Middle Head show the area later to hold the four subject buildings to have been a flat grassed area, located immediately to the west of the Royal Australian Garrison Artillery and Australian Engineers camps and the Middle Head fortifications (see Figure 2.5).

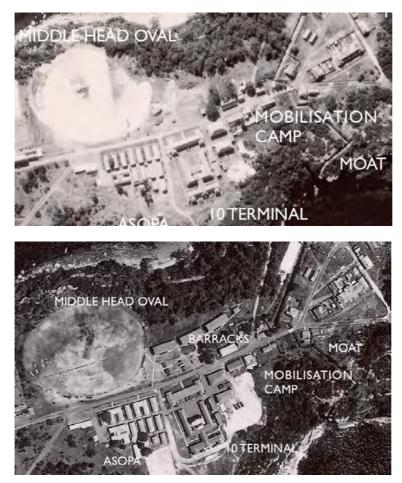
Figure 2. 7: Detail from 1951 aerial photograph of the precinct showing the Anti-Aircraft and Fortress Engineering School and the Signals Camp. By this time the Middle Head oval had been constructed. Source: Middle Head CMP 2007, p. 279

It appears that the three timber-framed barrack buildings and timber-framed laundry on the north of Middle Head Road and opposite the former School buildings were constructed about this time, but no data has been found about their construction. They were shown on a plan of 12 March 1958, labelled as ORs (other Ranks) Barracks, Numbers 8, 9 and 10 and aerial photographs indicate they were constructed between 1951 and 1955 (see Figures 2.7 and 2.8).

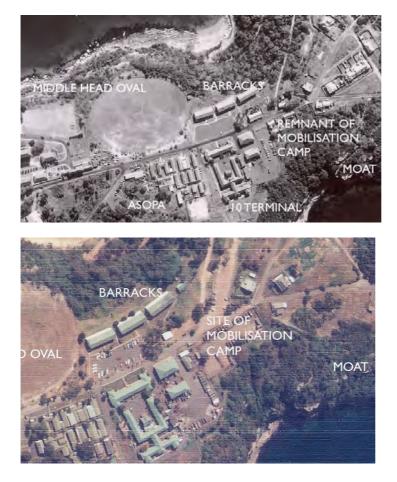
Figure 2. 10: Detail from 1961 aerial photograph of the precinct showing the Anti-Aircraft and Fortress Engineering School and the Signals Camp, with the barracks building and laundry and the parade ground now in place. Source: Middle Head CMP 2007, p. 281

The parade ground which first appears in the 1961 aerial (see Figure 2.10) in the location of the earlier car parking area, appears to have reverted to a car park by the early 1980s, as indicated by the 1982 aerial photograph (see Figure 2.11).

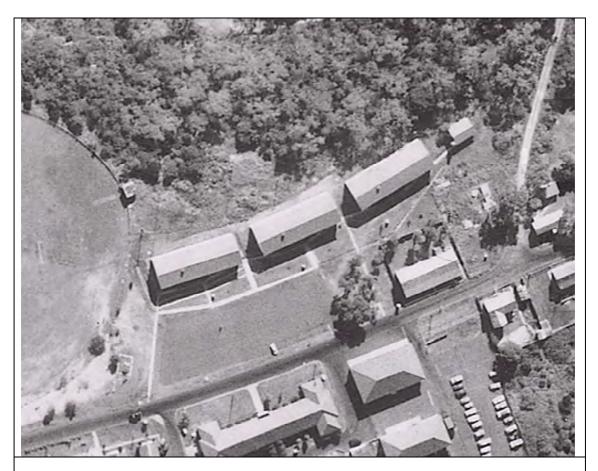
This enlargement from the 1961 aerial photograph shows the layout of paths and planting to Buildings B1 to B4. Also shown is the parade ground constructed between Middle Head Road and the buildings between 1955 and 1961. Also note the remaining buildings from the 1915 Mobilisation Camp and the dirt road to Cobblers Beach. (1961 aerial photograph courtesy SHFT)

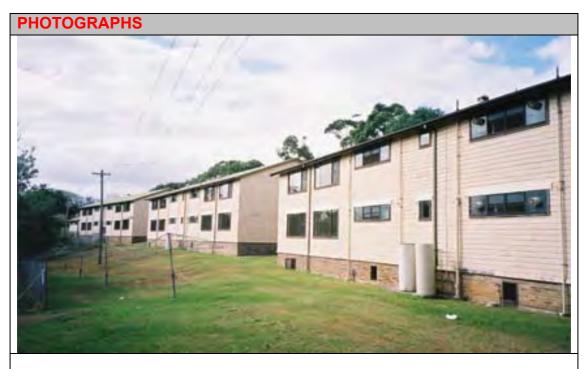
Current view of (from the right) Buildings B1, B2, B3 & B4 from the north-west (Photo: Robertson & Hindmarsh Pty Ltd, 2006)

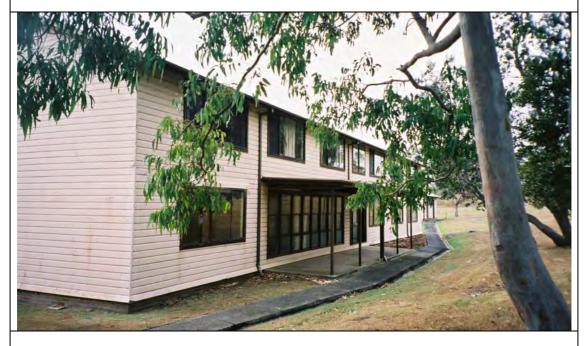
Current view of Building B3 from the south-west (Photo: Robertson & Hindmarsh Pty Ltd, 2006)

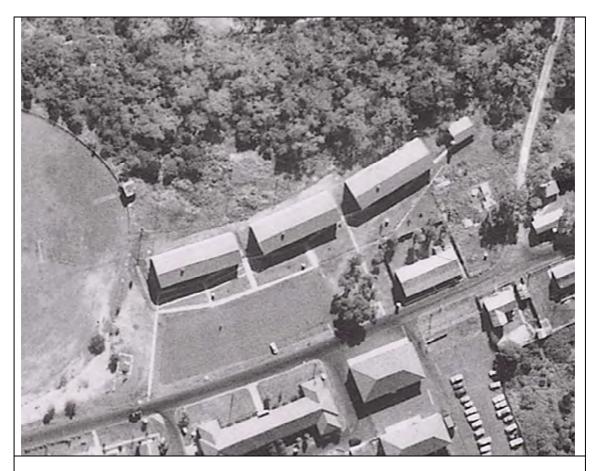
This enlargement from the 1961 aerial photograph shows the layout of paths and planting to Buildings B1 to B4. Also shown is the parade ground constructed between Middle Head Road and the buildings between 1955 and 1961. Also note the remaining buildings from the 1915 Mobilisation Camp and the dirt road to Cobblers Beach. (1961 aerial photograph courtesy SHFT)

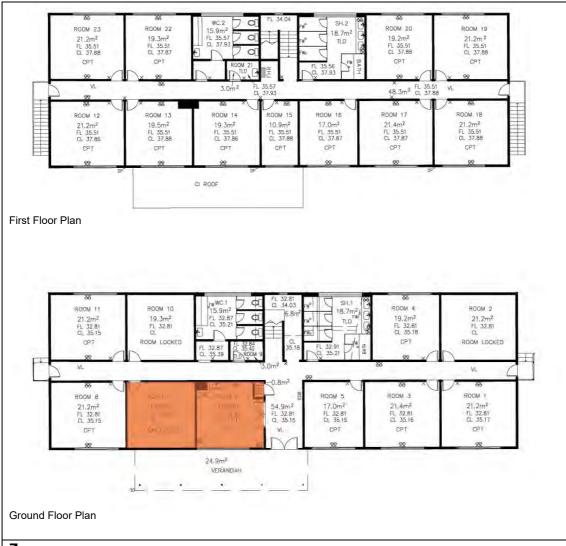
Zones

Retain the surviving volumes in the uncoloured areas. Ideally a single volume could be re-instated in each of the two areas shaded red.

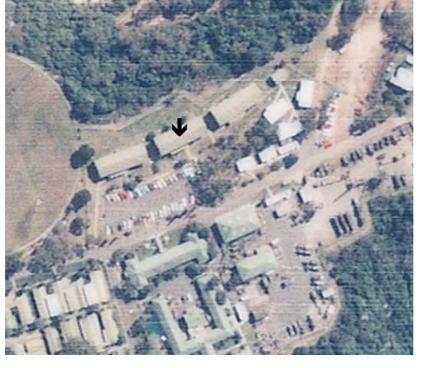
Extract from the 1991 aerial showing Building B2

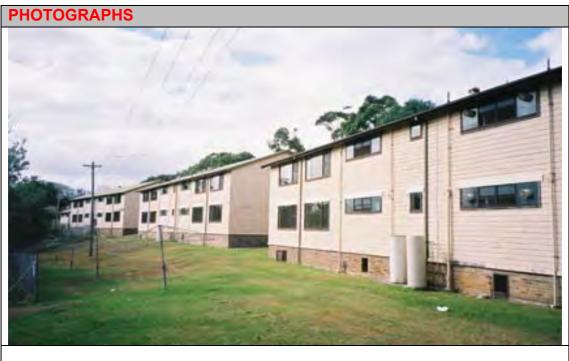
Current view of (from the right) Buildings B1, B2, B3 & B4 from the north-west (Photo: Robertson & Hindmarsh Pty Ltd, 2006)

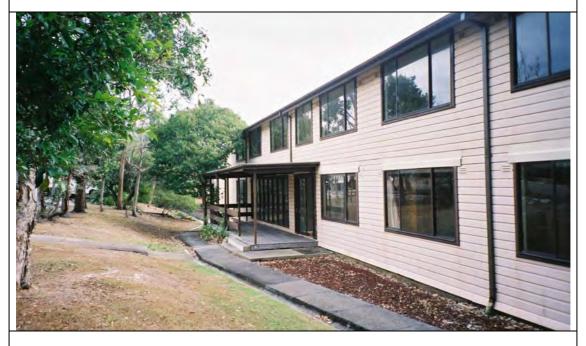
Current view of Building B2 from the south-east (Photo: Robertson & Hindmarsh Pty Ltd, 2006)

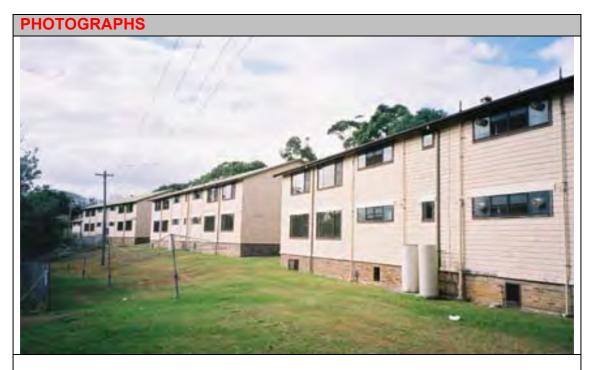
Current view of (from the right) Buildings B1, B2, B3 & B4 from the north-west (Photo: Robertson & Hindmarsh Pty Ltd, 2006)

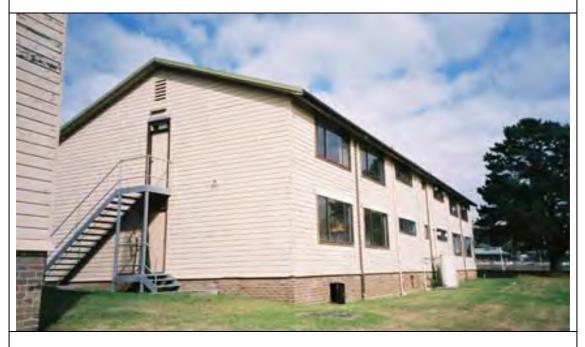
Current view of Building B1 from the north-east (Photo: Robertson & Hindmarsh Pty Ltd, 2006)

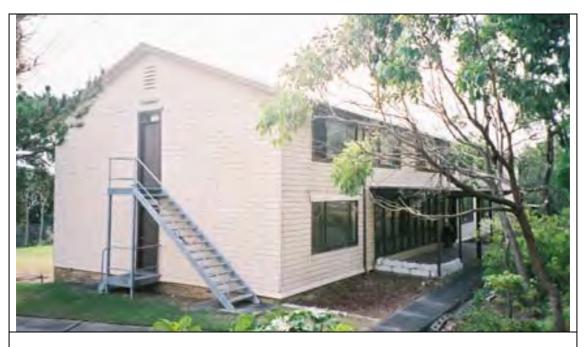
Current view of Building B1 from the south-west (Photo: Robertson & Hindmarsh Pty Ltd, 2006)

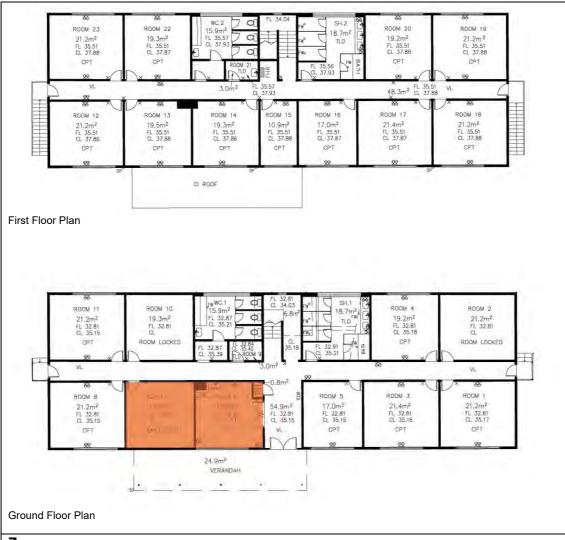
Zones

Retain the surviving volumes in the uncoloured areas. Ideally a single volume could be re-instated in each of the two areas shaded red.
