## Snapper Island, Sydney Harbour

Draft Conservation Management Plan

16 November 2020

Project No.: 0571293

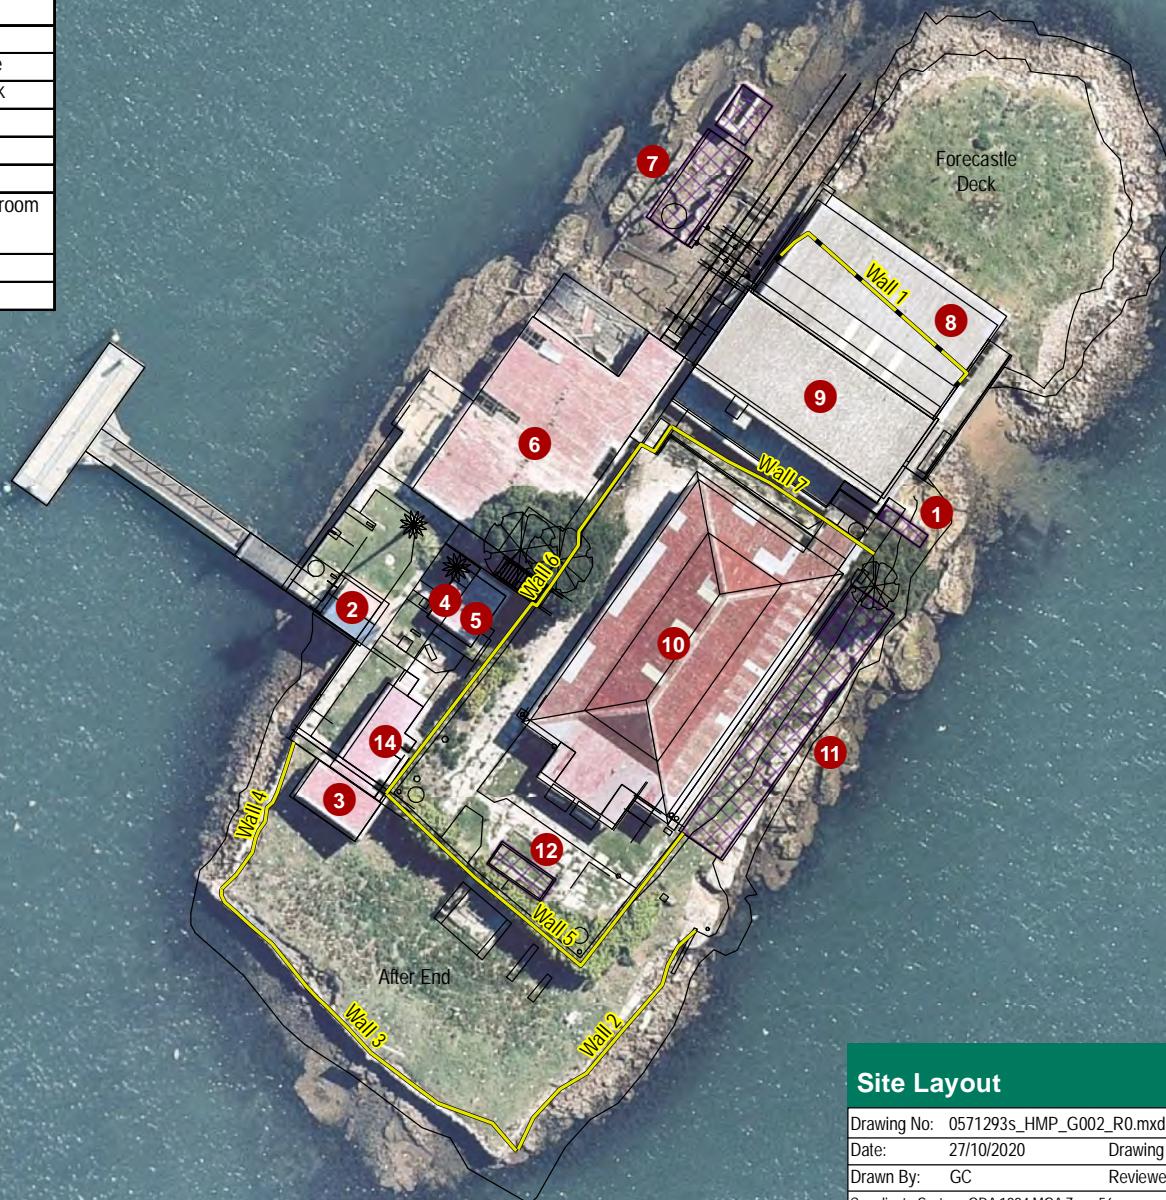
### Site Layout

Site Features	
1	Flammable Store (Demolished)
2	Guard House
3	Officers Wardroom Mess
4	Storage Room
5	Women's Toilet Room
6	Boatshed, Workshop & Store
7	Men's Toilet & Shower Block
8	Gymnasium
9	J. Payne Memorial Building
10	Main Deck, Museum
11	Mess Deck, Standard Classroom (Demolished)
12	Signal Station (Demolished)
14	Officers Cottage

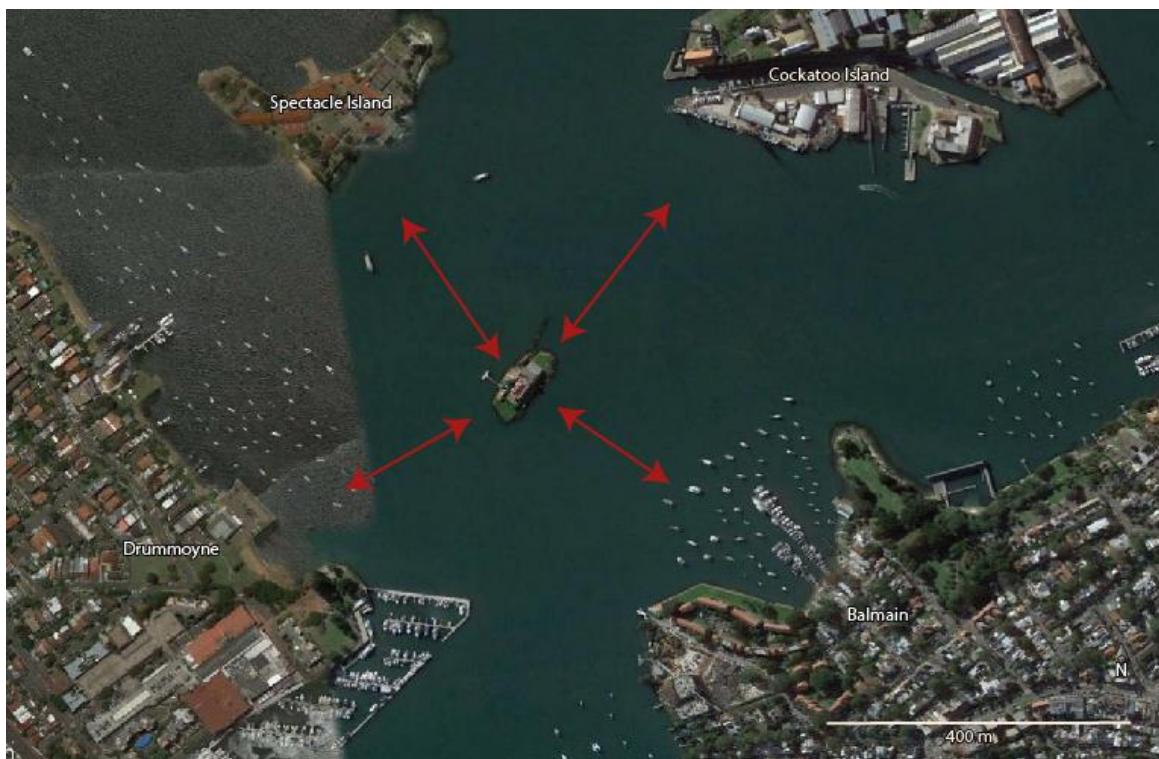
**Figure 6.1 Significant views to and from Snapper Island**

All future development proposals should seek to retain and enhance existing heritage values as part of the Site planning process. The retention of an appropriate visual setting and physical environment is an essential element of heritage conservation. The island retains the physical siting and general layout from when it was established, and contributes to the landscape values of Sydney Harbour. The Site has a visual relationship with the surrounding islands in the harbour (Spectacle and Cockatoo Islands) along with the coastal locations of Drummoyne and Balmain (refer to *Figure 6.1*). These views to and from the island should be retained.

ERM 2020
Significant Views	Refer to <i>Figure 6.1</i>	Very Good	N/A	Low	N/A	Future development should include the retention of significant view lines to and from Snapper Island – refer to <i>Figure 6.1</i> .

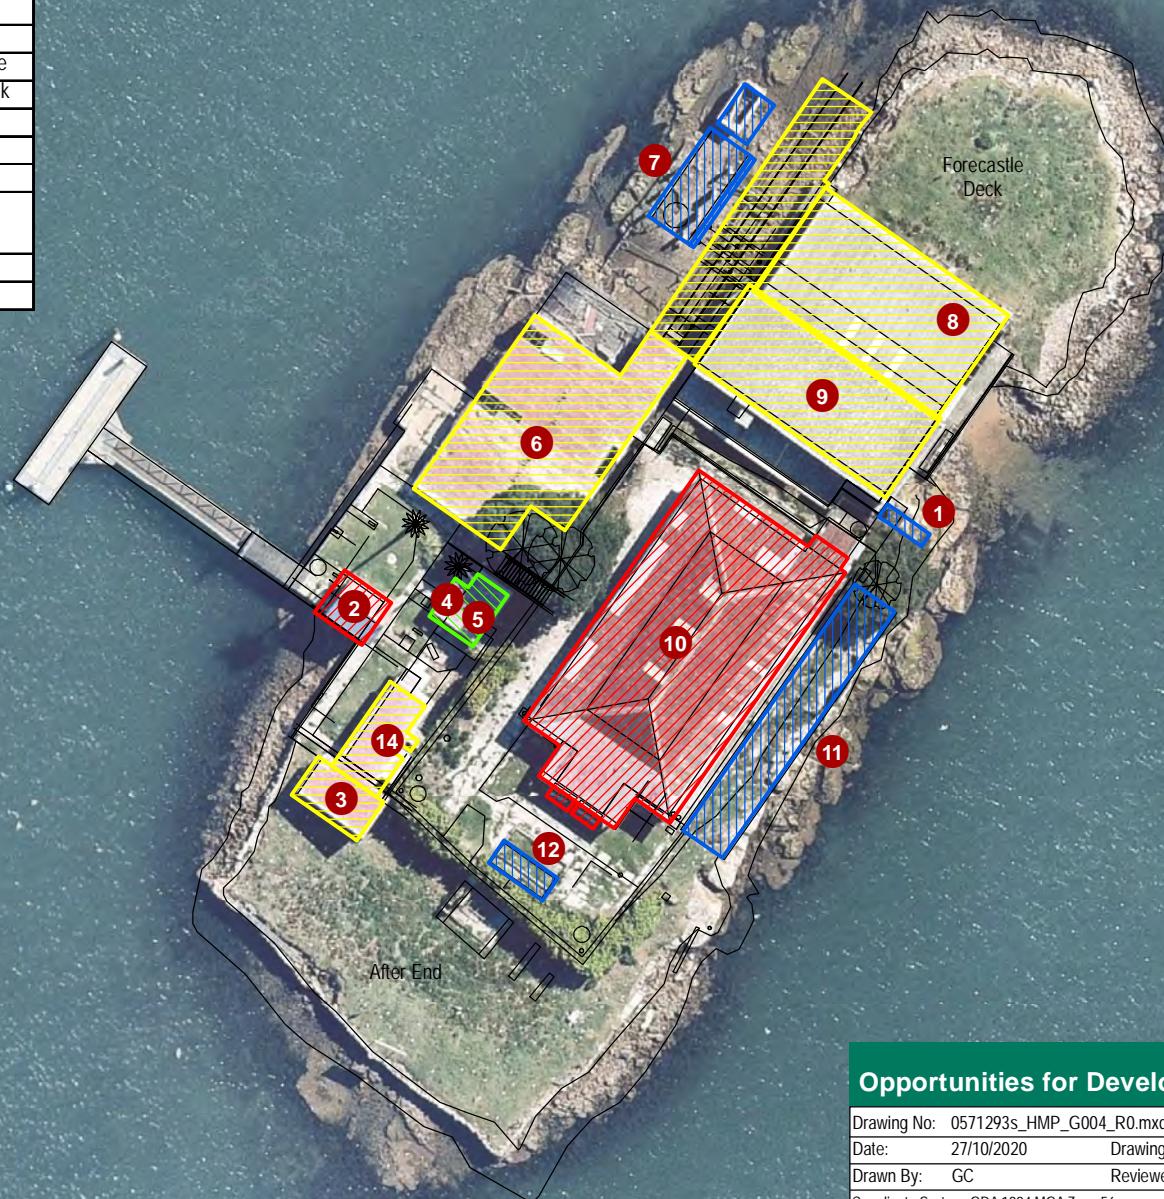
### Opportunities for Development

*Figure 6.2 shows areas for development opportunity and buildings where opportunities exist for conservation and restoration.*

Site Features	
1	Flammable Store (Demolished)
2	Guard House
3	Officers Wardroom Mess
4	Storage Room
5	Women's Toilet Room
6	Boatshed, Workshop & Store
7	Men's Toilet & Shower Block
8	Gymnasium
9	J. Payne Memorial Building
10	Main Deck, Museum
11	Mess Deck, Standard Classroom (Demolished)
12	Signal Station (Demolished)
14	Officers Cottage

ERM 2018
Building 2 - Guard House	Entrance to Island – Refer to Figure 6.2	Fair – some rust and corrosion evident	Constructed 1932 - one of the first buildings on Site – restituted in its current position in 1950s	High	Low	Retain and conserve exterior fabric. Minimal intervention and tolerance for change. Any protective finishes should be suitable for the fabric and reflective of the present treatment. If no suitable finishes can be obtained, no new finishes should be applied. Maintain in accordance with maintenance schedule Section 6.5.3.

Building 3 - Officer's Wardroom Mess	South-west corner of Island – Refer to Figure 6.2	Fair	Constructed 1942 as part of the island's expansion during WWII.	Moderate	Moderate	Retain and conserve fabric where possible. Fabric may be removed to reconstruct earlier configurations. Restoration/reconstruction preferred. Maintain in accordance with the maintenance schedule Section 6.5.3.

Building 6 - Boatshed and Workshop	Port side of the island. Refer to <i>Figure 6.2</i>	Very Poor – considerable deterioration of all fabric.	c.1931 – one of the first buildings constructed on the island	Moderate	Moderate	Removal and replacement of fabric as necessary and to provide structural stability. Replacement of finishes should only be undertaken where suitable products are available. Restoration or reconstruction is recommended. Demolition should only be approved where no other feasible alternatives remain. Undertake all critical repairs and maintenance in accordance with <i>Section 6.5.3</i> .

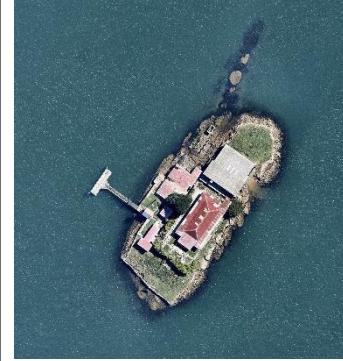
Near Map 2020
Sea walls	Around the Forecastle Deck and After Deck of the Island	Poor	1931 – during the formation of the island into a ship by unskilled labour.	Moderate	Moderate	Sea walls require a level of engineering to ensure longevity. Recommend consultation with maritime engineer and heritage architect to devise suitable repair or replacement approach to deteriorating sea walls. The sea walls are significantly linked with the general layout of the island and assist in the ‘reading’ of the ship aesthetic. Works should be sympathetic to this element and associated value.

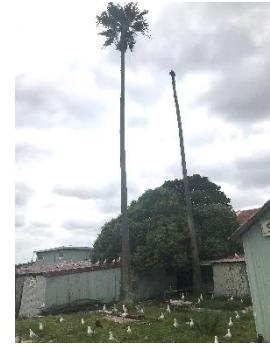
ERM 2018
Cabbage Trees (x 2)	Lower Deck, to the north-east of the Guardhouse	Fair	1930s	Moderate	Moderate	An arborists report should be commissioned to ascertain the health of the trees and determine options for retention or removal (as appropriate). Efforts should be made to retain the Cabbage Tree Palms, subject to health, and annual inspections should be undertaken. The palms are to be protected during any works undertaken on the island and should not be removed to allow future development.

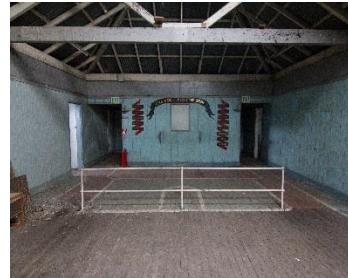
Description	Location	Condition	History/ Date of construction	Significance Ranking	Tolerance for Change	Recommendations	Photo
Building - 10 Main Deck	Centre of island. Refer to <i>Figure 6.2</i>	Fair	1928-1932 – one of the first buildings to be constructed at Snapper Island. The Main Deck originally constructed at Drummoyne Depot and reconstructed on Snapper.	High	Low	Decontaminate (including asbestos removal), stabilise and maintain current configuration. Full roof replacement required to seal the building and prevent egress of water. Retain and conserve fabric. Exterior finishes should only be replaced if suitable options are available, including consideration of current treatment. Internally, reversible fittings and fit-out is appropriate to accommodate sympathetic new uses. The doors from <i>HMAS Sydney</i> should be conserved and maintained. Maintain fabric in accordance with <i>Section 6.5.3</i> .

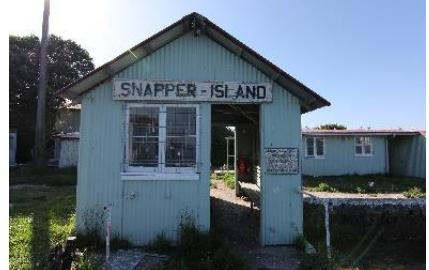
Location	Priority	Fault	Recommendation	Photograph
<b>Building 2 – Guard House</b>				
All internal spaces	Low Complete within 2 years.	Cleanliness of the spaces to be improved.	Deep clean to be undertaken in all internal spaces to remove accumulated dust and grime to establish base maintenance level. Removal of refuse and broken furniture.

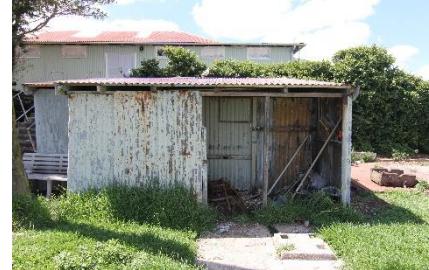
ERM 2020
All internal spaces	High Complete within 6 months.	Rodent baits to be replaced.	Check/replace all rodent baits and traps to limit potential for infestation of buildings.	
<b>Buildings 4 and 5 – Generator Room and Women's Toilet</b>				
Generator Room and Women's toilet.	Medium Complete within 12 months.	Asbestos material to be removed.	Isolation and removal of asbestos material within structure, prior to cleaning and maintenance inspection.

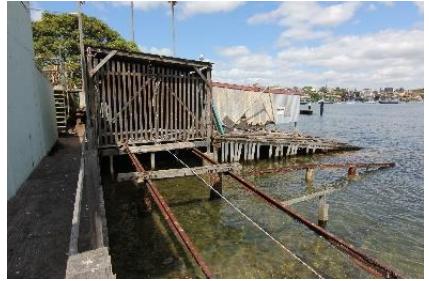
Location	Priority	Fault	Recommendation	Photograph
Boatshed Timbers	High Complete within 6 months.	Timbers failing due to marine weathering and wave action.	Additional engineering assessment of structure to guide repair and replacement should be undertaken and recommendations should be implemented. The structure is integral to the significance of the island and should be retained.

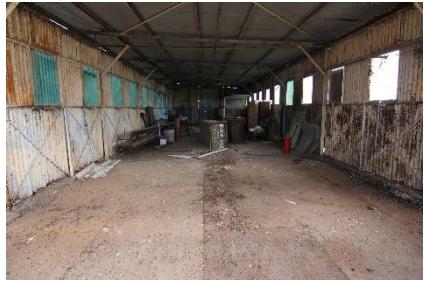
Gymnasium	Medium Complete within 12 months.	Foundation, floor and interior spaces in poor condition.	Engineering assessment of sub floor to guide repair and replacement. Repair and replacement within the gymnasium to be undertaken to allow for use of the space. Removal of miscellaneous refuse and debris.

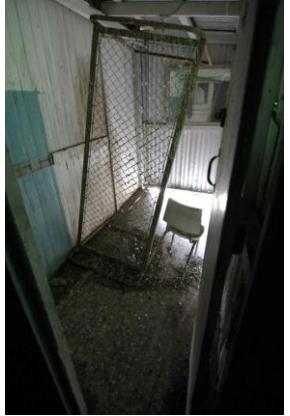
Former Sick Bay	High Complete within 6 months.	Damage to floor.	Engineering assessment of sub floor to guide repair and replacement. Floor to be repaired and reinstated. This process will limit access of animals and water/contaminants into the space.

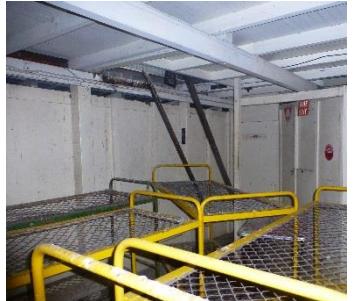
ERM 2018
Stairs	Medium Complete within 12 months.	Stairs missing.	Stairs to be reinstated, to allow easy access to the upper level. Include assessment of the viability of the structure.

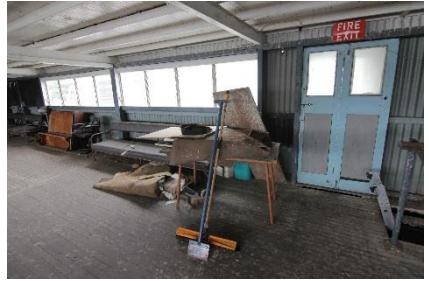
Location	Priority	Fault	Recommendation	Photograph
			maintenance level. Removal of refuse and broken furniture.	
All internal spaces	High Complete within 6 months.	Rodent baits to be replaced.	Check/replace all rodent baits and traps to limit potential for infestation of buildings.

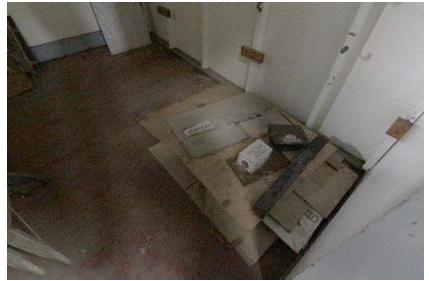
All internal spaces	High Complete within 6 months.	Rodent baits to be replaced.	Check/replace all rodent baits and traps to limit potential for infestation of buildings.

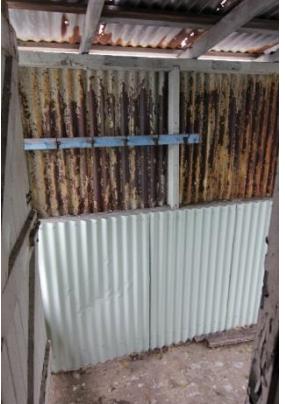
ERM 2018
External Doors	High Complete within 6 months.	External doors not all closed/secured	Repairs should be made to external doors to ensure birds and other animals cannot access the internal spaces and increase security.

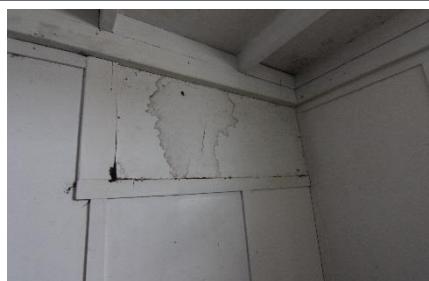
ERM 2018
North-west corner room	Medium Complete within 12 months.	Water damage to plaster panelling.	Investigate source of water damage and repair, conduct inspection for additional damage in surrounding panels. Replace damaged panel with like material.

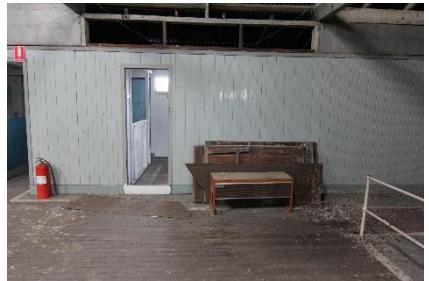
ERM 2018
All internal spaces	Medium Complete within 12 months.	Cleanliness of the spaces is low, animal activity has had detrimental impact throughout.	Deep clean to be undertaken in all internal spaces to remove accumulated dust, grime and animal droppings. Additional inspection to be undertaken to establish maintenance base level and determine if any additional urgent repairs

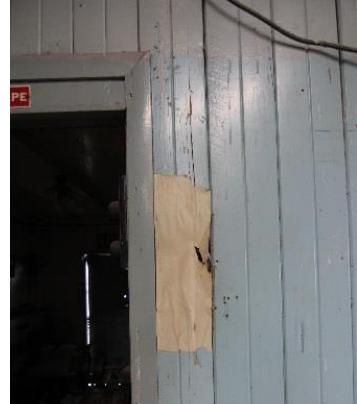
Location	Priority	Fault	Recommendation	Photograph
			required. Removal of refuse and broken furniture.	ERM 2018
North end, central room	Low Complete within 2 years.	Damaged wall panelling.	Remove tape, repair damaged panelling and repaint along with cyclical maintenance schedule.

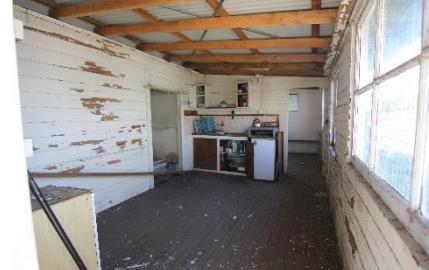
Throughout Officer's Cottage	Moderate Complete within 2 years.	Water damage to be repaired	Internal finishes, such as flooring and timber cladding, should be repaired to previous standard.

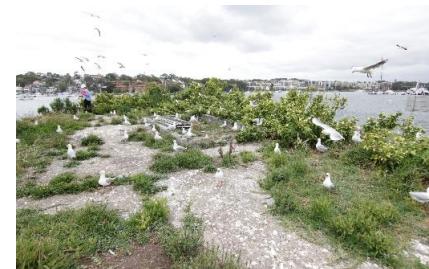
Upper deck and lower deck	High Complete within 6 months.	Vegetation overgrown and unmanaged.	General vegetation management/removal to be undertaken. Slashing, weeding and preventative spraying.

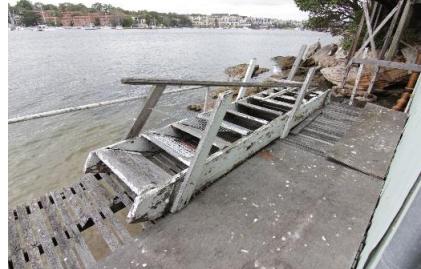
Location	Priority	Fault	Recommendation	Photograph
Walkways and gantries	High Complete within 6 months.	Timber walkways badly degraded and unsafe for use.	Timber walkways to be repaired/replaced. Degraded and broken timbers to be removed from the island and disposed of appropriately.

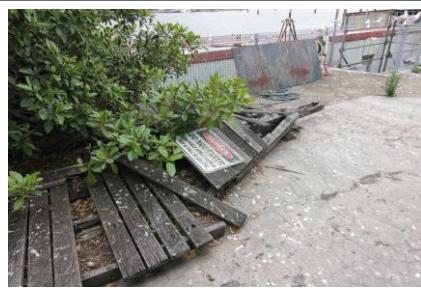
ERM 2018
Upper deck and lower deck	MHigh Complete within 6 months.	General refuse dumping	Refuse, miscellaneous items and unusable building materials to be removed and disposed of appropriately.

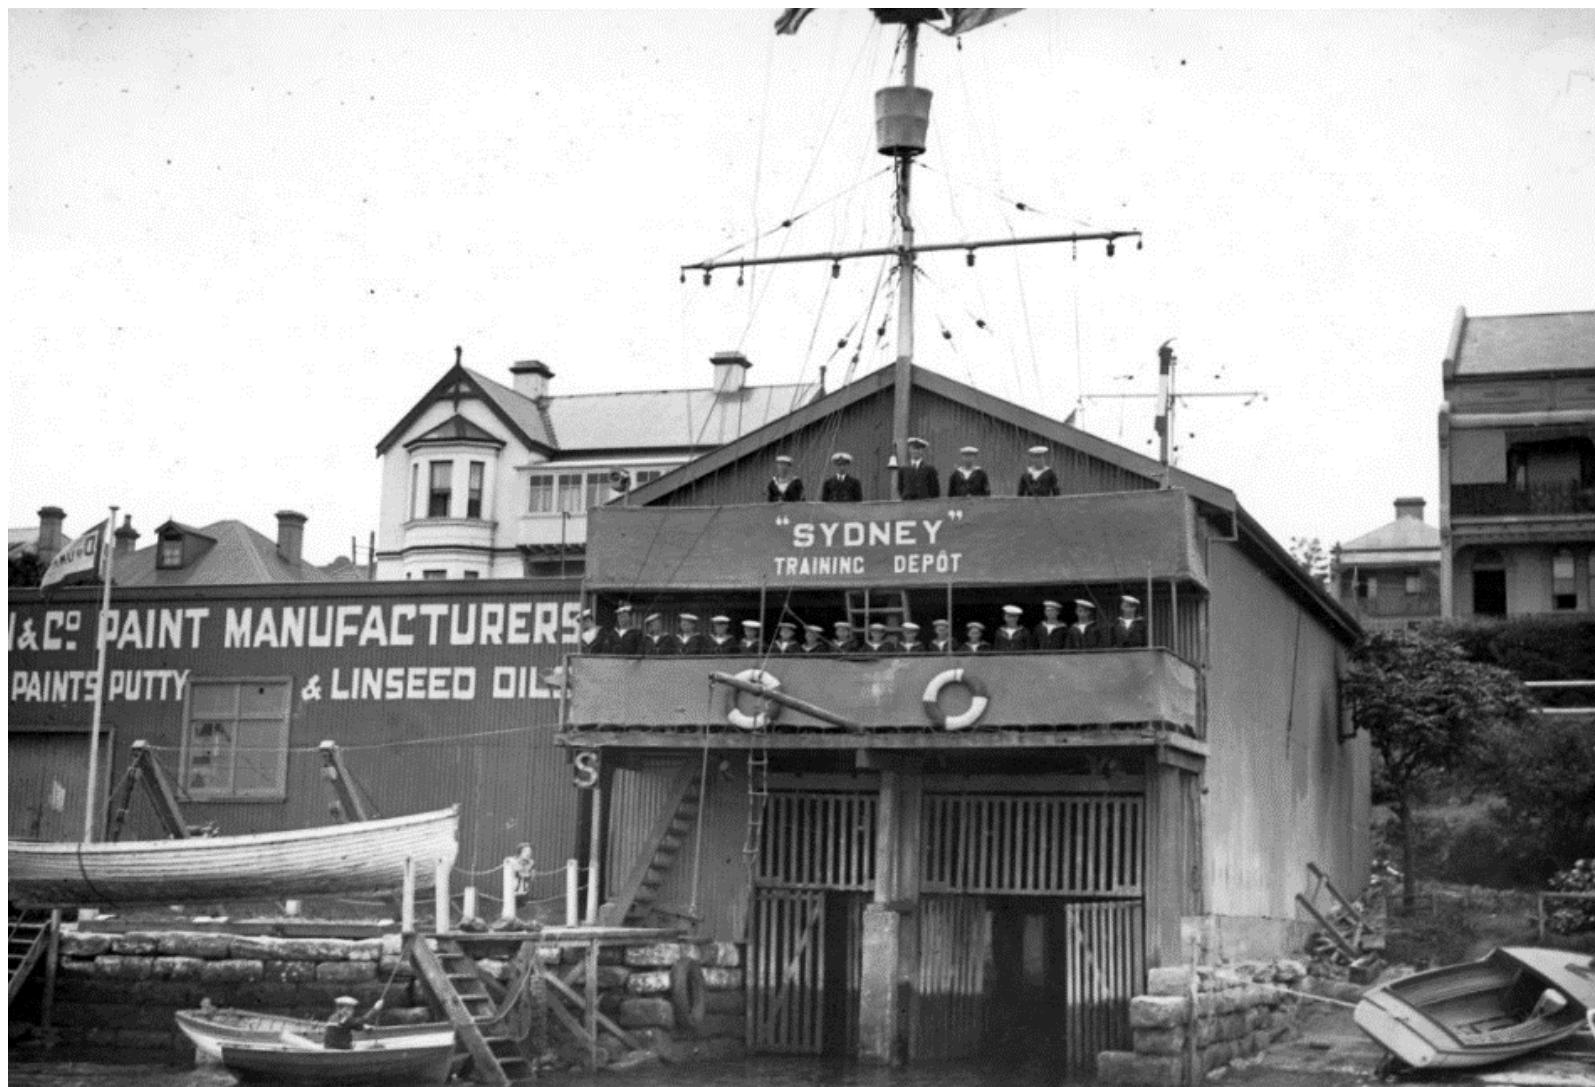
Photograph B.10 "Sydney" Training Depot, Drummoyne 1928 (State Library of Victoria Image H98.105/223)

The depot building for the Naval League at Drummoyne was established in 1928, it was a two story gabled roof structure. The building was later repurposed for use at Snapper Island as the Main Deck (building 10) (*Figure B.3 & Photograph B.10*). In the same year, Forsythe also formed a company at Iron Cove which he called 'Sydney' as a memorial to HMAS *Sydney*.

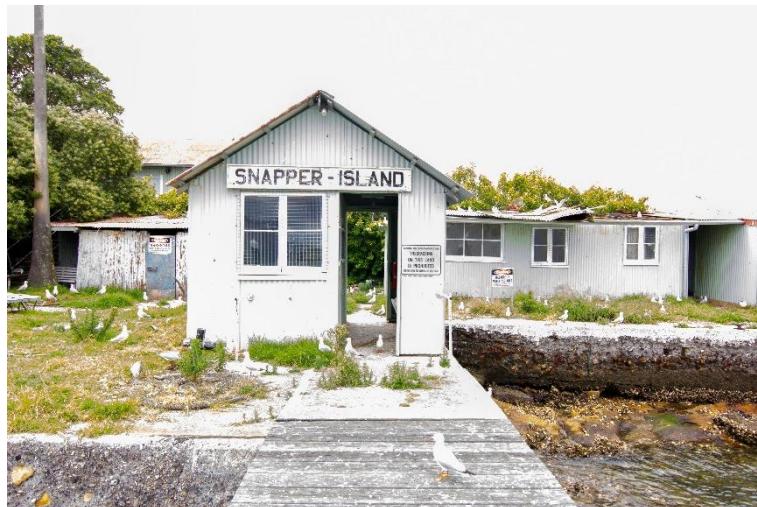
**Figure 8.13 Guardhouse, from Port Wharf (ERM, 2018)**

The Guard House is situated on the far port side of the island, at the end of the port wharf. The building acts as the entry way to Snapper Island and is labelled with the name in bold letters. The structure is timber and corrugated iron, with a narrow hallway running directly through with a small room to the north of the hallway. There is a bench on the southern side of the hallway. The structure is in fair condition, with some corrosion. There appears to be no major structural damage to the building.

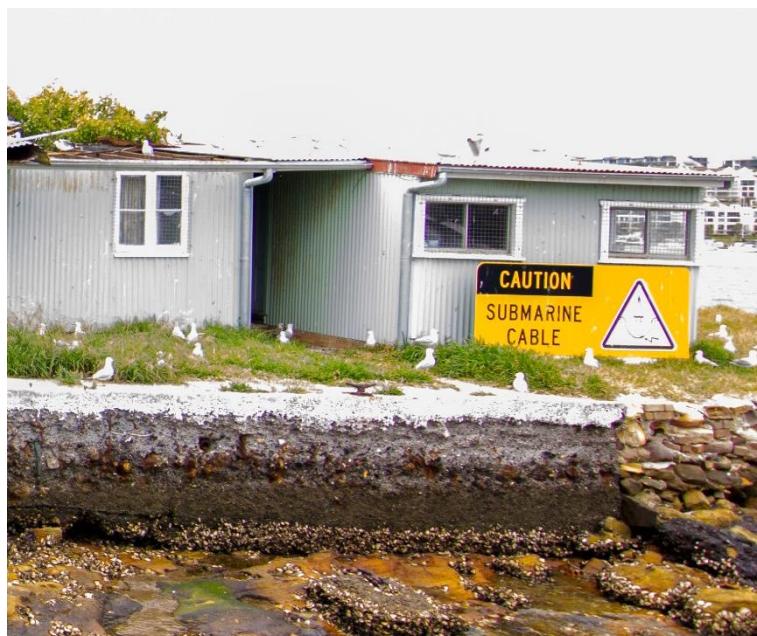
**Figure 8.14 Officer’s Wardroom Mess, from Port Wharf (ERM, 2018)**

The Officer’s Wardroom Mess is a small single storey timber and corrugated iron structure at the aft end of the island, adjacent to the Officer’s Cottage (Building 14). An internal inspection of the building could not be undertaken during the site inspection. The building is in poor to fair condition, with corrosion and flaking paint noted (as is common across the island).

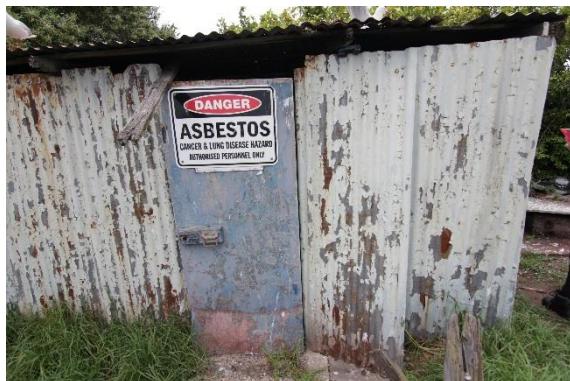
**Photograph 8.29 Generator room, from port side (ERM, 2018)**

The Generator room and Women’s Toilet block are small timber framed corrugated iron structures located on port side of the lower deck of the island. Access to the interior of the structures was not available during the site inspection and a thorough analysis of the internal condition could not be undertaken. The exterior of the structures is corroded and there is evidence of flaking paint. Additionally, the generator room is marked as containing asbestos. The structures are in poor condition and no subject to regular use or maintenance.

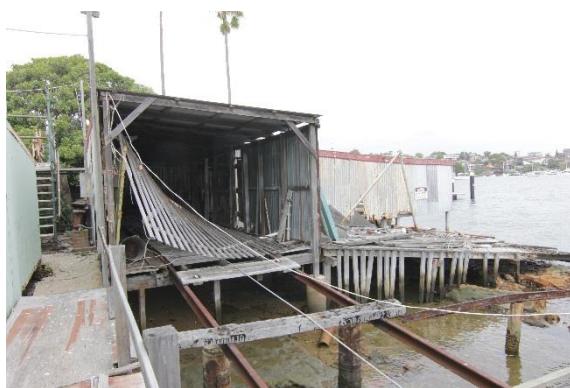
**Photograph 8.31 Boatshed from fore end of island (ERM, 2018)**

The Boatshed and Workshop are located on the port side of the island, to the north of the guardhouse. The Boatshed/workshop are timber framed structures with corrugated iron sheeting on the exterior. The Boatshed is open at the northern end, the workshop has a small opening at the western end. The structures are in very poor condition, with hazard signage indicating asbestos contamination and unstable surfaces. The open end of the Boatshed shows the poor condition of the flooring and of the internal framing – some of which has decayed and fallen. Leading from the Boatshed is a ramp constructed of timber and iron 'I' beams. The 'I' beams are heavily corroded and the timbers are water damaged.

<b>Building 6 – Boatshed and Workshop</b>				
Boatshed Timbers	High Complete within 6 months.	Timbers failing due to marine weathering and wave action.	Additional engineering assessment of structure to guide repair and replacement should be undertaken and recommendations should be implemented. The structure is integral to the significance of the island and should be retained.

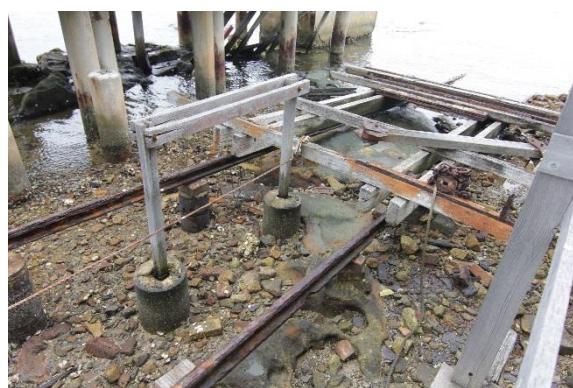
**Photograph 8.32 Iron boat ramp, with heavy corrosion (ERM, 2018)**

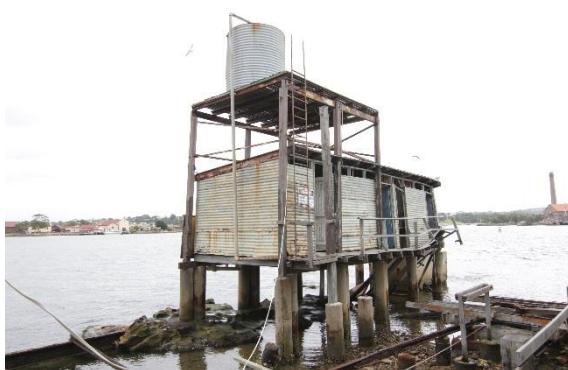
**Figure 8.15 Ablutions Block, from port side of Gymnasium prior to demolition (ERM, 2018)**

The Ablutions Block is a simple timber frame corrugated iron structure situated on concrete pillars to raise it above the tide level. The structure is a single storey containing showers and toilets, with an additional elevated timber structure at the aft end which holds a corrugated iron water tank. To the north of the structure is the remains of a concrete septic tank, located at water level.

The structure is in very poor condition. The concrete pillars are suffering spalling and cracking, the timber have rotted and cause collapse of portions, and the lead paints are flaking and falling away from the structure. As a result of this condition and the serious health and safety risks posed by the structure, with EPBC Approval this building was demolished in early 2019.

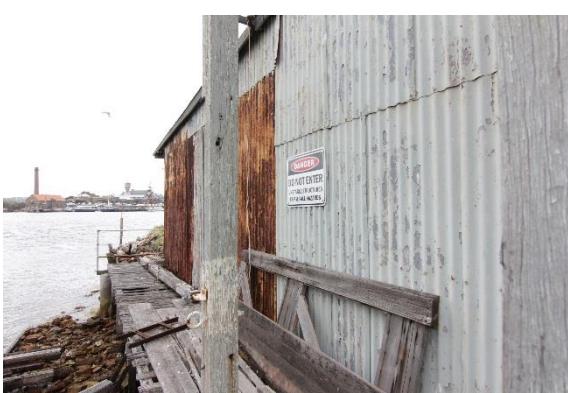
**Photograph 8.33 Port side of the Gymnasium (ERM, 2018)**

The gymnasium is a single storey timber and corrugated iron structure located just north of the J. Payne Memorial Building at the fore end of the island. The interior could not be accessed, as the door (at the starboard end) was locked and there was no available key. Previous investigations indicate that the building consists of one long room with no internal divisions. The structure is in poor condition, with significant corrosion of the corrugated iron noted during the inspection.

<b>Location</b>	<b>Priority</b>	<b>Fault</b>	<b>Recommendation</b>	<b>Photograph</b>
<b>Building 8 - Gymnasium</b>				
Gymnasium	Medium Complete within 12 months.	Foundation, floor and interior spaces in poor condition.	Engineering assessment of sub floor to guide repair and replacement. Repair and replacement within the gymnasium to be undertaken to allow for use of the space. Removal of miscellaneous refuse and debris.

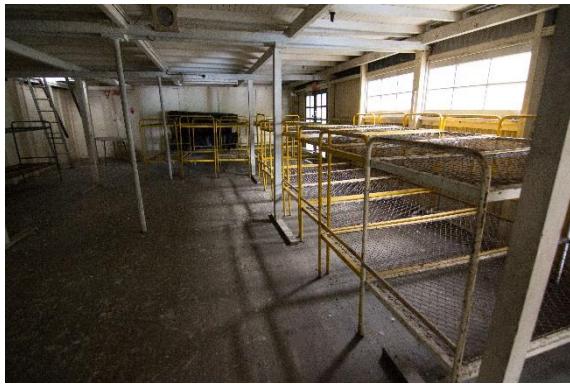
**Photograph 8.35 Lower floor, bunks and general layout (ERM, 2018)**

The lower floor has two sets of double doors leading to a covered walkway between the J. Payne building and the Gymnasium, on the aft side. The doors lead into a main bunk room, containing a number of steel frame bunk beds. There are a series of smaller rooms leading off the main bunk, including an officer's quarters with lockers and additional beds; a storage/locker room which still contains uniforms and provisions; a small sick bay containing an upturned bed, in which the flooring has collapsed; and a sitting room.

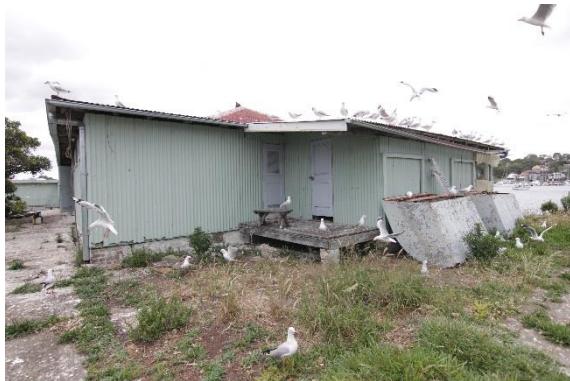
**Photograph 8.39 Exterior of Main Deck, from Aft end (ERM, 2018)**

The structure is in fair conditions, although there is significant dust, grime and bird droppings throughout the interior. No significant damage impacting the main structure was noted during the inspection. There is evidence of some water damage and peeling paint throughout, along with some carpets in side rooms which are in need of replacement. The concrete flooring in the kitchen has significant cracking and is in need of repair.

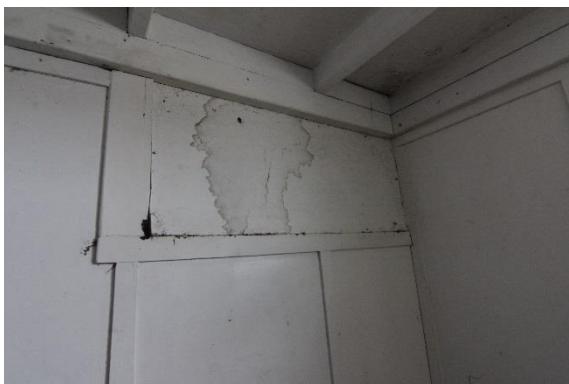
**Photograph 8.43 Evidence of water damage to a portion of internal walling (ERM, 2018)**

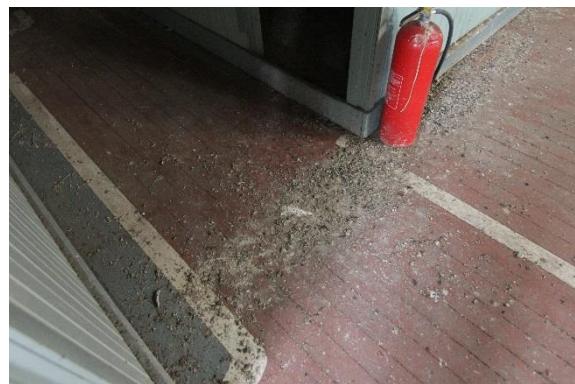
**Photograph 8.44 Evidence of significant bird activity within the structure (ERM, 2018)**

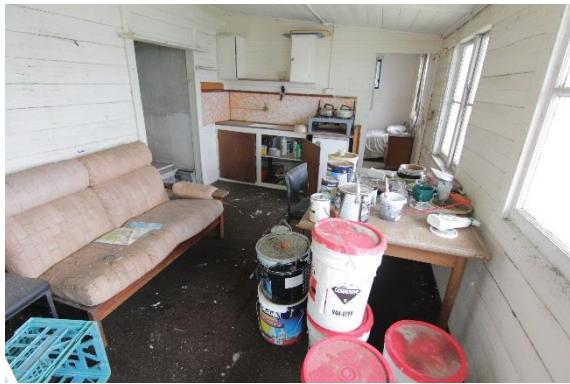
**Photograph 8.45 Living/dining space  
(ERM, 2018)**

The interior is in fair condition, with no major structural damage. The carpets are dirty and paint splattered but largely intact. The cabinets are water damaged and dirty, but appear structurally sound and could be repaired. The bathroom is in fair condition, although it is unlikely that the plumbing is still in good working order.

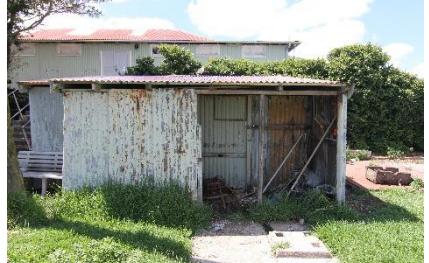
ERM 2020
All internal spaces	High Complete within 6 months.	Rodent baits to be replaced.	Check/replace all rodent baits and traps to limit potential for infestation of buildings.	
<b>Buildings 4 and 5 – Generator Room and Women's Toilet</b>				
Generator Room and Women's toilet.	Medium Complete within 12 months.	Asbestos material to be removed.	Isolation and removal of asbestos material within structure, prior to cleaning and maintenance inspection.
