FINAL REPORT

Long-term Environmental Management Plan

Platypus Site, High Street, North Sydney NSW

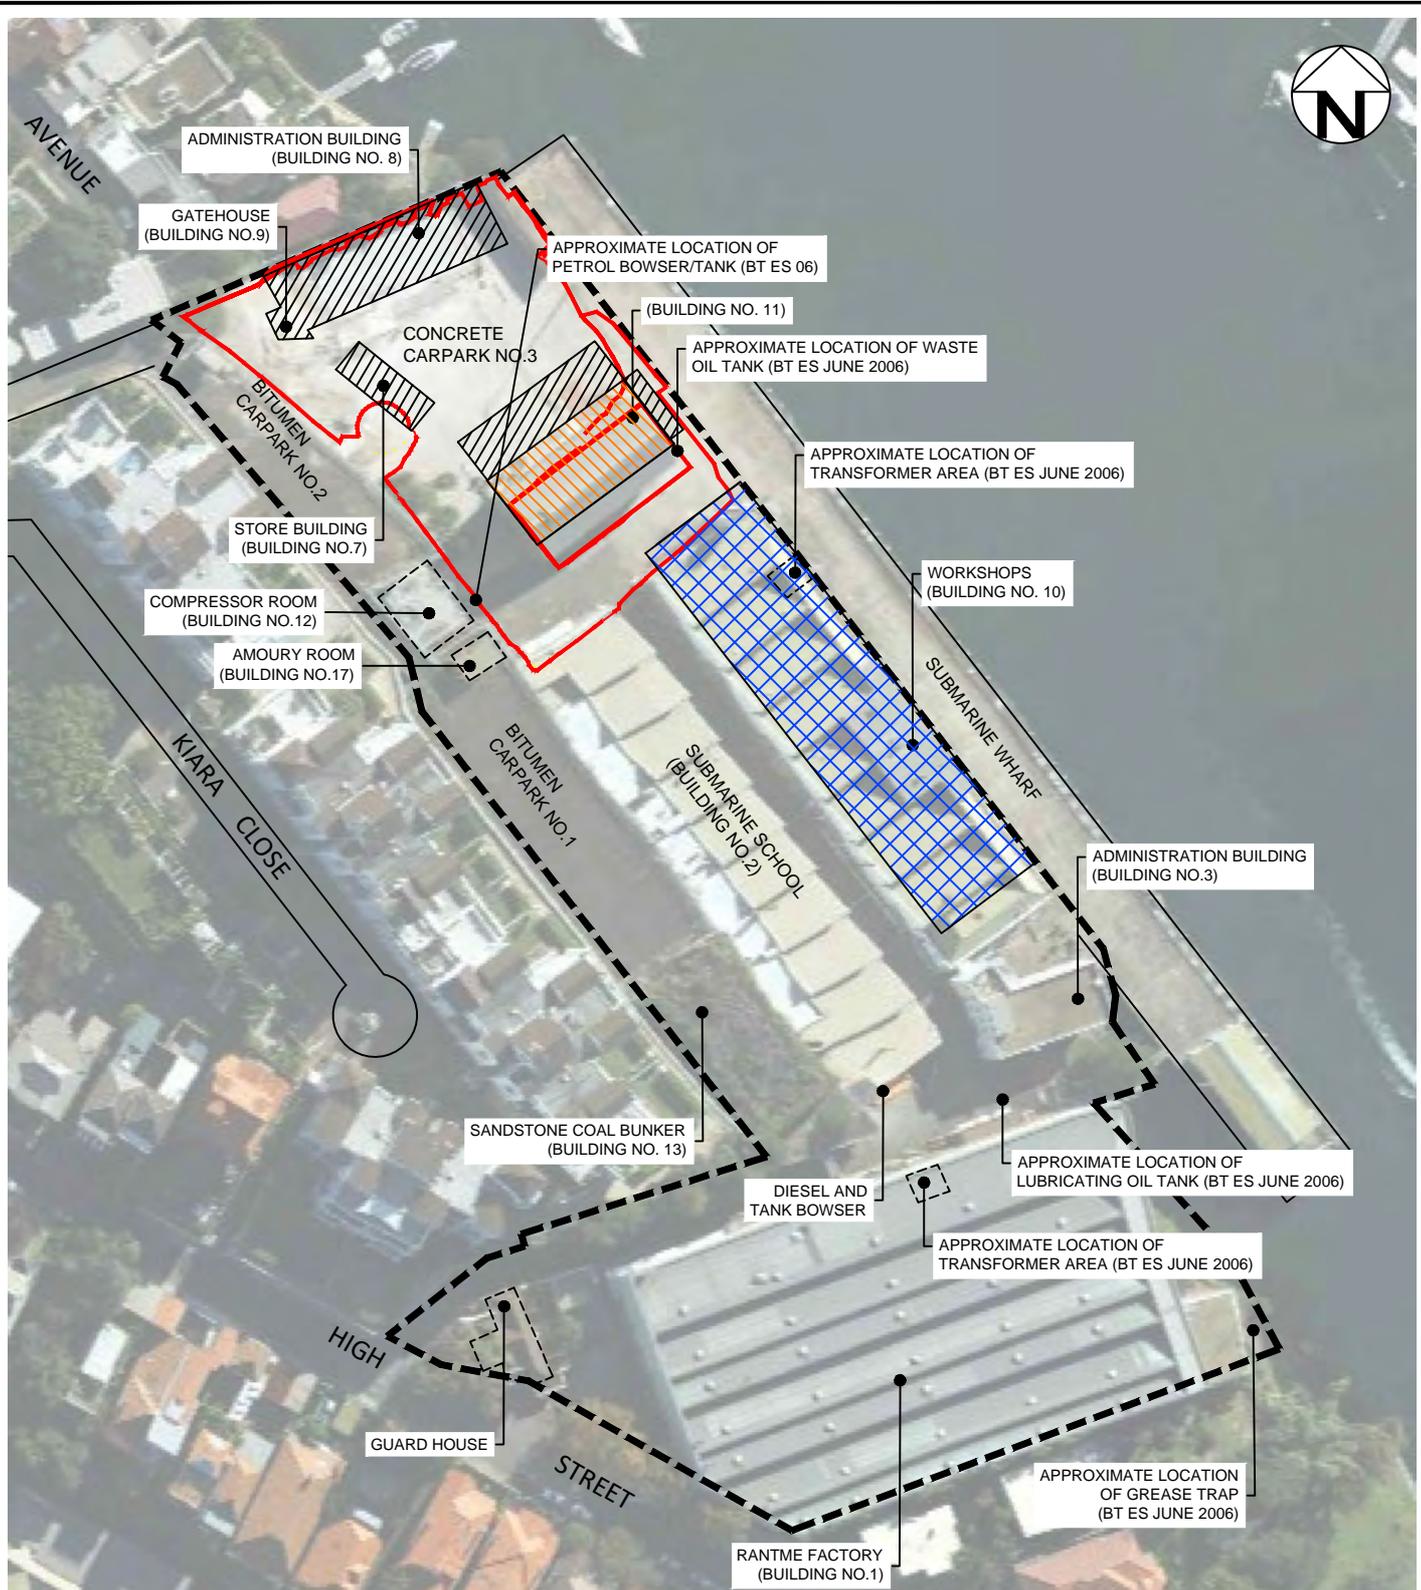
client:	THIESS SERVICES		
project:	SITE VALIDATION, PLATYPUS REMEDIATION PROJECT, 118 HIGH STREET, NORTH SYDNEY, NEW SOUTH WALES		
title:	SITE LAYOUT PLAN AND FEATURES		
project no:	ENAUHOD04128AB-R00A	figure no:	FIGURE 2
		rev.:	-

- APPROXIMATE SITE BOUNDARY
- BUILDING TO BE USED TO STORE BUILDING 11 (WHEN BUILDING 11 IS DISMANTLED)
- BUILDING 7 & 8 WERE DEMOLISHED IN 2010
- BUILDING OF FORMER RETORT HOUSE

- Stage 1 – Preparatory works including hazardous materials removal or stabilisation in all buildings, demolition of the administration building (Building No. 8 – see Figure 2 in Appendix A) and Store (Building No. 7- see Figure 2 in Appendix A) and wharf repairs;

former retort house (Building No. 11 see Figure 2 in Appendix A and plans in Appendix D), containment of existing contaminated and potentially contaminated soils beneath existing buildings and paved surfaces and construction of a seepage collection system at the base of the cut sandstone walls on Site;

- **RANTME Factory (Building No.1), Administration Building (Building No.3), Coal Bunker House (Building No.13) and Compressor House (Building No. 12)** (see Figure 2 of Appendix A) – These buildings were subject to various remedial works, including excavation and removal of contaminated materials present in the floors or sub-floors and, where practicable, re-surfacing with concrete. The final surfaces of these areas is shown on Figure 13 of Appendix A. However, there remains the potential for contaminated materials to have been retained beneath the ground floor slabs, retained on-ground slabs and footings and/or for hazardous building materials to be present.

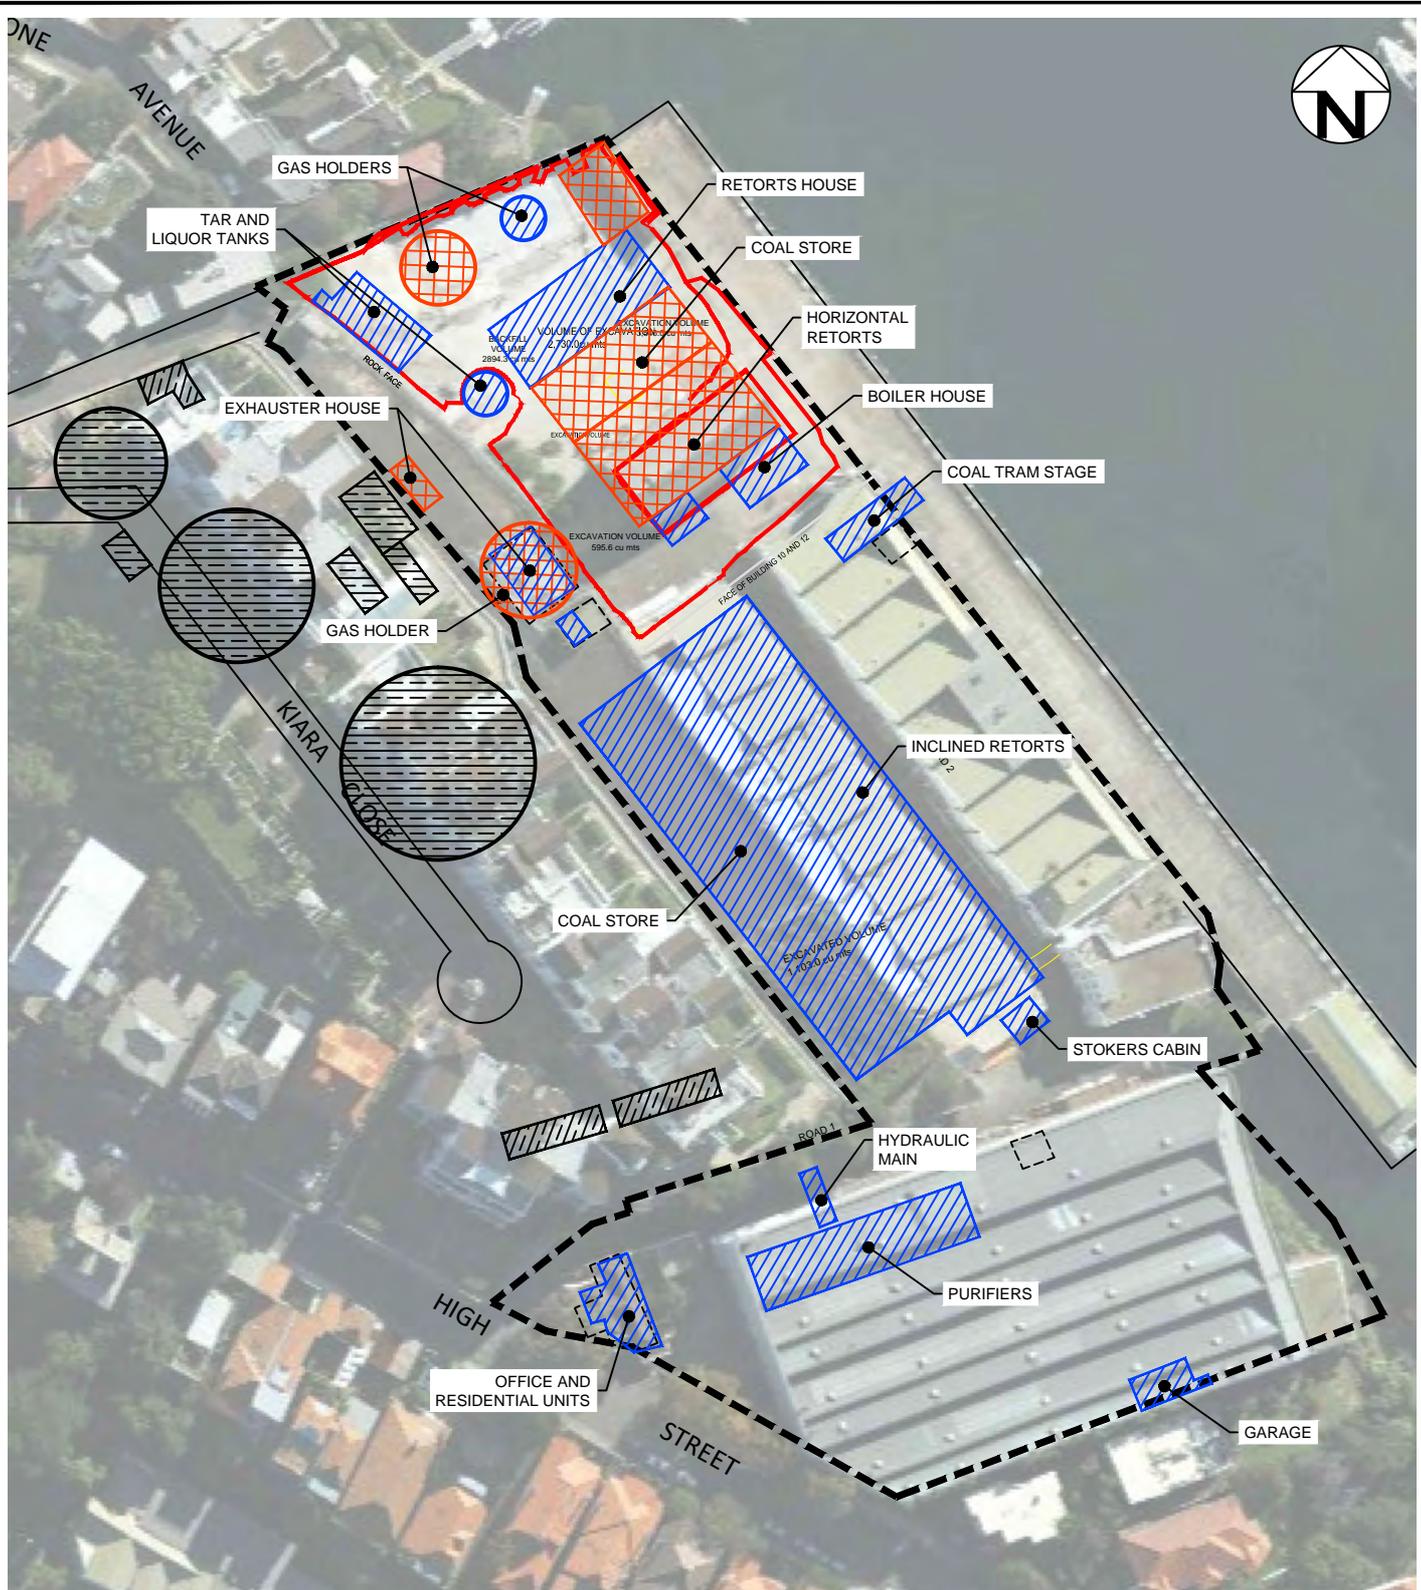
client:	THIESS SERVICES		
project:	SITE VALIDATION, PLATYPUS REMEDIATION PROJECT, 118 HIGH STREET, NORTH SYDNEY, NEW SOUTH WALES		
title:	SITE LAYOUT PLAN AND FORMER GASWORKS FEATURES		
project no:	ENAUHOD04128AB-R00A	figure no:	FIGURE 3
		rev.:	-

- APPROXIMATE SITE BOUNDARY
- APPROXIMATE LOCATION OF FOR FORMER GASWORK STRUCTURES (1890)
- APPROXIMATE LOCATION OF FORMER GASWORK STRUCTURES (1913)
- APPROXIMATE LOCATION OF FORMER GAS STRUCTURES ON THE IORA SITE

The remediation works on the Northern Remediation Area, shown outlined in red on Figure 2 and 3 of Appendix A, resulted in the removal of all soil materials to bedrock. Whilst the most significantly contaminated materials were disposed off-site, the less contaminated materials were treated on the Site. This treatment served to stabilise the primary contaminants, PAHs and TPHs, in the soils. These stabilised soils were then reinstated into the deepest areas of the resultant excavation in compacted layers and were finished above the pre-existing surface levels to form the basis of the final landscaping works. A Cap comprised of various layers of materials was then placed over the stabilised soils. The extent of the retained stabilised materials is referred to as the Northern Remediation Containment Area as shown in plans provided in Appendix C and Appendix E. Details of the Cap are provided in detail below.

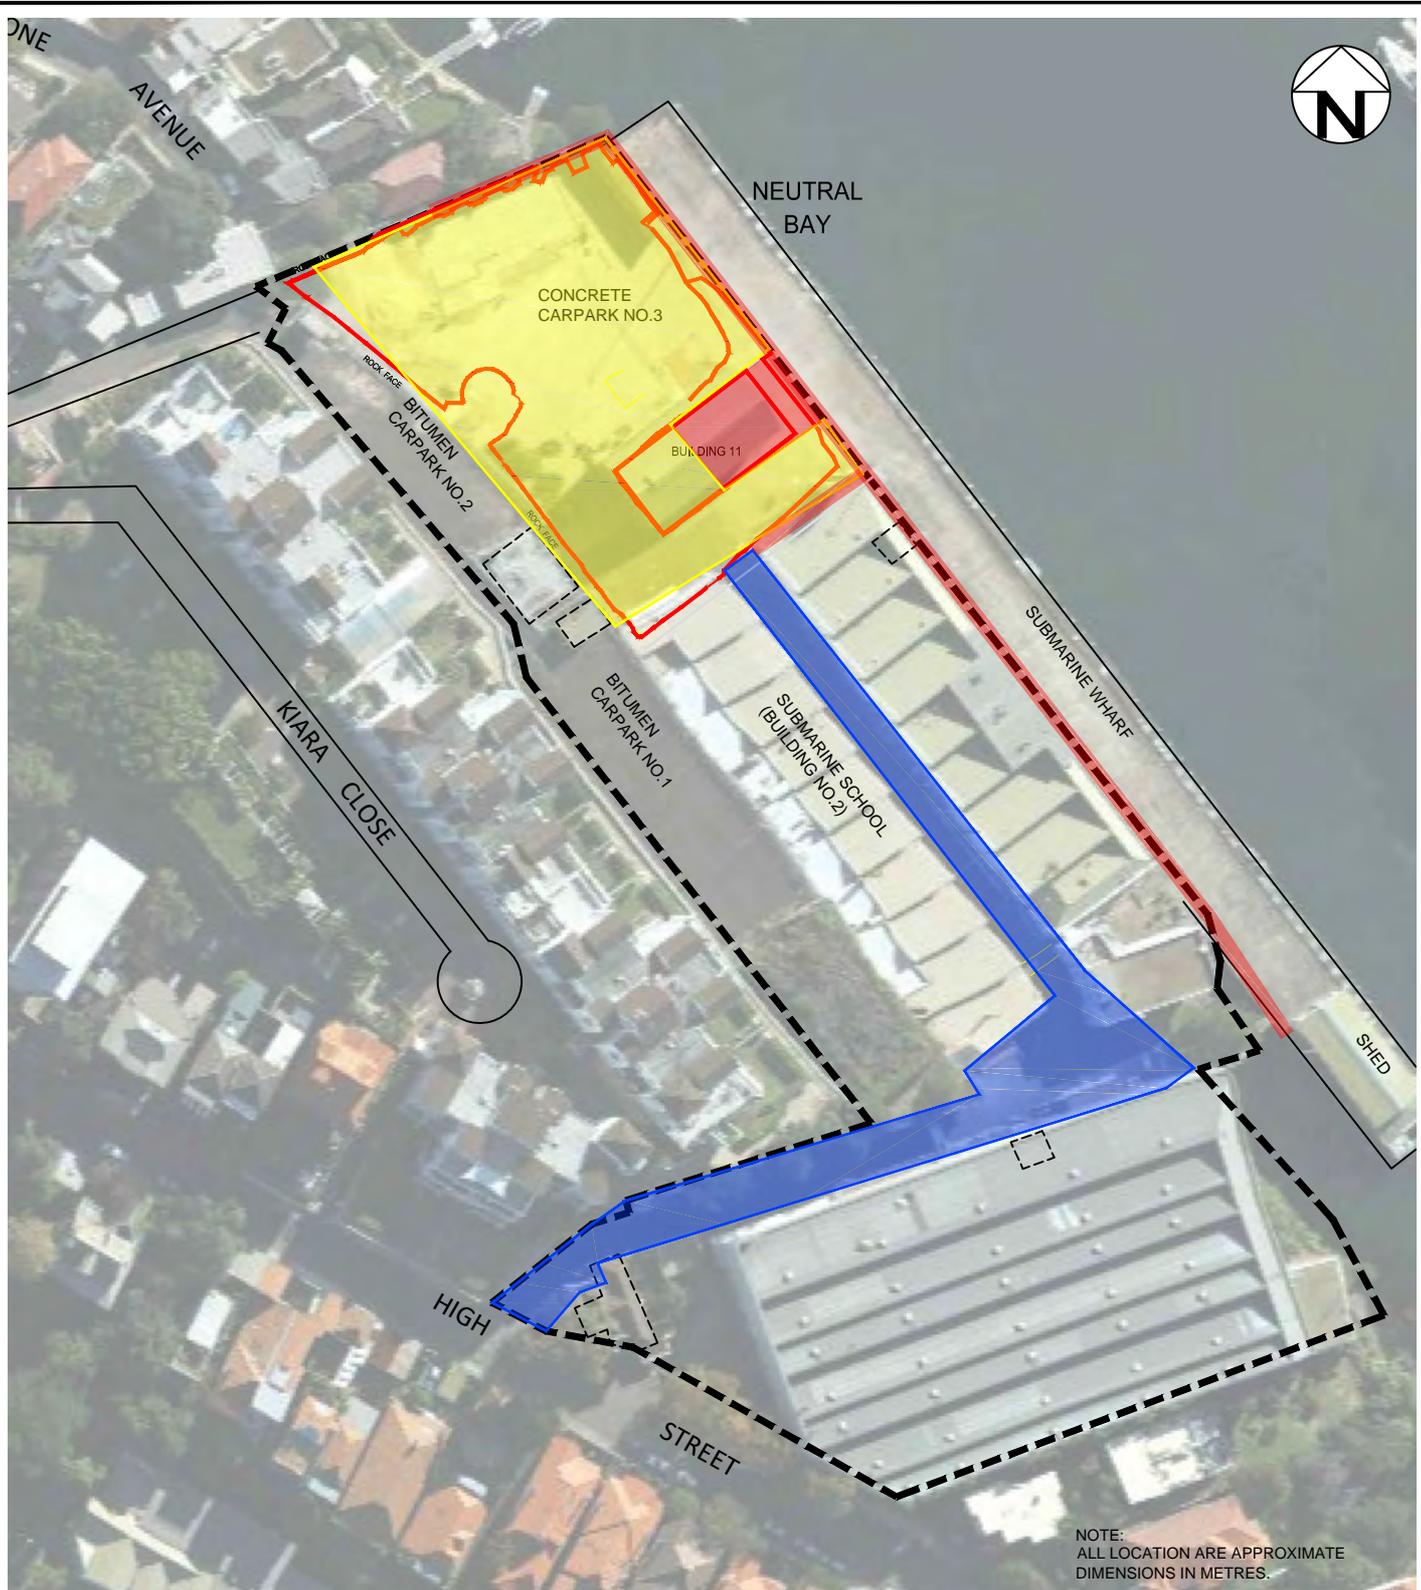
client:	THIESS SERVICES		
project:	SITE VALIDATION, PLATYPUS REMEDIATION PROJECT, 118 HIGH STREET, NORTH SYDNEY, NEW SOUTH WALES		
title:	REMEDICATION LAYOUT - MAIN ELEMENTS		
project no:	ENAUHOD04128AB-R00A	figure no:	FIGURE 4
		rev.:	-

- SITE BOUNDARY
- CONTAINMENT
- DRIVEWAY
- JET GROUT WALL / IN-SITU CONTAINMENT

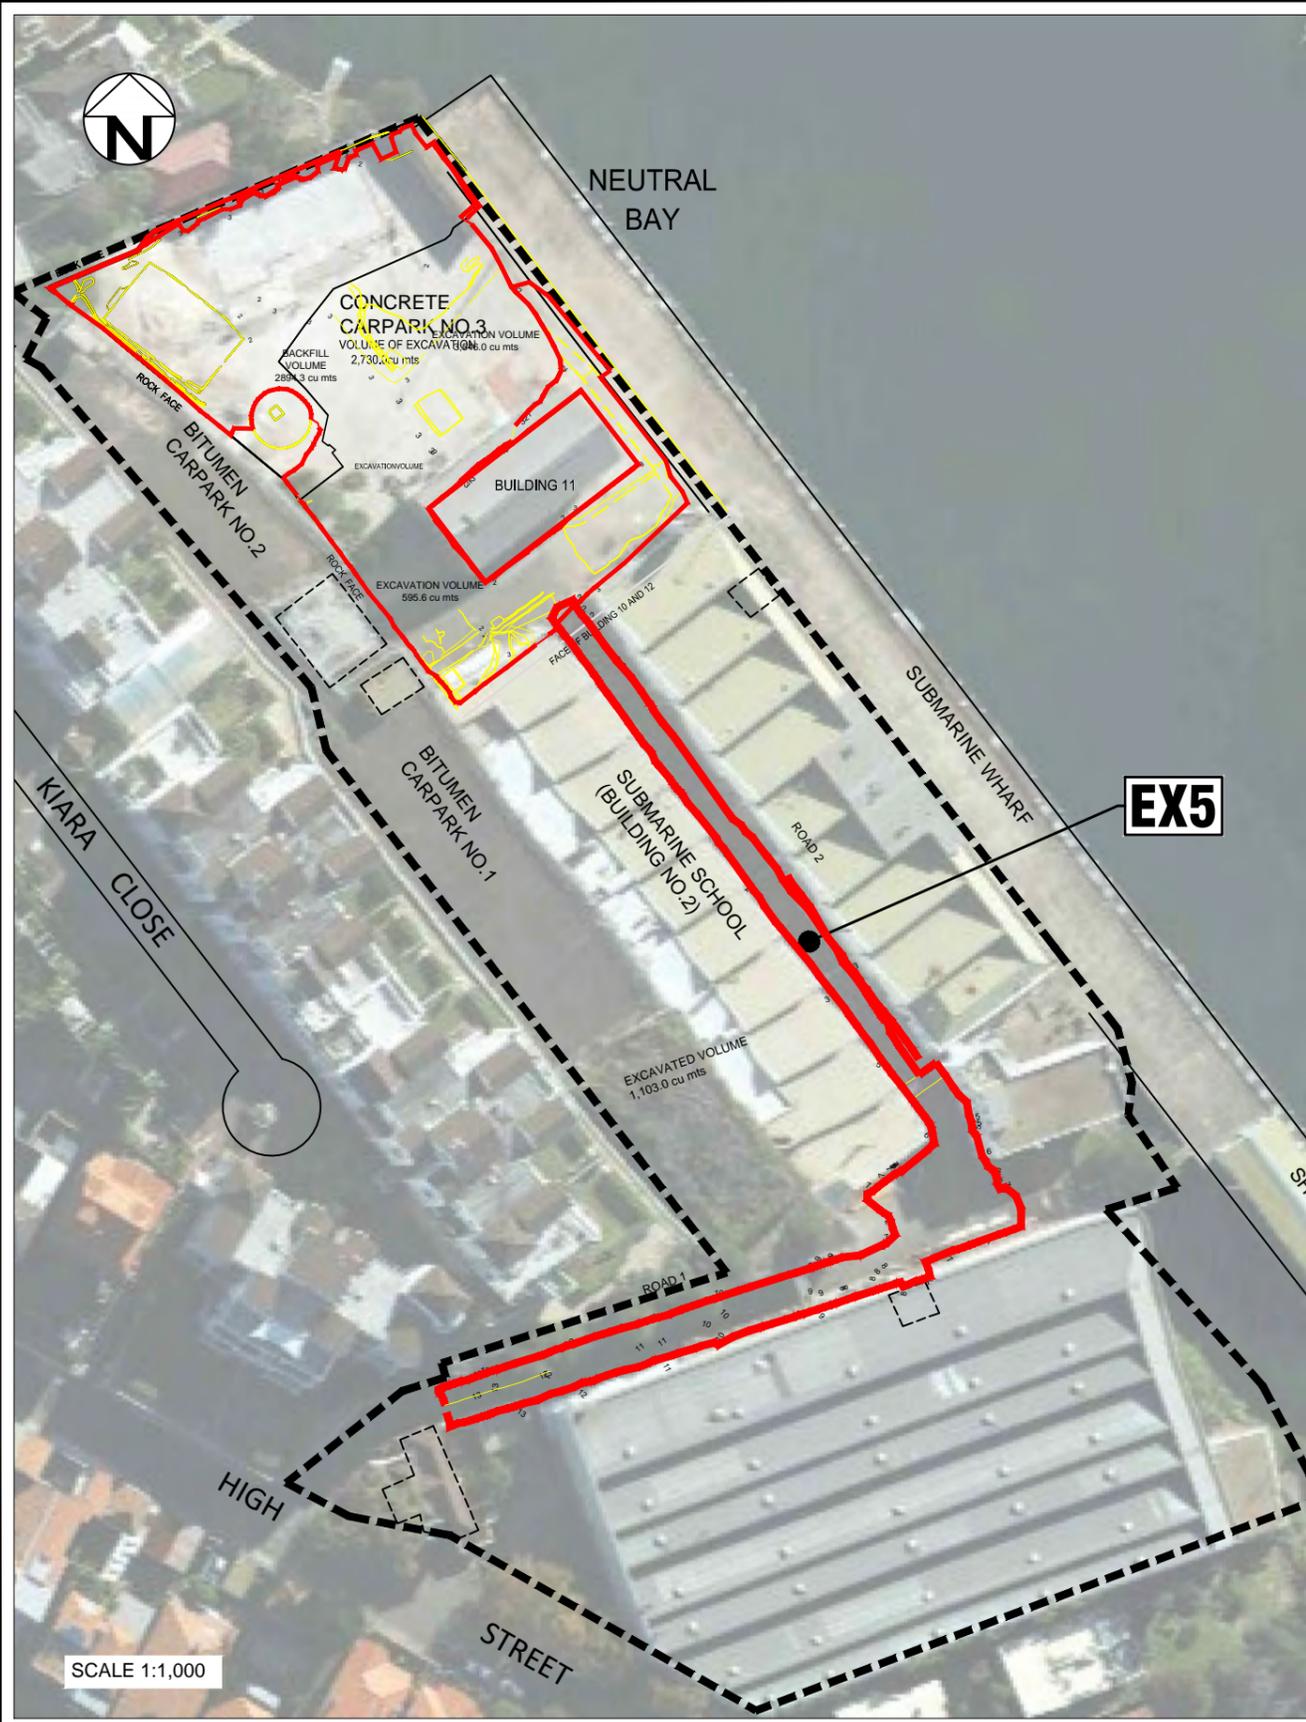
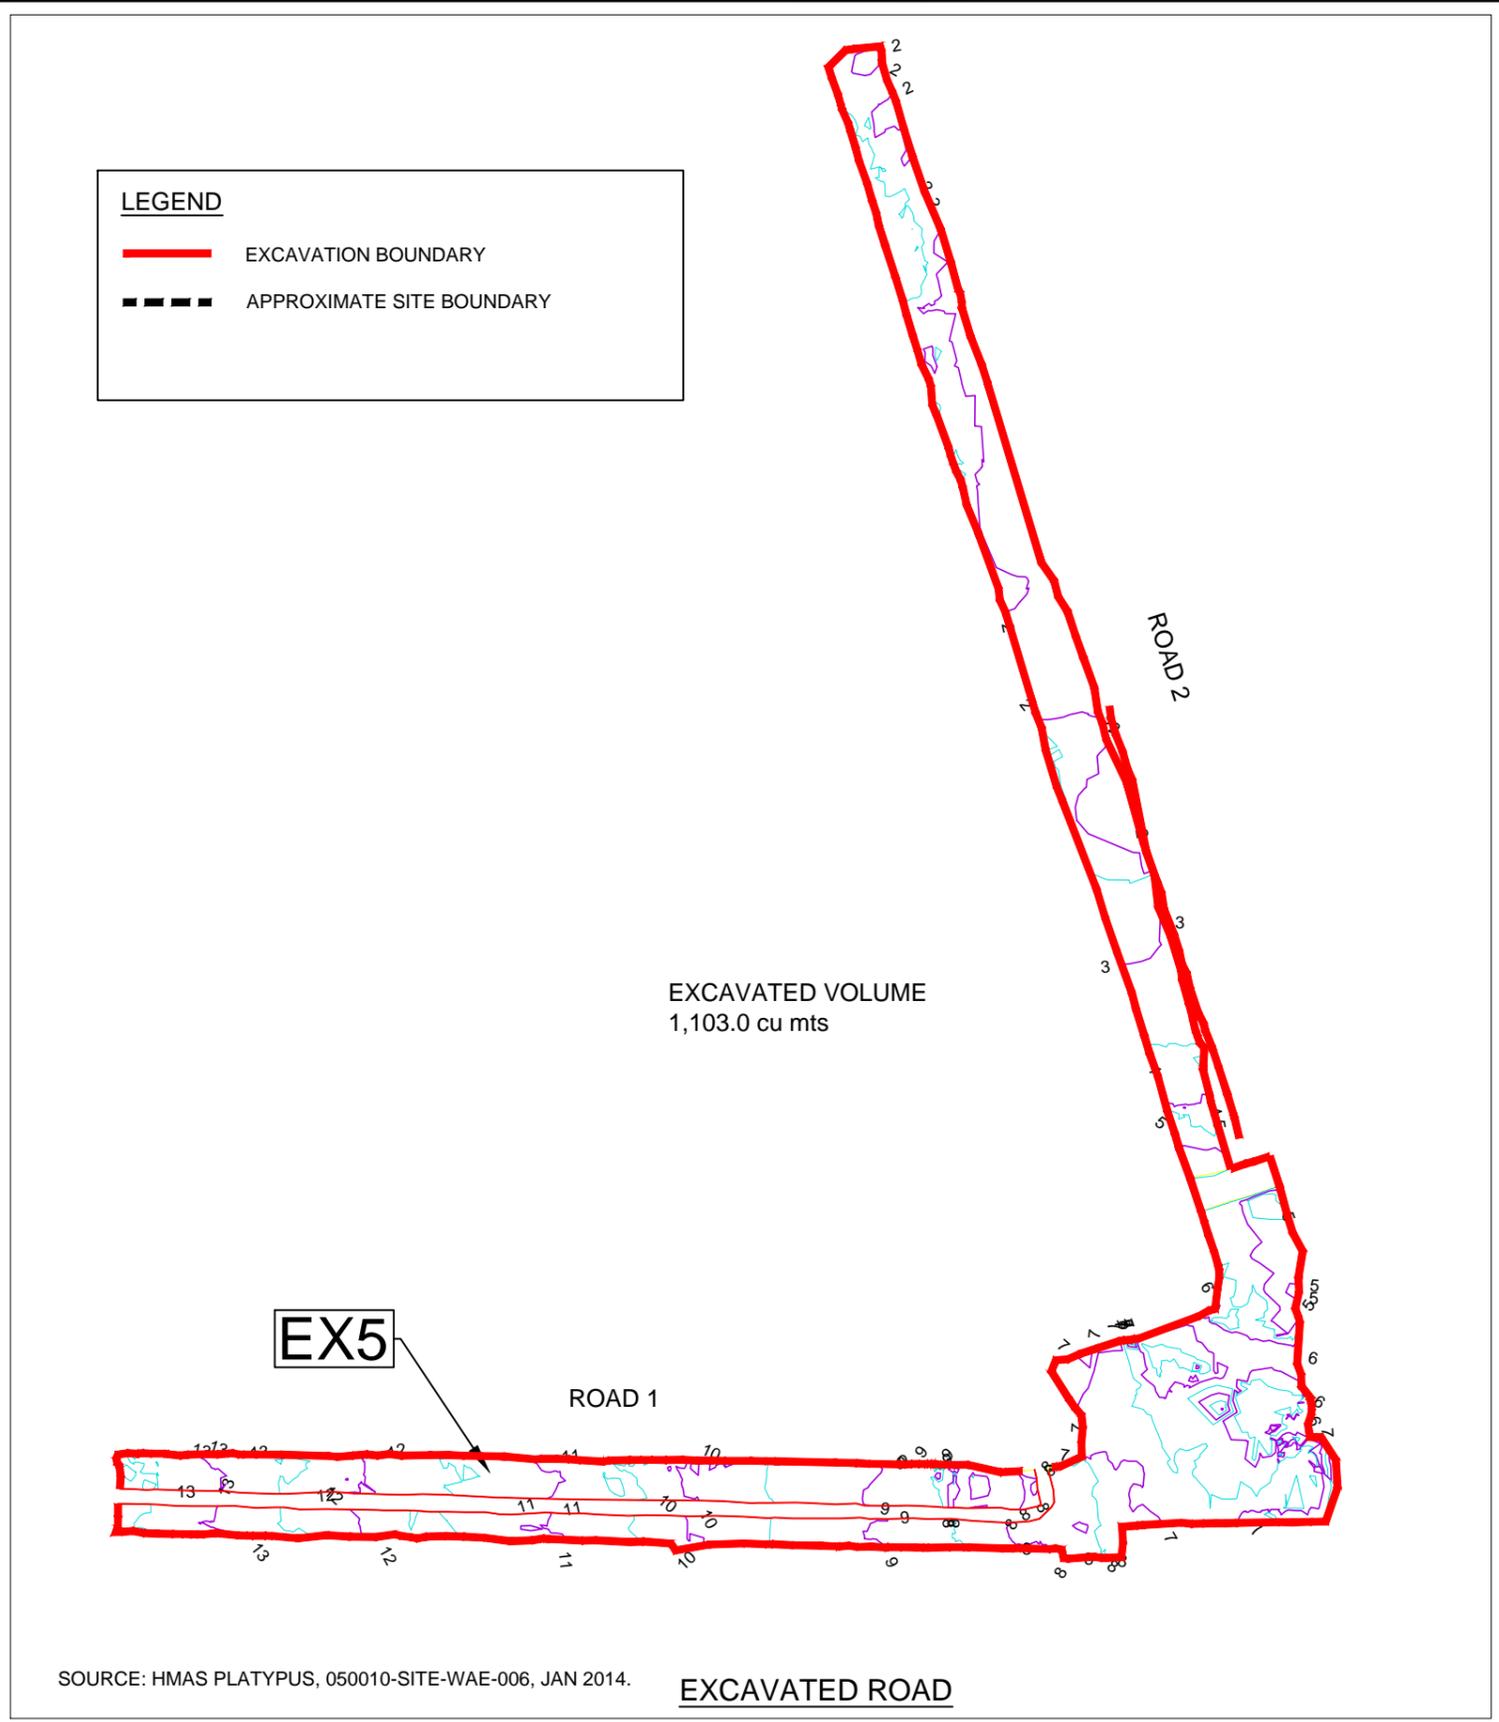
client:	THIESS SERVICES
project:	SITE VALIDATION, PLATYPUS REMEDIATION PROJECT, 118 HIGH STREET, NORTH SYDNEY, NEW SOUTH WALES
title:	REMEDIAION EXCAVATION 5
project no:	ENAUHOD04128AB-R00A
figure no:	FIGURE 10

EXCAVATED VOLUME
1,103.0 cu mts

- **Driveway Area between the Workshops (Building No.10) and the Submarine School (Building No.2)** (as shown in Figure 10 of Appendix A) – The driveway that extends from High Street in an L-shape to the southern boundary of the Northern Remediation Containment Area was subject to excavation to depths of 1.2 metres below the ground surface (m bgs) or to/into sandstone bedrock, whichever was first encountered.

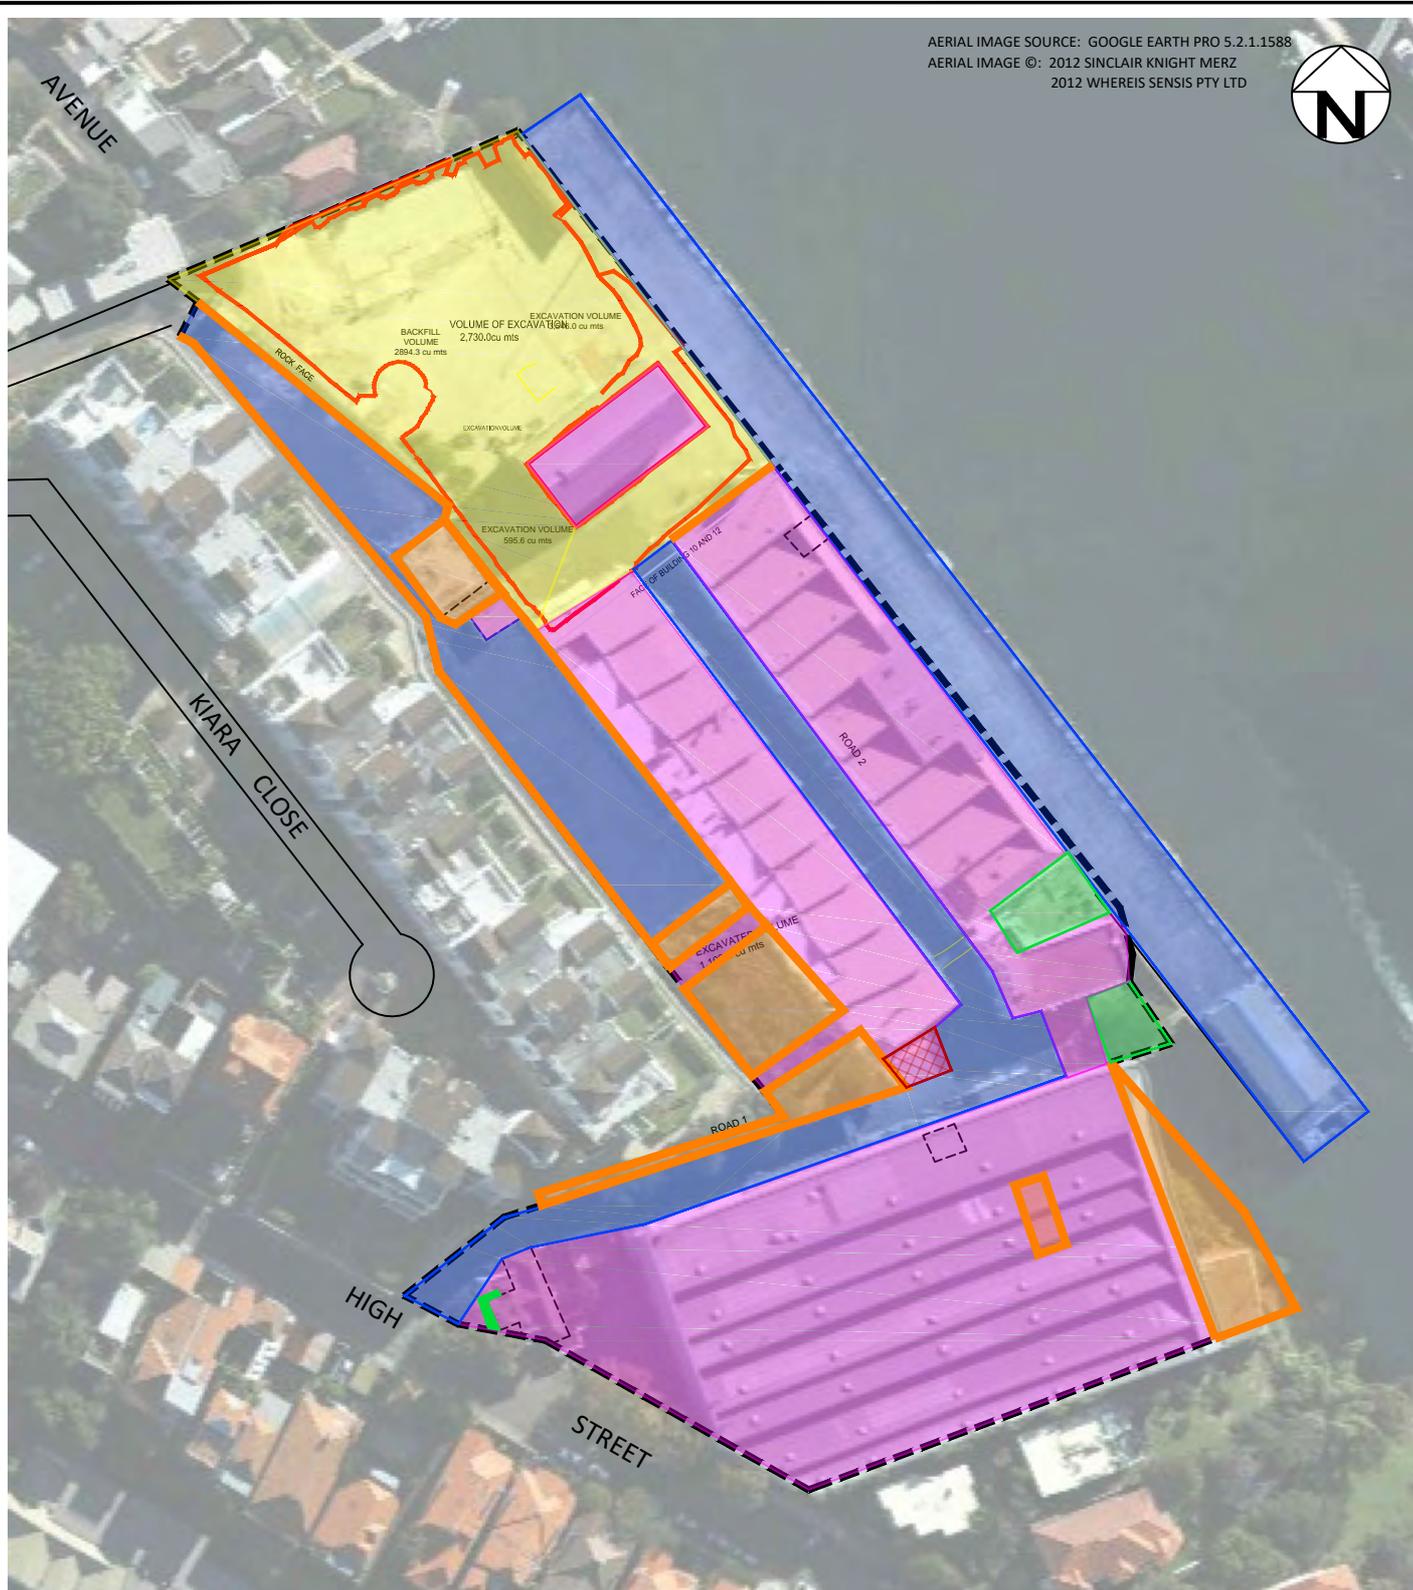
client:	THIESS SERVICES		
project:	SITE VALIDATION, PLATYPUS REMEDIATION PROJECT, 118 HIGH STREET, NORTH SYDNEY, NEW SOUTH WALES		
title:	IN-SITU CONTAINMENT		
project no:	ENAUHOD04128AB-R00A	figure no:	FIGURE 13
		rev.:	-

- APPROXIMATE SITE BOUNDARY
- ASPHALT SEALED
- CONCRETE FLOOR SLABS
- EXPOSED SANDSTONE SURFACES
- GRASS
- EXPOSED CAP
- SUBSTATION

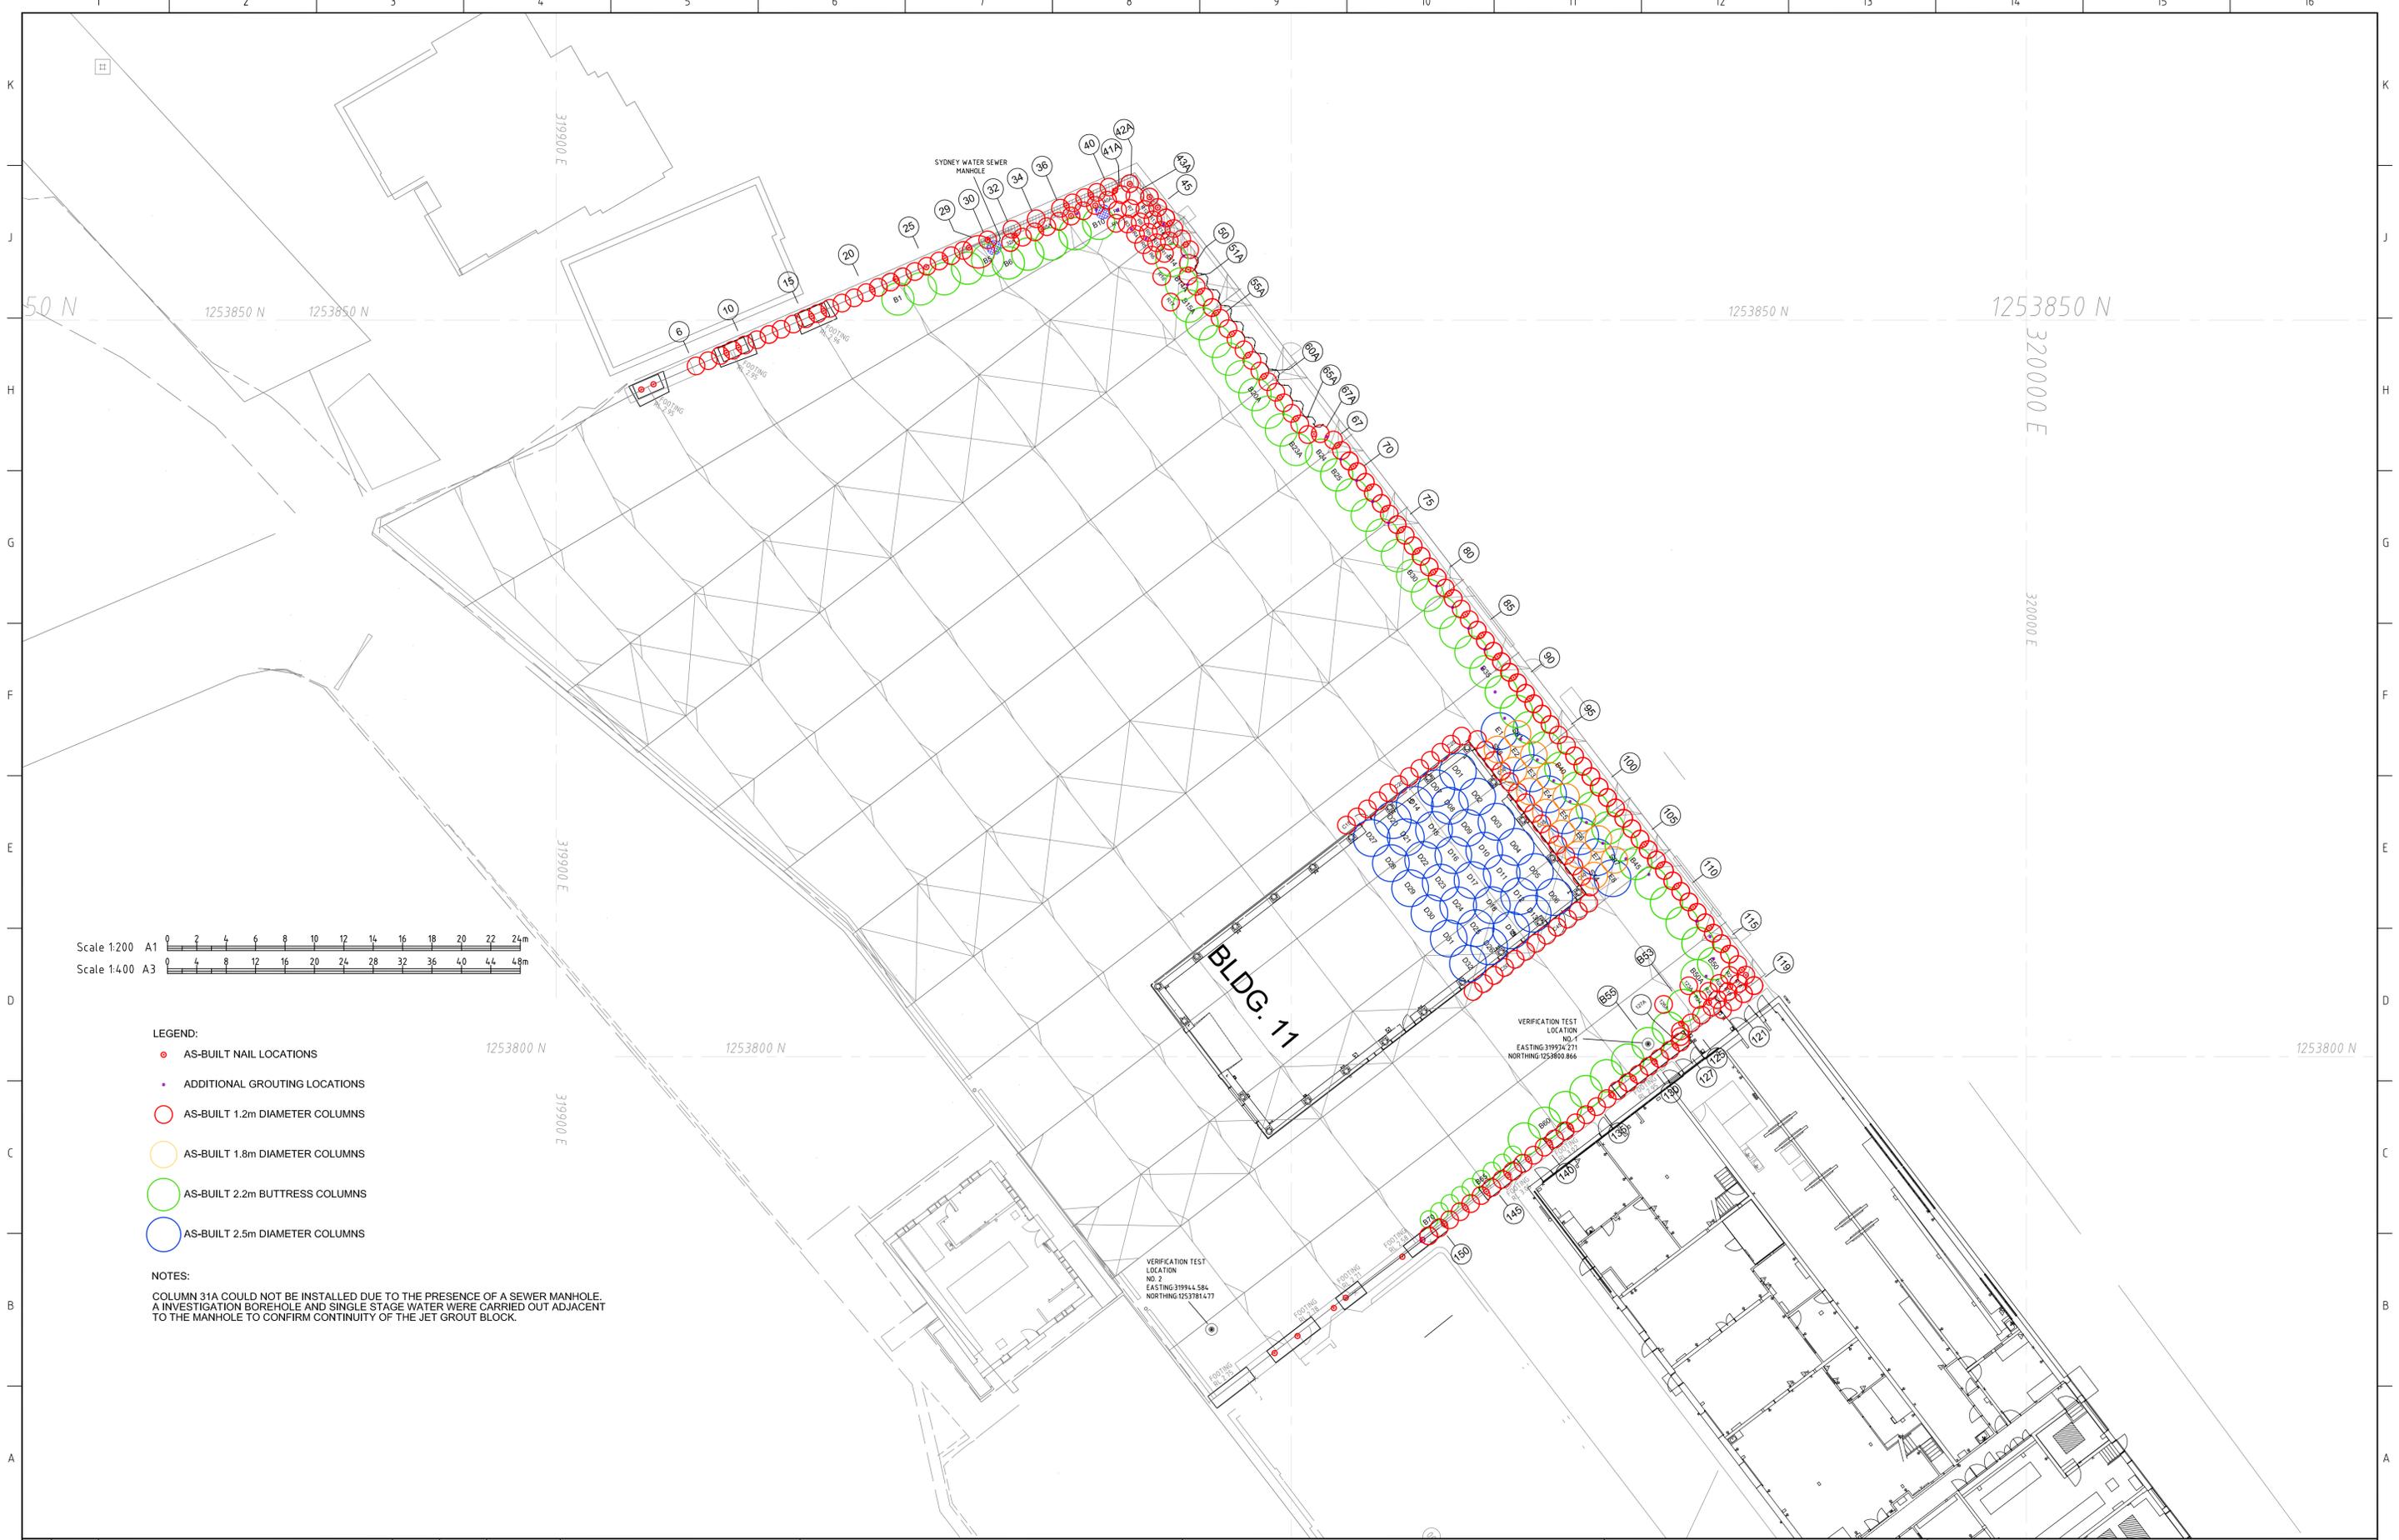
- LEGEND:**
- AS-BUILT NAIL LOCATIONS
 - ADDITIONAL GROUTING LOCATIONS
 - AS-BUILT 1.2m DIAMETER COLUMNS
 - AS-BUILT 1.8m DIAMETER COLUMNS
 - AS-BUILT 2.2m BUTTRESS COLUMNS
 - AS-BUILT 2.5m DIAMETER COLUMNS

NOTES:
 COLUMN 31A COULD NOT BE INSTALLED DUE TO THE PRESENCE OF A SEWER MANHOLE. AN INVESTIGATION BOREHOLE AND SINGLE STAGE WATER WERE CARRIED OUT ADJACENT TO THE MANHOLE TO CONFIRM CONTINUITY OF THE JET GROUT BLOCK.

1. Column diameters and positions shown are at slab level

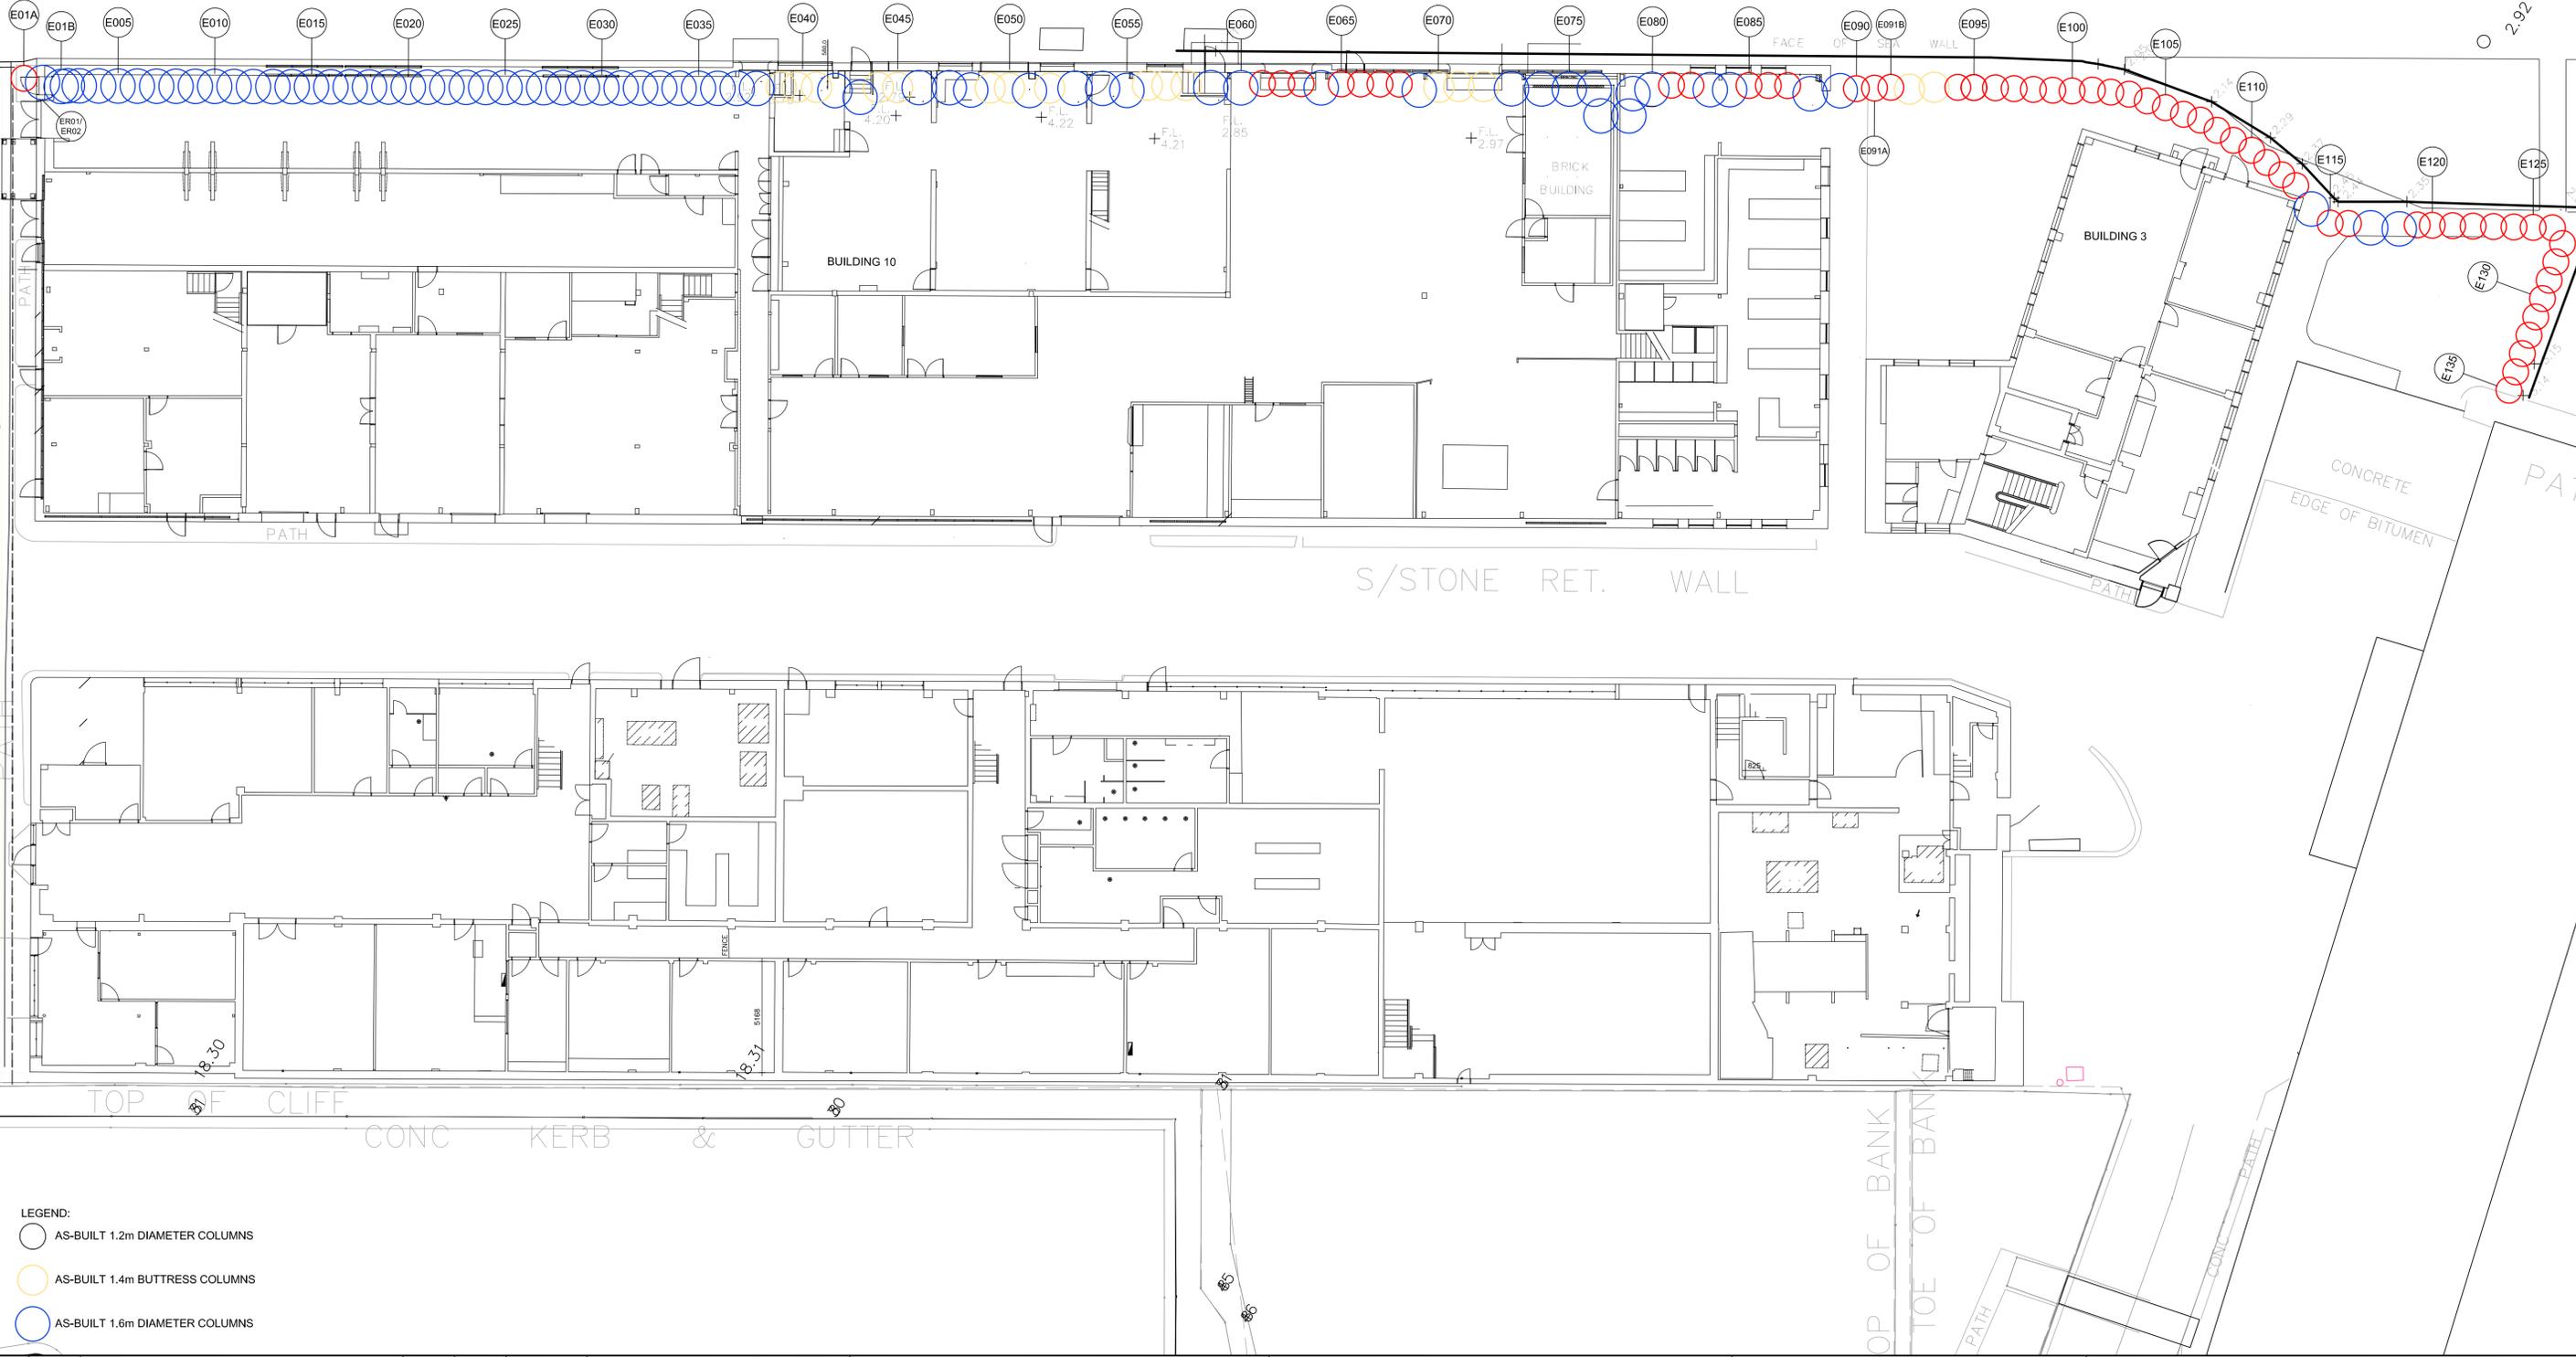
HMAS PLATYPUS STAGE 2 REMEDIATION WORKS		
DRAWING TITLE		
AS BUILT COLUMN LOCATIONS		
CENTRAL SECTION		
PLAN VIEW		
SCALE	DRG NO.	REV
A1 1:150	050010-JGW-WAE-003	A

- LEGEND:
- AS-BUILT 1.2m DIAMETER COLUMNS
 - AS-BUILT 1.4m BUTTRESS COLUMNS
 - AS-BUILT 1.6m DIAMETER COLUMNS
