FINAL REPORT

Long-term Environmental Management Plan

Platypus Site, High Street, North Sydney NSW

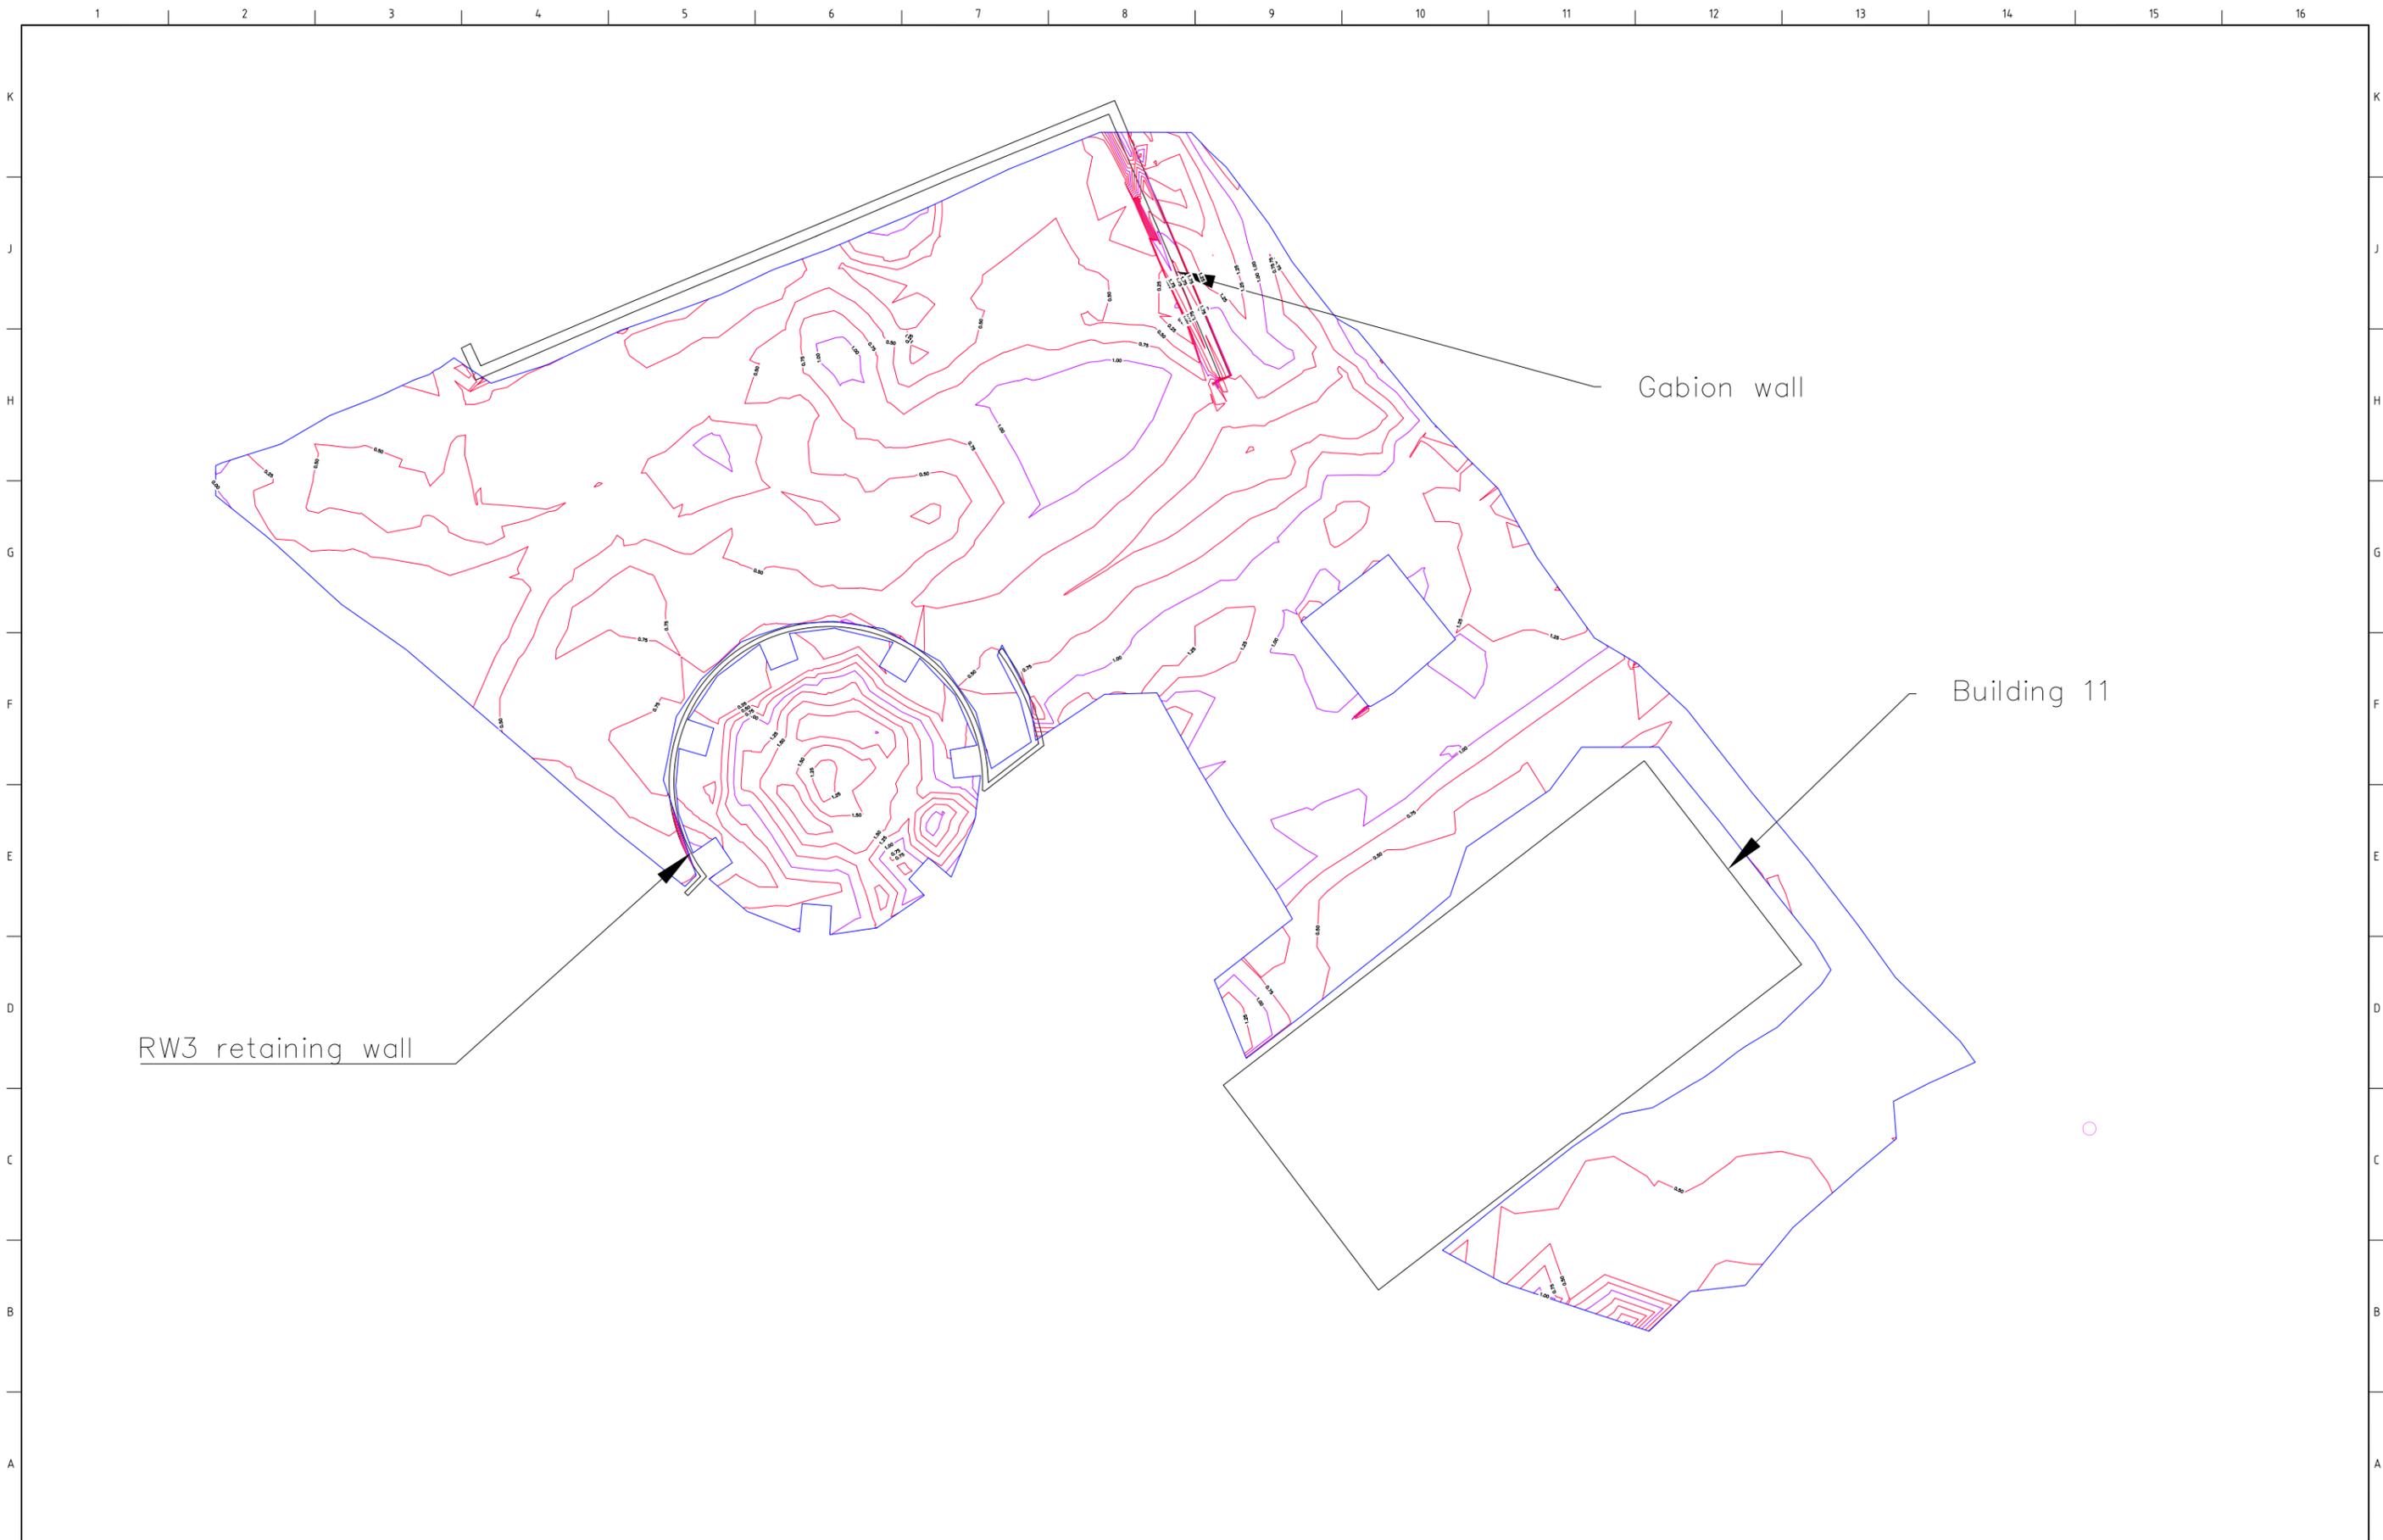
- G 10.00 GEOSYNTHETIC CLAY LINER LEVEL
- [Grid Pattern] EXTENT OF GEOSYNTHETIC CLAY LINER AND TREATED FILL

- GCL Interfaces - Legend
- [Red Line] GCL interface with Gabion walls - refer Detail C of Drawing 050010 - CAP-CIVIL - 038
 - [Blue Line] GCL interface with structures - refer Detail A of Drawing 050010 - CAP-CIVIL - 038
 - [Orange Line] GCL interface with rock - refer Detail E of Drawing 050010 - CAP-CIVIL - 038
 - [Yellow Line] GCL interface with sandstone wall - refer Detail B of Drawing 050010 - CAP-CIVIL - 038.

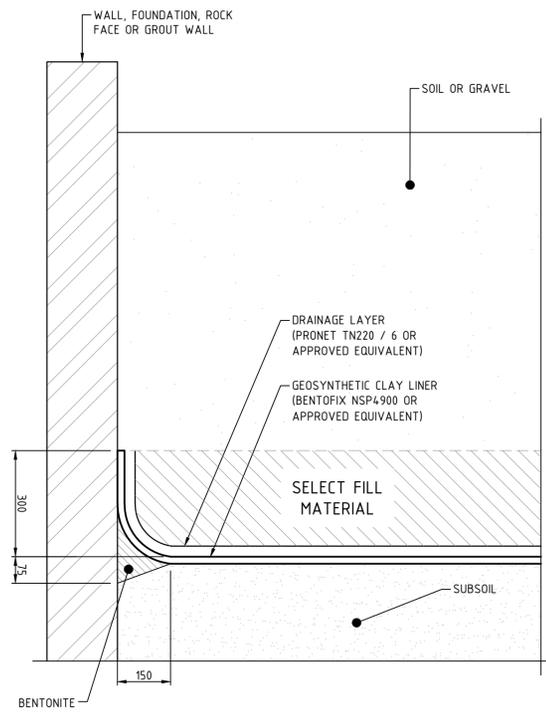
DETAIL SCALE 1:10
SEALING GEOSYNTHETIC CLAY LINER TO STRUCTURES

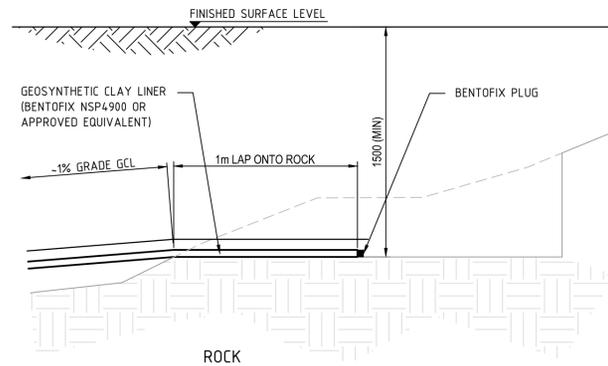
DETAIL SCALE 1:10
ANCHORING TRENCH FOR GEOSYNTHETIC CLAY LINER

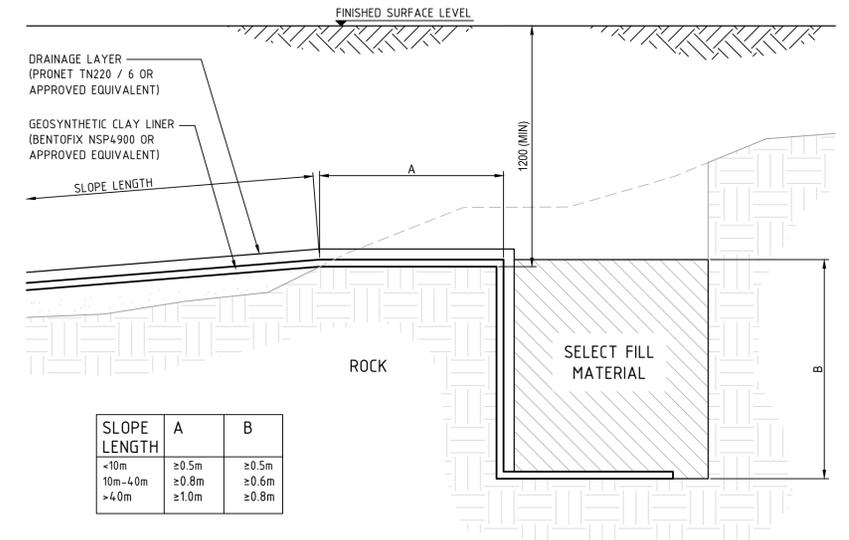
SLOPE LENGTH	A	B
<10m	≥0.5m	≥0.5m
10m-4.0m	≥0.8m	≥0.6m
>4.0m	≥1.0m	≥0.8m

DETAIL SCALE 1:10
ANCHORING TRENCH FOR GEOSYNTHETIC CLAY LINER

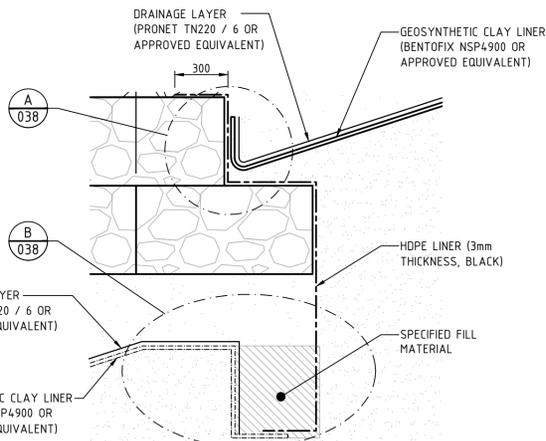
DETAIL SCALE 1:20
GEOSYNTHETIC CLAY LINER AT GW4 GABION WALLS

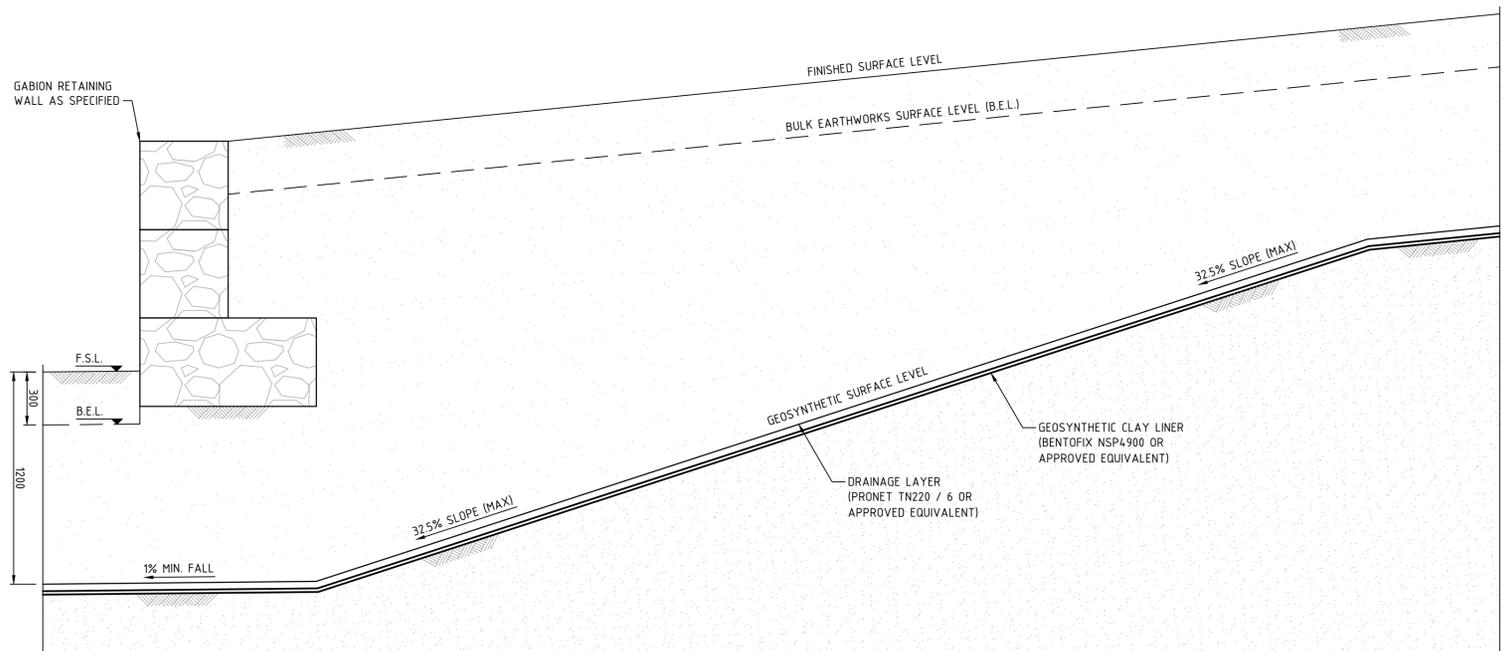
GEOSYNTHETIC CLAY LINER UNDER RETAINING WALL - TYPICAL DETAIL
 SCALE 1:20

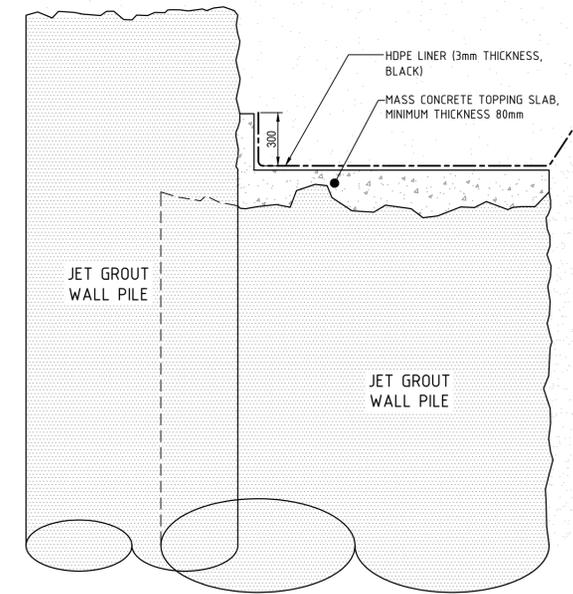
DETAIL SCALE 1:20
SEALING HDPE LINER TO GROUT WALL

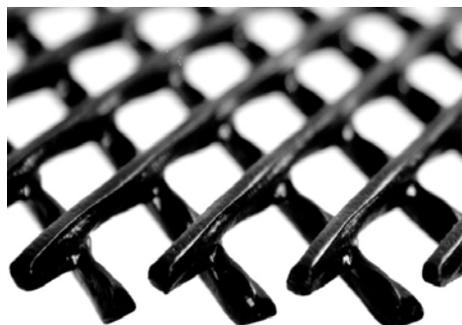
INTERDRAIN M5 is a high-density polyethylene (HDPE) geonet. The geonet is made with 2 overcrossed strands at 60°, whose geometry create channels with a high flow capacity, also under pressure and at very low gradients.

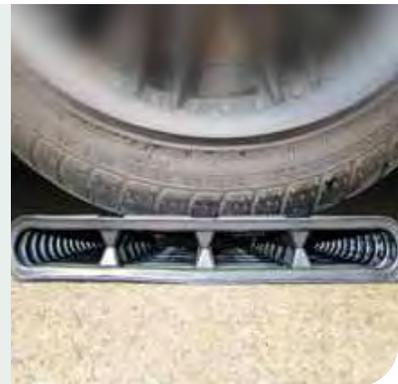
Strength

Vertically installing the **Megaflo**® drainage panel utilises the ribbed structure to provide higher strength under traffic loads. The properties of high compressive modulus, longitudinal stiffness and structural rigidity aids the mechanical performance of **Megaflo**®, ensuring the long term hydraulic flow capacity of the drain. High structural strength allows for a minimum cover depth of 100mm, recommended for **Megaflo**® in most applications. **Megaflo**® typically requires less backfill in comparison to a traditional trench which results in cost savings and faster installation.

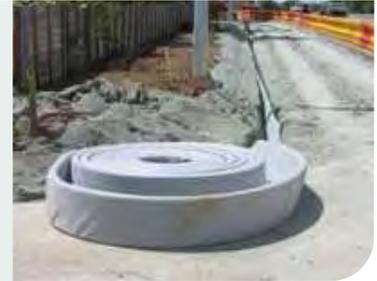
ROADSIDE EDGE DRAINS

Megaflor® provides faster and higher inflow capacity due to its high trench installation profile and earlier interception of pavement infiltration. **Megaflor**® has a high compressive modulus and structural rigidity (preventing deflection under normal service loads), due to its elongated ribbed profile incorporating internal support.

Simple installation techniques provide installation savings compared to a traditional round pipe drainage system.

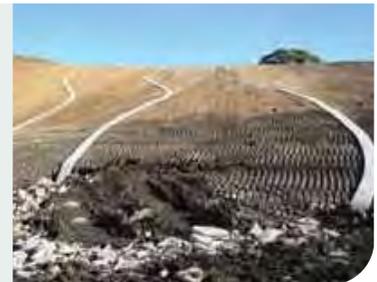
LANDFILL

Landfill leachate and gas collection systems are an integral part of landfill design for lining and capping systems.

The high compressive strength of **Megaflor**® under normal and inclined loads makes it the ideal product for a range of landfill drainage applications.

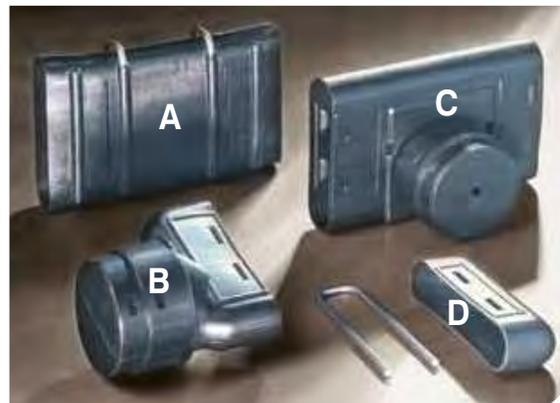
Fittings are available to suit all Megaflo® sizes:

- **Megaflo®** couplers are a high strength, secure means to join continuous sections of **Megaflo®**, inserted beneath the geotextile.
- Connecting to 100mm diameter round pipe is easily achieved using either the **Megaflo®** side outlet or **Megaflo®** end outlet where required.
- **Megaflo®** end caps can be fitted to terminations to prevent backfill ingress into the system. Other fittings are available for connecting **Megaflo®** in various arrangements depending on the application.

A	Joiner Coupling	C	Side Outlet
B	End Outlet	D	End Cap

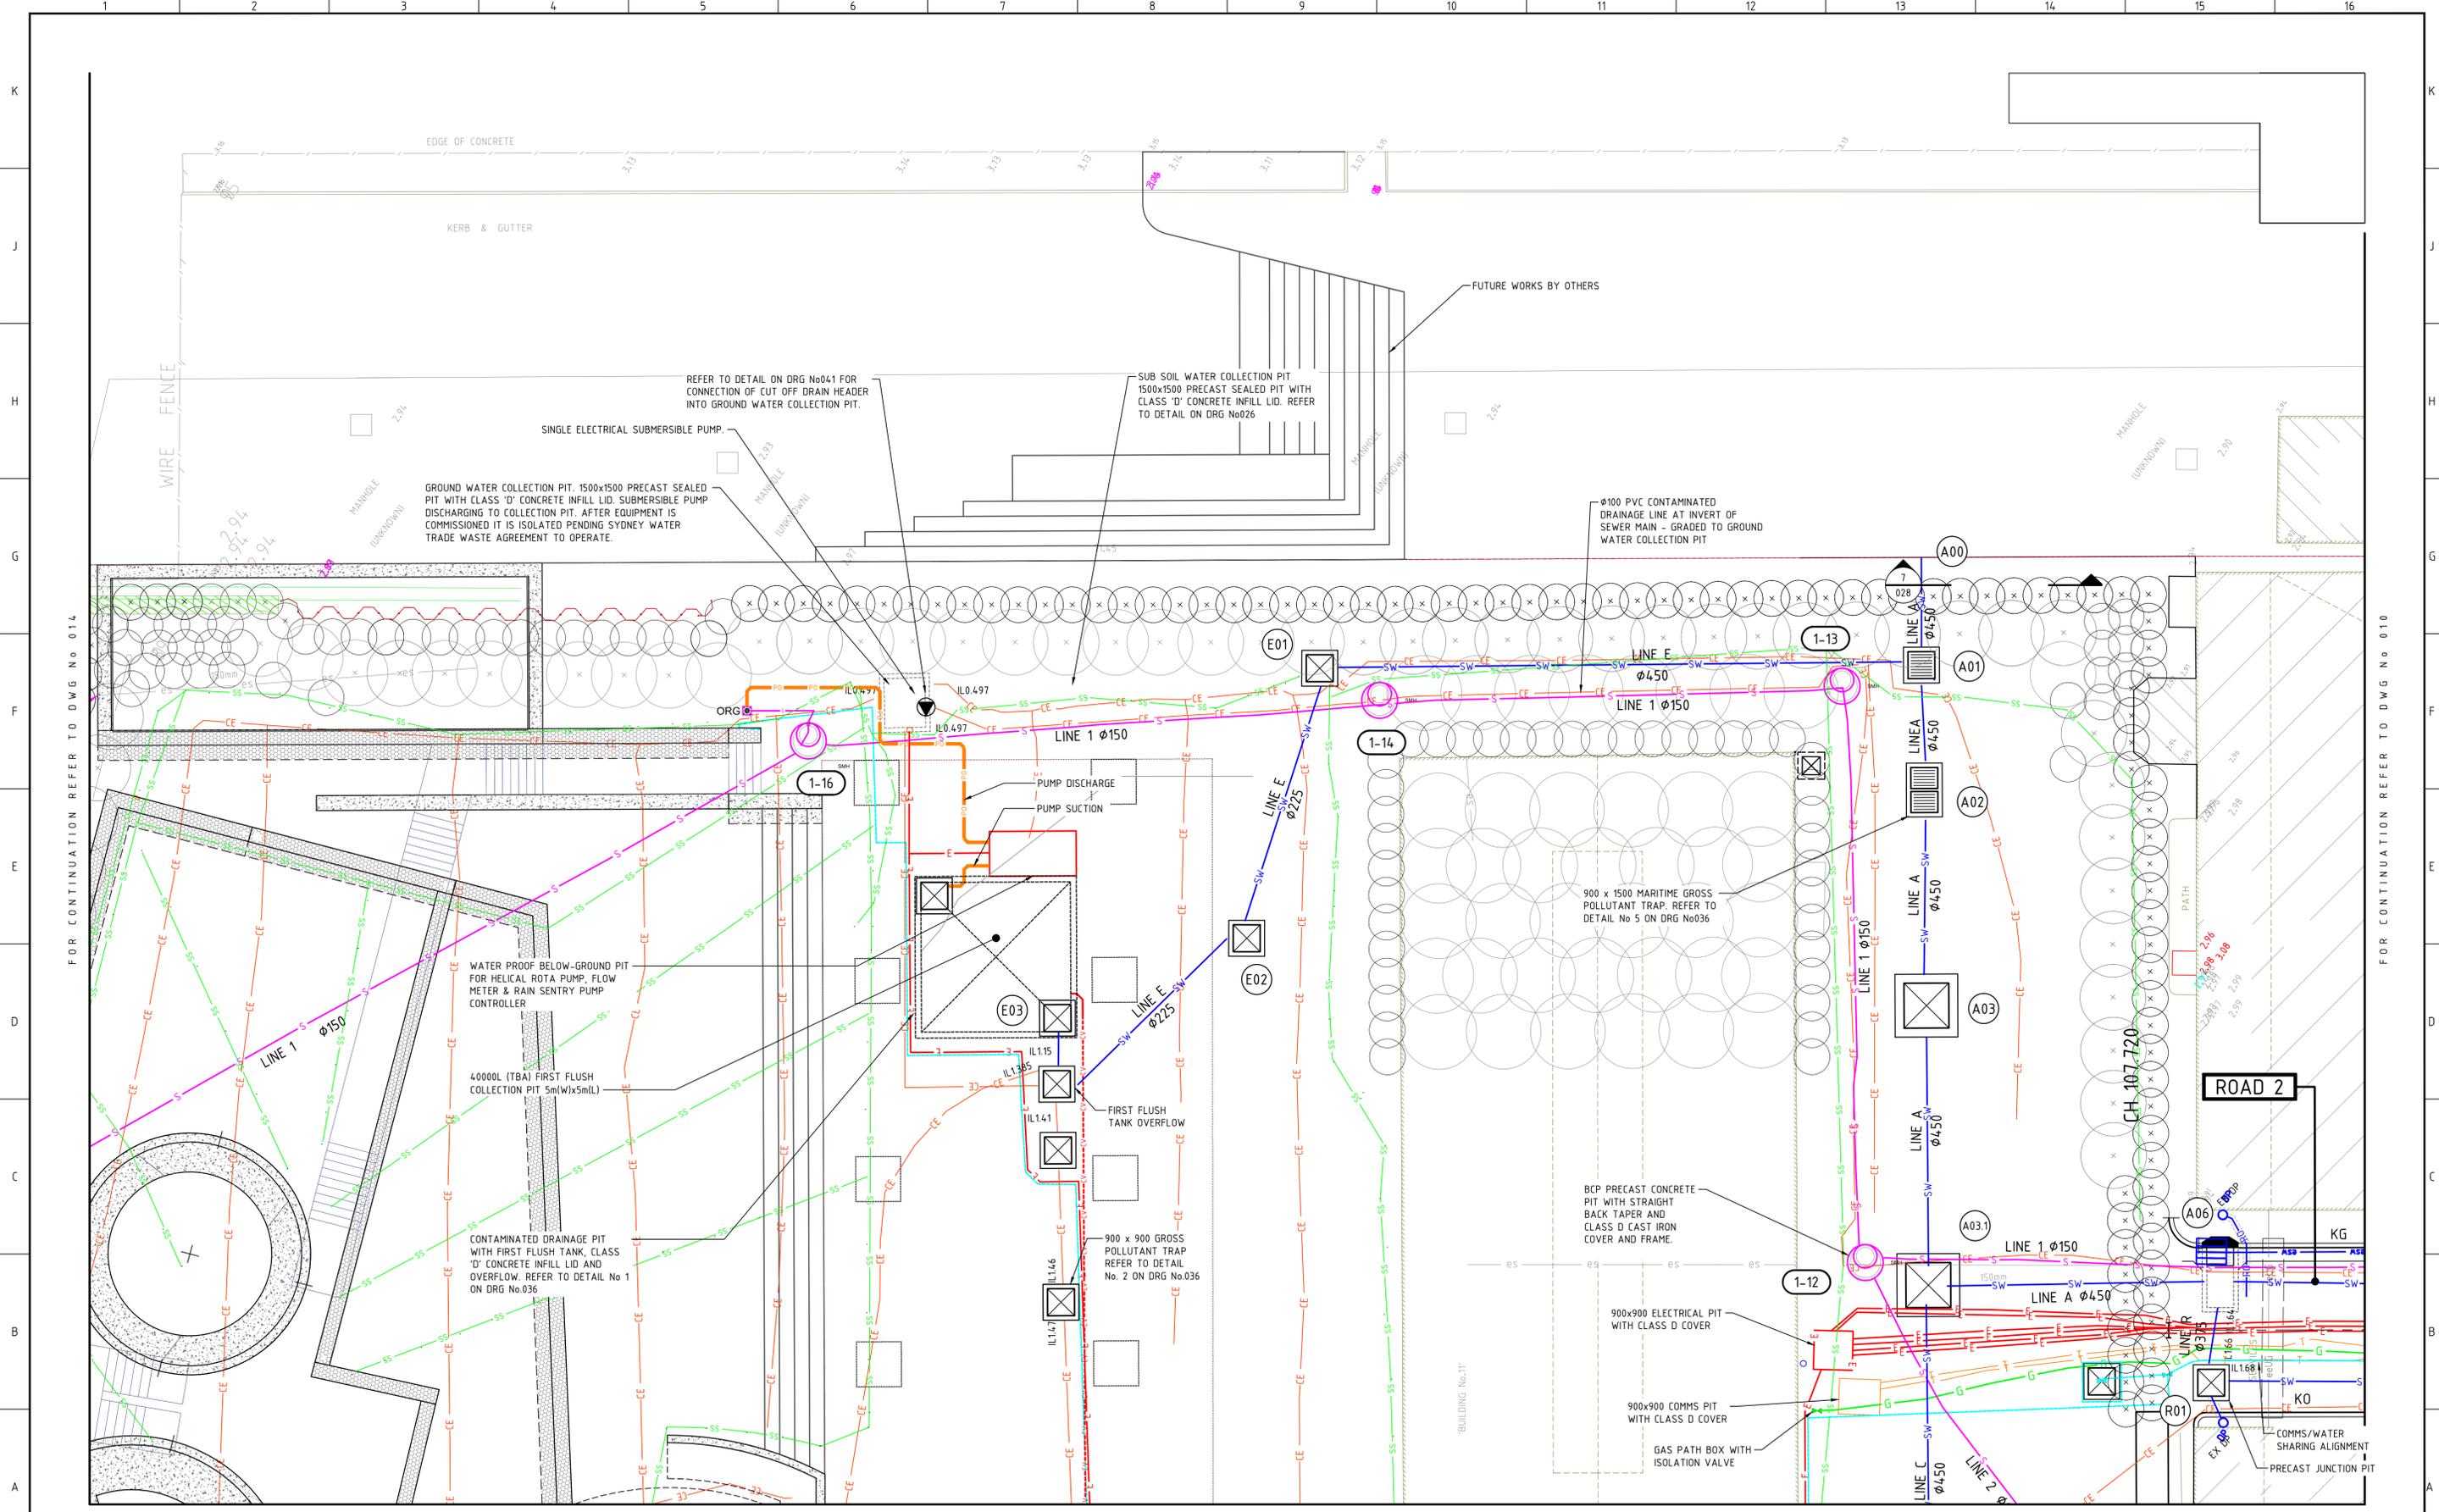
HMAS PLATYPUS STAGE 2 REMEDIATION WORKS		REV	WAE
DRAWING TITLE		SCALE	A1 1:100
SITWORKS PLAN		DRG NO.	050010-CAP-CIVIL-011
SHEET 4 OF 7

Appendix G: Drainage System As-Builts in Northern Remediation Containment Area
