## FINAL REPORT

# Long-term Environmental Management Plan, Platypus Site High Street, North Sydney NSW

**10 May 2018**

**CONSARA Pty Ltd**  
ABN: 27 161 027 881  
ACN: 161 027 881  
Suite 2, Unit 6, 10 Rodborough Road Frenchs Forest NSW 2100  
PO Box 7360 Warringah Mall NSW 2100  
admin@consara.com.au

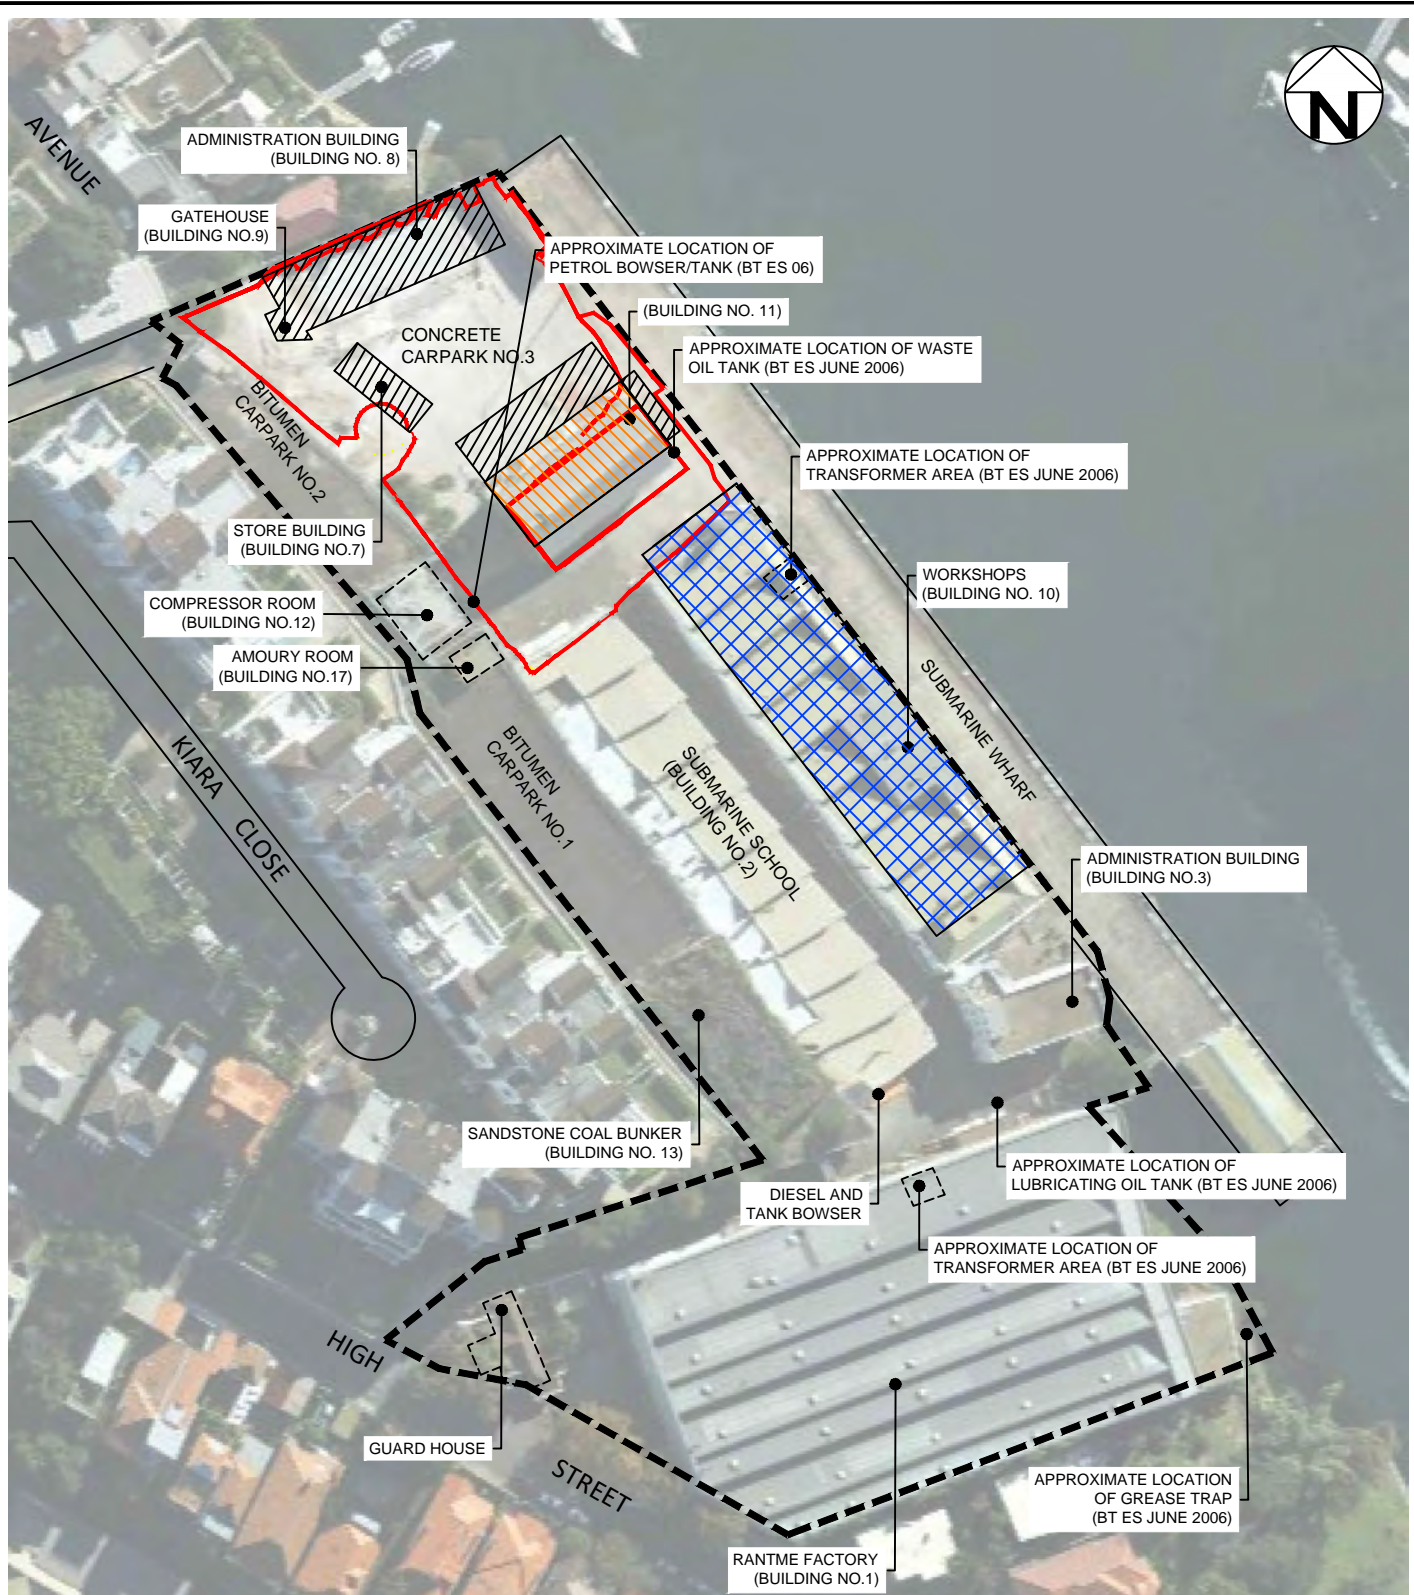
client:	THIESS SERVICES		
project:	SITE VALIDATION, PLATYPUS REMEDIATION PROJECT, 118 HIGH STREET, NORTH SYDNEY, NEW SOUTH WALES		
title:	SITE LAYOUT PLAN AND FEATURES		
project no:	ENAUHOD04128AB-R00A	figure no:	FIGURE 2
		rev.:	-

- APPROXIMATE SITE BOUNDARY
- BUILDING TO BE USED TO STORE BUILDING 11 (WHEN BUILDING 11 IS DISMANTLED)
- BUILDING 7 & 8 WERE DEMOLISHED IN 2010
- BUILDING OF FORMER RETORT HOUSE

- Stage 1 – Preparatory works including hazardous materials removal or stabilisation in all buildings, demolition of the administration building (Building No. 8 – see Figure 2 in Appendix A) and Store (Building No. 7- see Figure 2 in Appendix A) and wharf repairs;

- Other ancillary remediation works included installation of a jet-grout cut off wall along the lower eastern boundary of the Site (alignment shown in Appendix D), in-situ stabilisation of soil materials beneath the former retort house (Building No. 11 see Figure 2 in Appendix A and plans in Appendix D), containment of existing contaminated and potentially contaminated soils beneath existing buildings and paved surfaces and construction of a seepage collection system at the base of the cut sandstone walls on Site;

- **RANTME Factory (Building No.1), Administration Building (Building No.3), Coal Bunker House (Building No.13) and Compressor House (Building No. 12)** (see Figure 2 of Appendix A) – These buildings were subject to various remedial works, including excavation and removal of contaminated materials present in the floors or sub-floors and, where practicable, re-surfacing with concrete. The final surfaces of these areas is shown on Figure 13 of Appendix A. However, there remains the potential for contaminated materials to have been retained beneath the ground floor slabs, retained on-ground slabs and footings and/or for hazardous building materials to be present; and

- **Guardhouse Building and surrounding garden area (see Figure 2 of Appendix A)** – The former guardhouse building and surrounding garden bed areas are located at the entrance to the Site from High Street and was not subject to any remedial works during the remediation and validation of the Site. Detailed investigations on this area of the Site were completed by CONSARA in April 2018 (as reported in ‘*Environmental Site Assessment, Guardhouse Site located within the Platypus Site, High Street North Sydney NSW*’ prepared by CONSARA and dated 27 April 2018). The results of this investigation identified that the building appears to be underlain by sands and then bedrock whilst the concrete sealed and unsealed garden bed areas surrounding the building were underlain by a shallow horizon of fill materials that were directly underlain by weathered sandstone and sandstone bedrock. There was no evidence of significant or gross contamination, however, the soil analytical results identified concentrations of carcinogenic PAHs in the fill materials present at the surface and in the sub-surface in various locations surrounding the building, both beneath concrete hardstand and unsealed garden areas, that were greater than the adopted assessment criteria for open space land use but were less than the criteria for commercial/industrial land use. Chrysotile asbestos as fibres was also identified in one sample of fill materials collected from a depth of 0.2-0.3 m bgs from the rear garden area at concentrations that were greater than the adopted assessment criteria for open space and commercial/industrial land use.

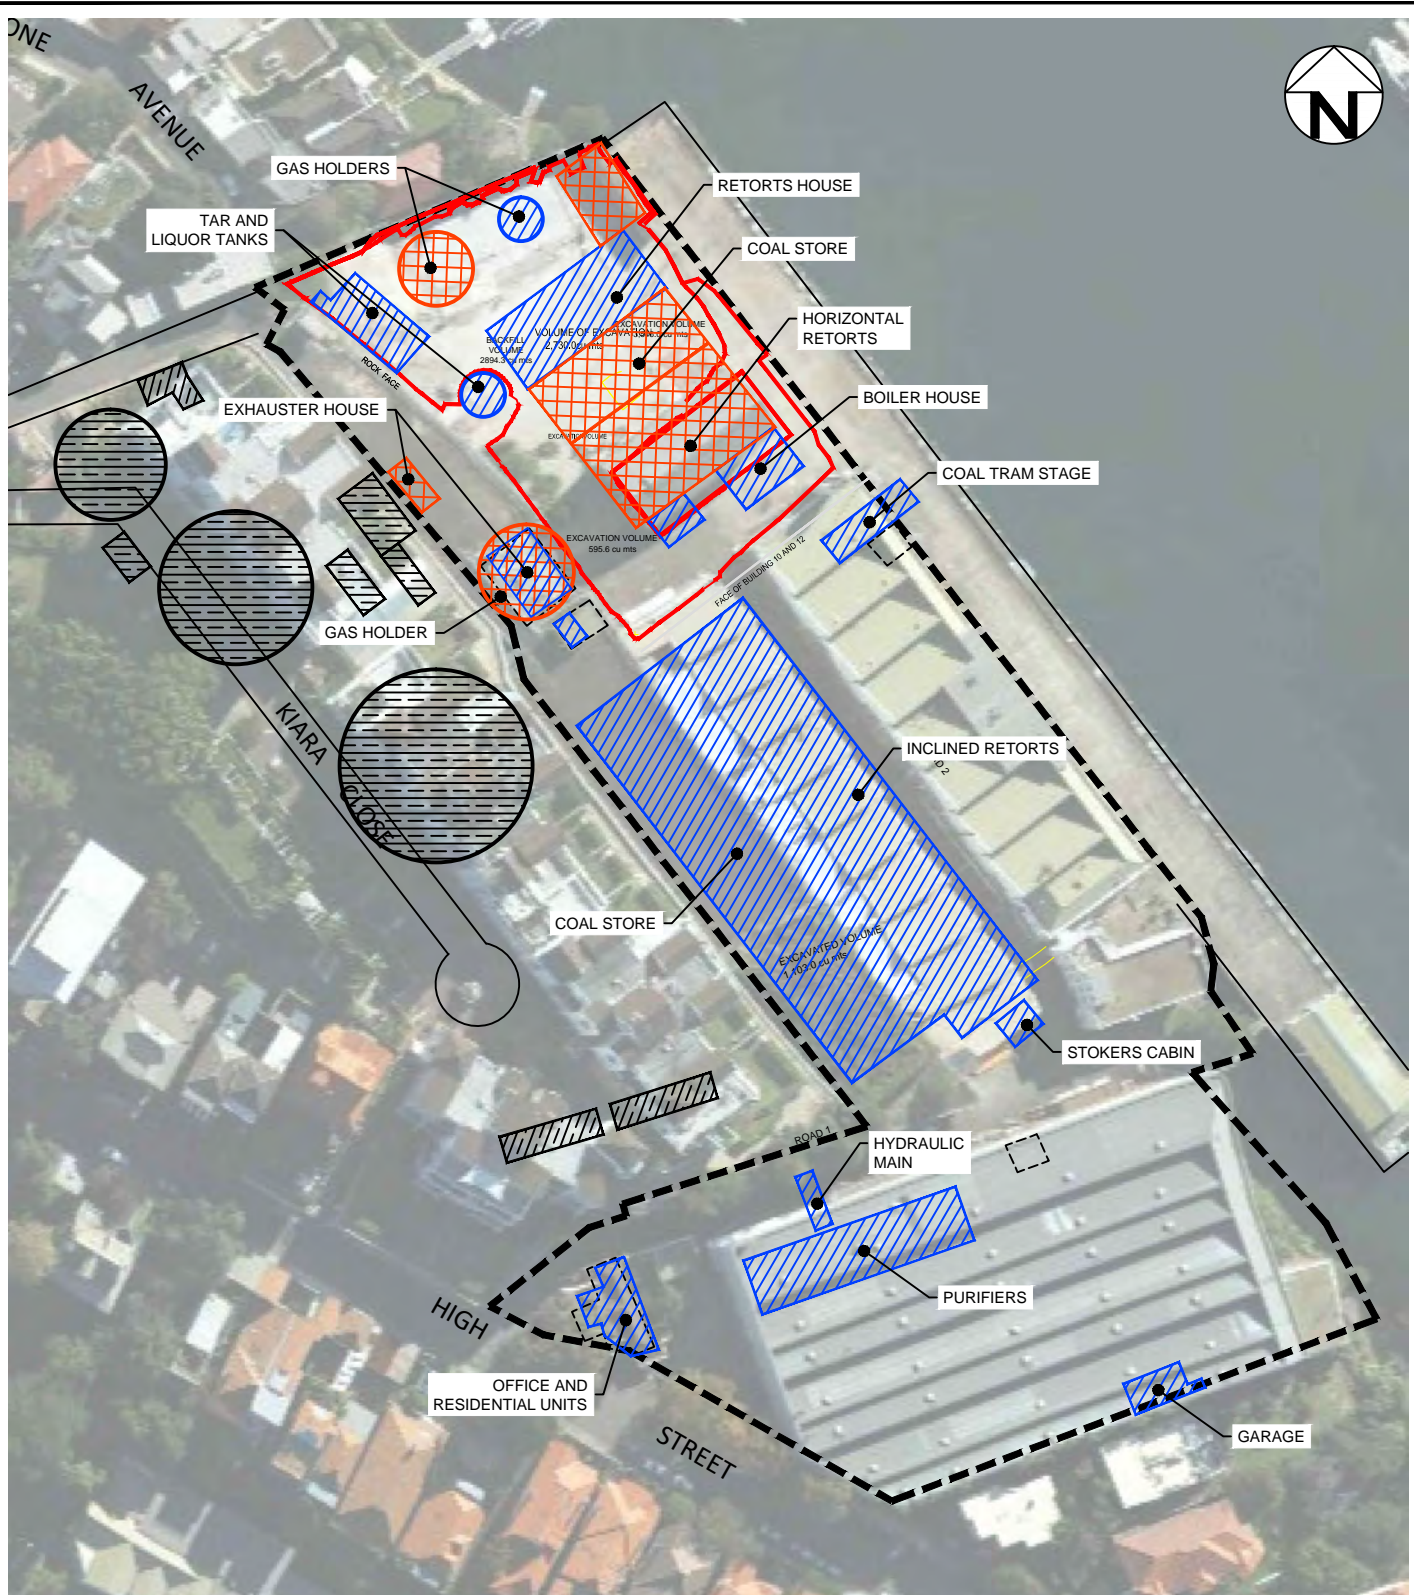
client:	THIESS SERVICES		
project:	SITE VALIDATION, PLATYPUS REMEDIATION PROJECT, 118 HIGH STREET, NORTH SYDNEY, NEW SOUTH WALES		
title:	SITE LAYOUT PLAN AND FORMER GASWORKS FEATURES		
project no:	ENAUHOD04128AB-R00A	figure no:	FIGURE 3
		rev.:	-

- APPROXIMATE SITE BOUNDARY
- APPROXIMATE LOCATION OF FOR FORMER GASWORK STRUCTURES (1890)
- APPROXIMATE LOCATION OF FORMER GASWORK STRUCTURES (1913)
- APPROXIMATE LOCATION OF FORMER GAS STRUCTURES ON THE IORA SITE

The remediation works on the Northern Remediation Area, shown outlined in red on Figure 2 and 3 of Appendix A, resulted in the removal of all soil materials to bedrock. Whilst the most significantly contaminated materials were disposed off-site, the less contaminated materials were treated on the Site. This treatment served to stabilise the primary contaminants, PAHs and TPHs, in the soils. These stabilised soils were then reinstated into the deepest areas of the resultant excavation in compacted layers and were finished above the pre-existing surface levels to form the basis of the final landscaping works. A Cap comprised of various layers of materials was then placed over the stabilised soils. The extent of the retained stabilised materials is referred to as the Northern Remediation Containment Area as shown in plans provided in Appendix C and Appendix E. Details of the Cap are provided in detail below.

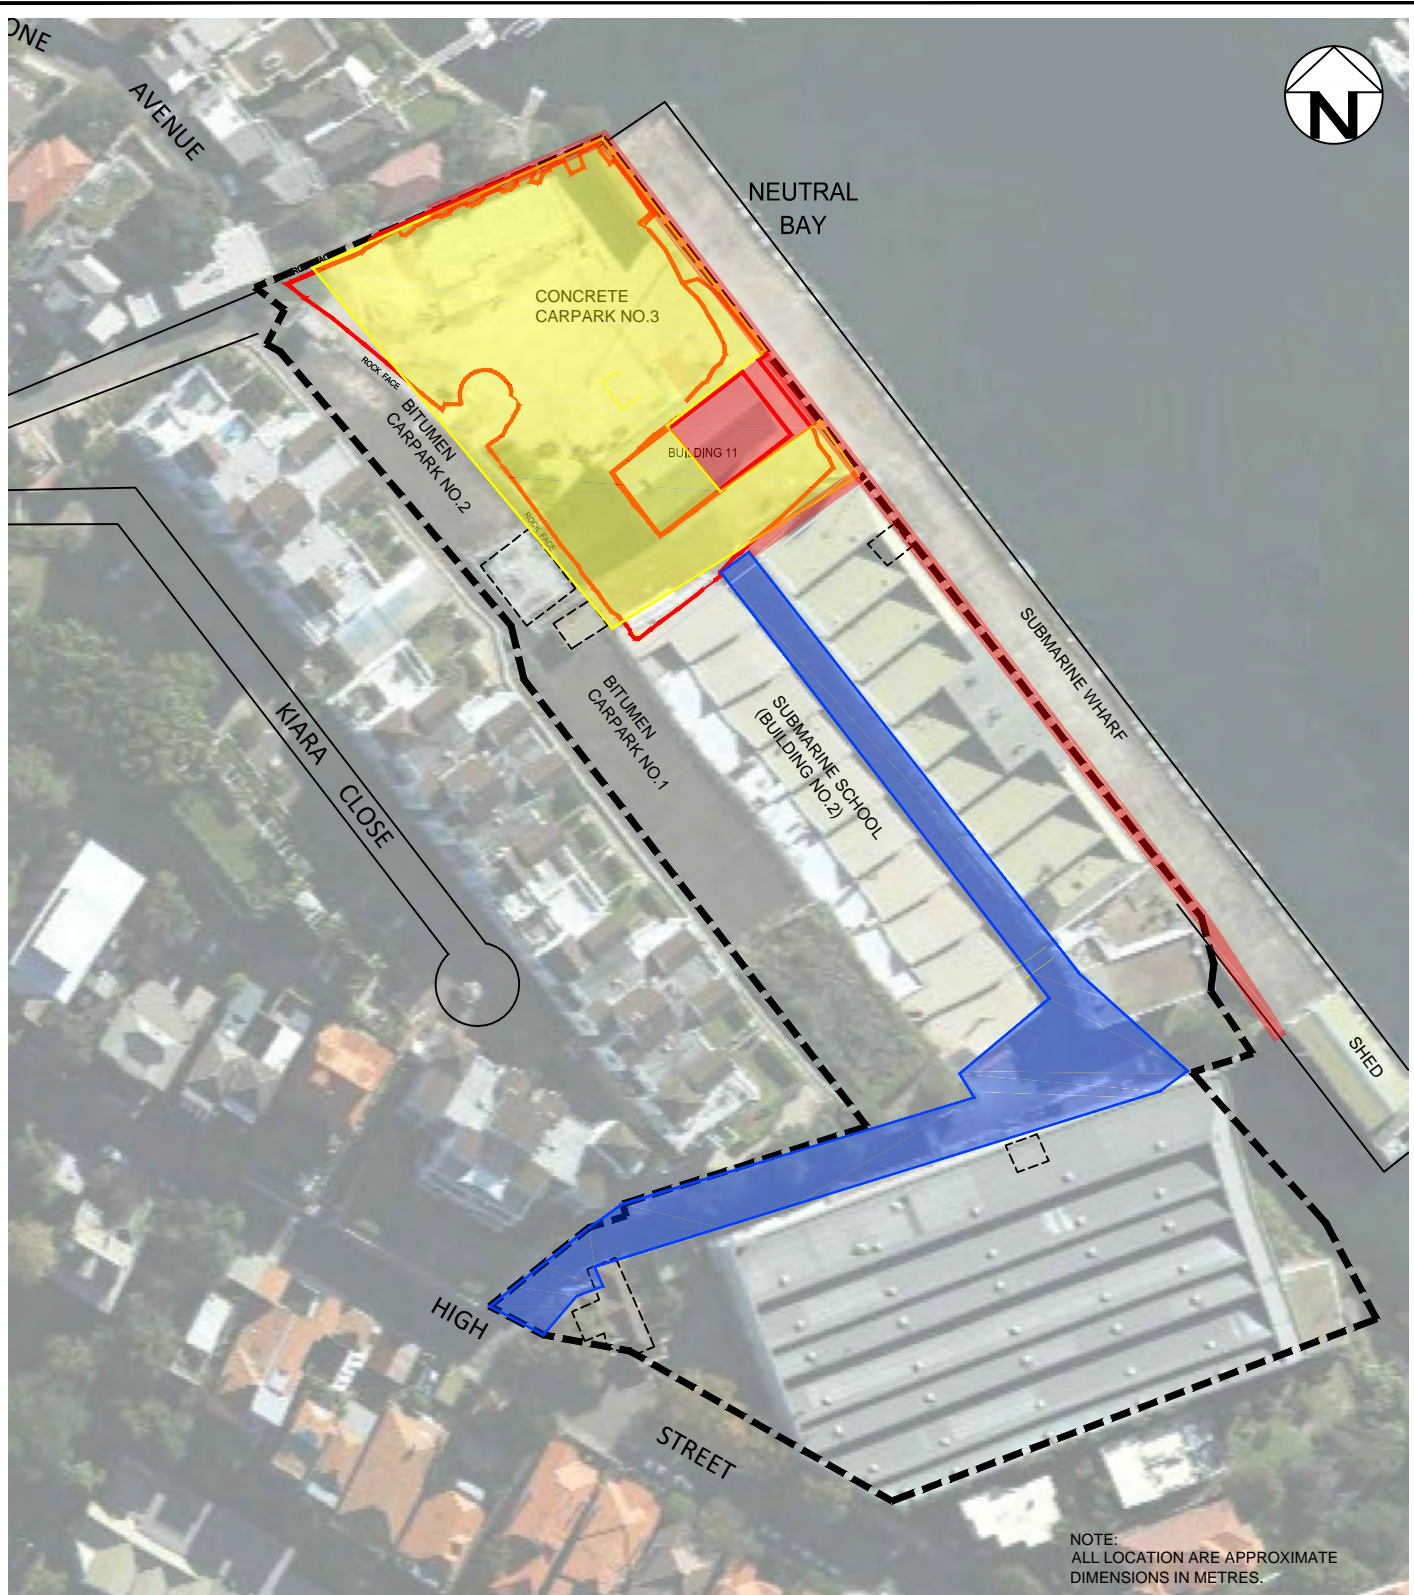
client:	THIESS SERVICES		
project:	SITE VALIDATION, PLATYPUS REMEDIATION PROJECT, 118 HIGH STREET, NORTH SYDNEY, NEW SOUTH WALES		
title:	REMEDICATION LAYOUT - MAIN ELEMENTS		
project no:	ENAUHOD04128AB-R00A	figure no:	FIGURE 4
		rev.:	-

- SITE BOUNDARY
- CONTAINMENT
- DRIVEWAY
- JET GROUT WALL / IN-SITU CONTAINMENT

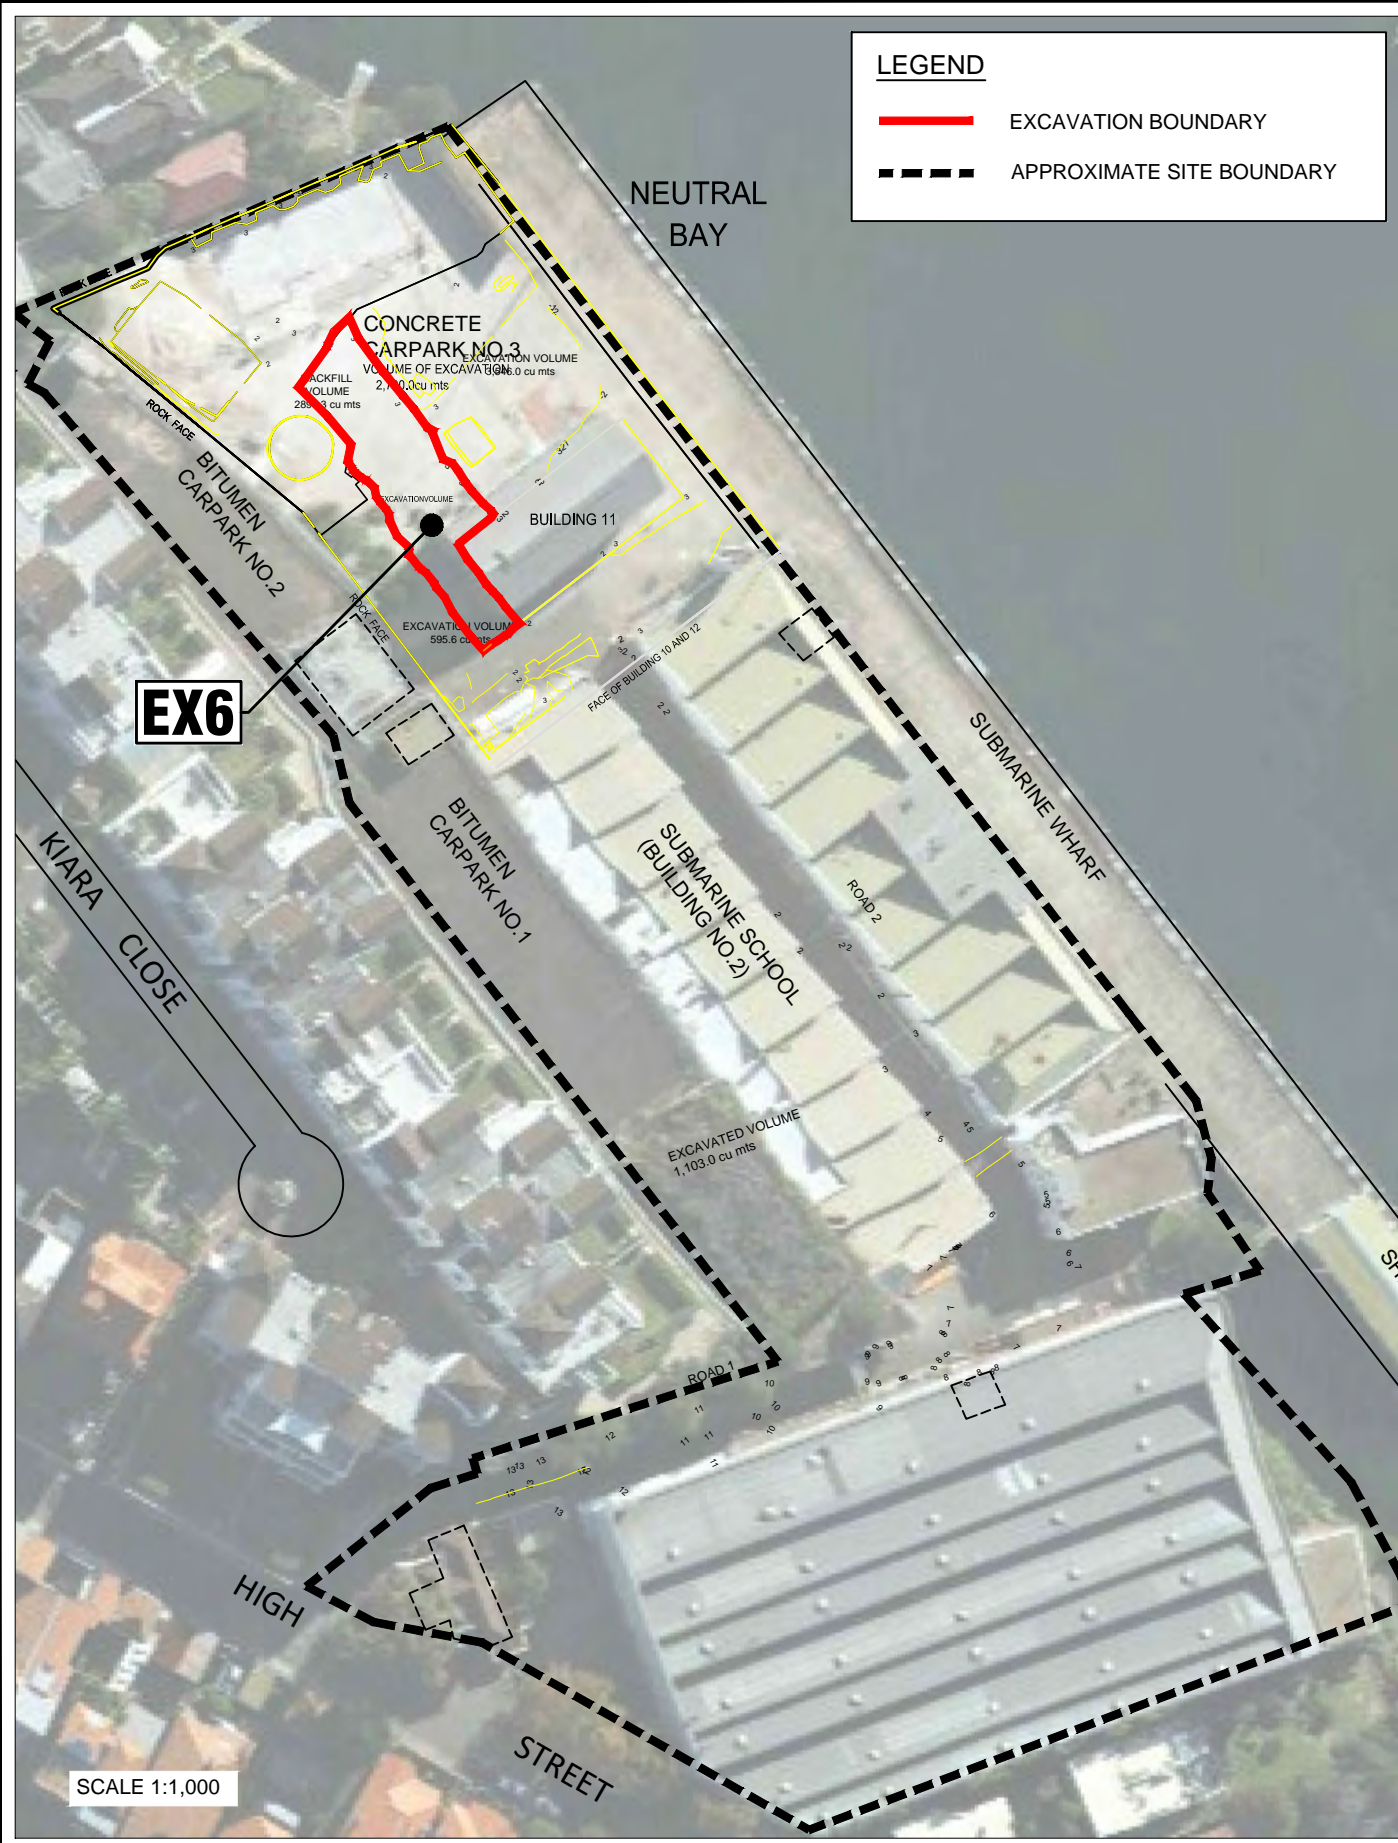
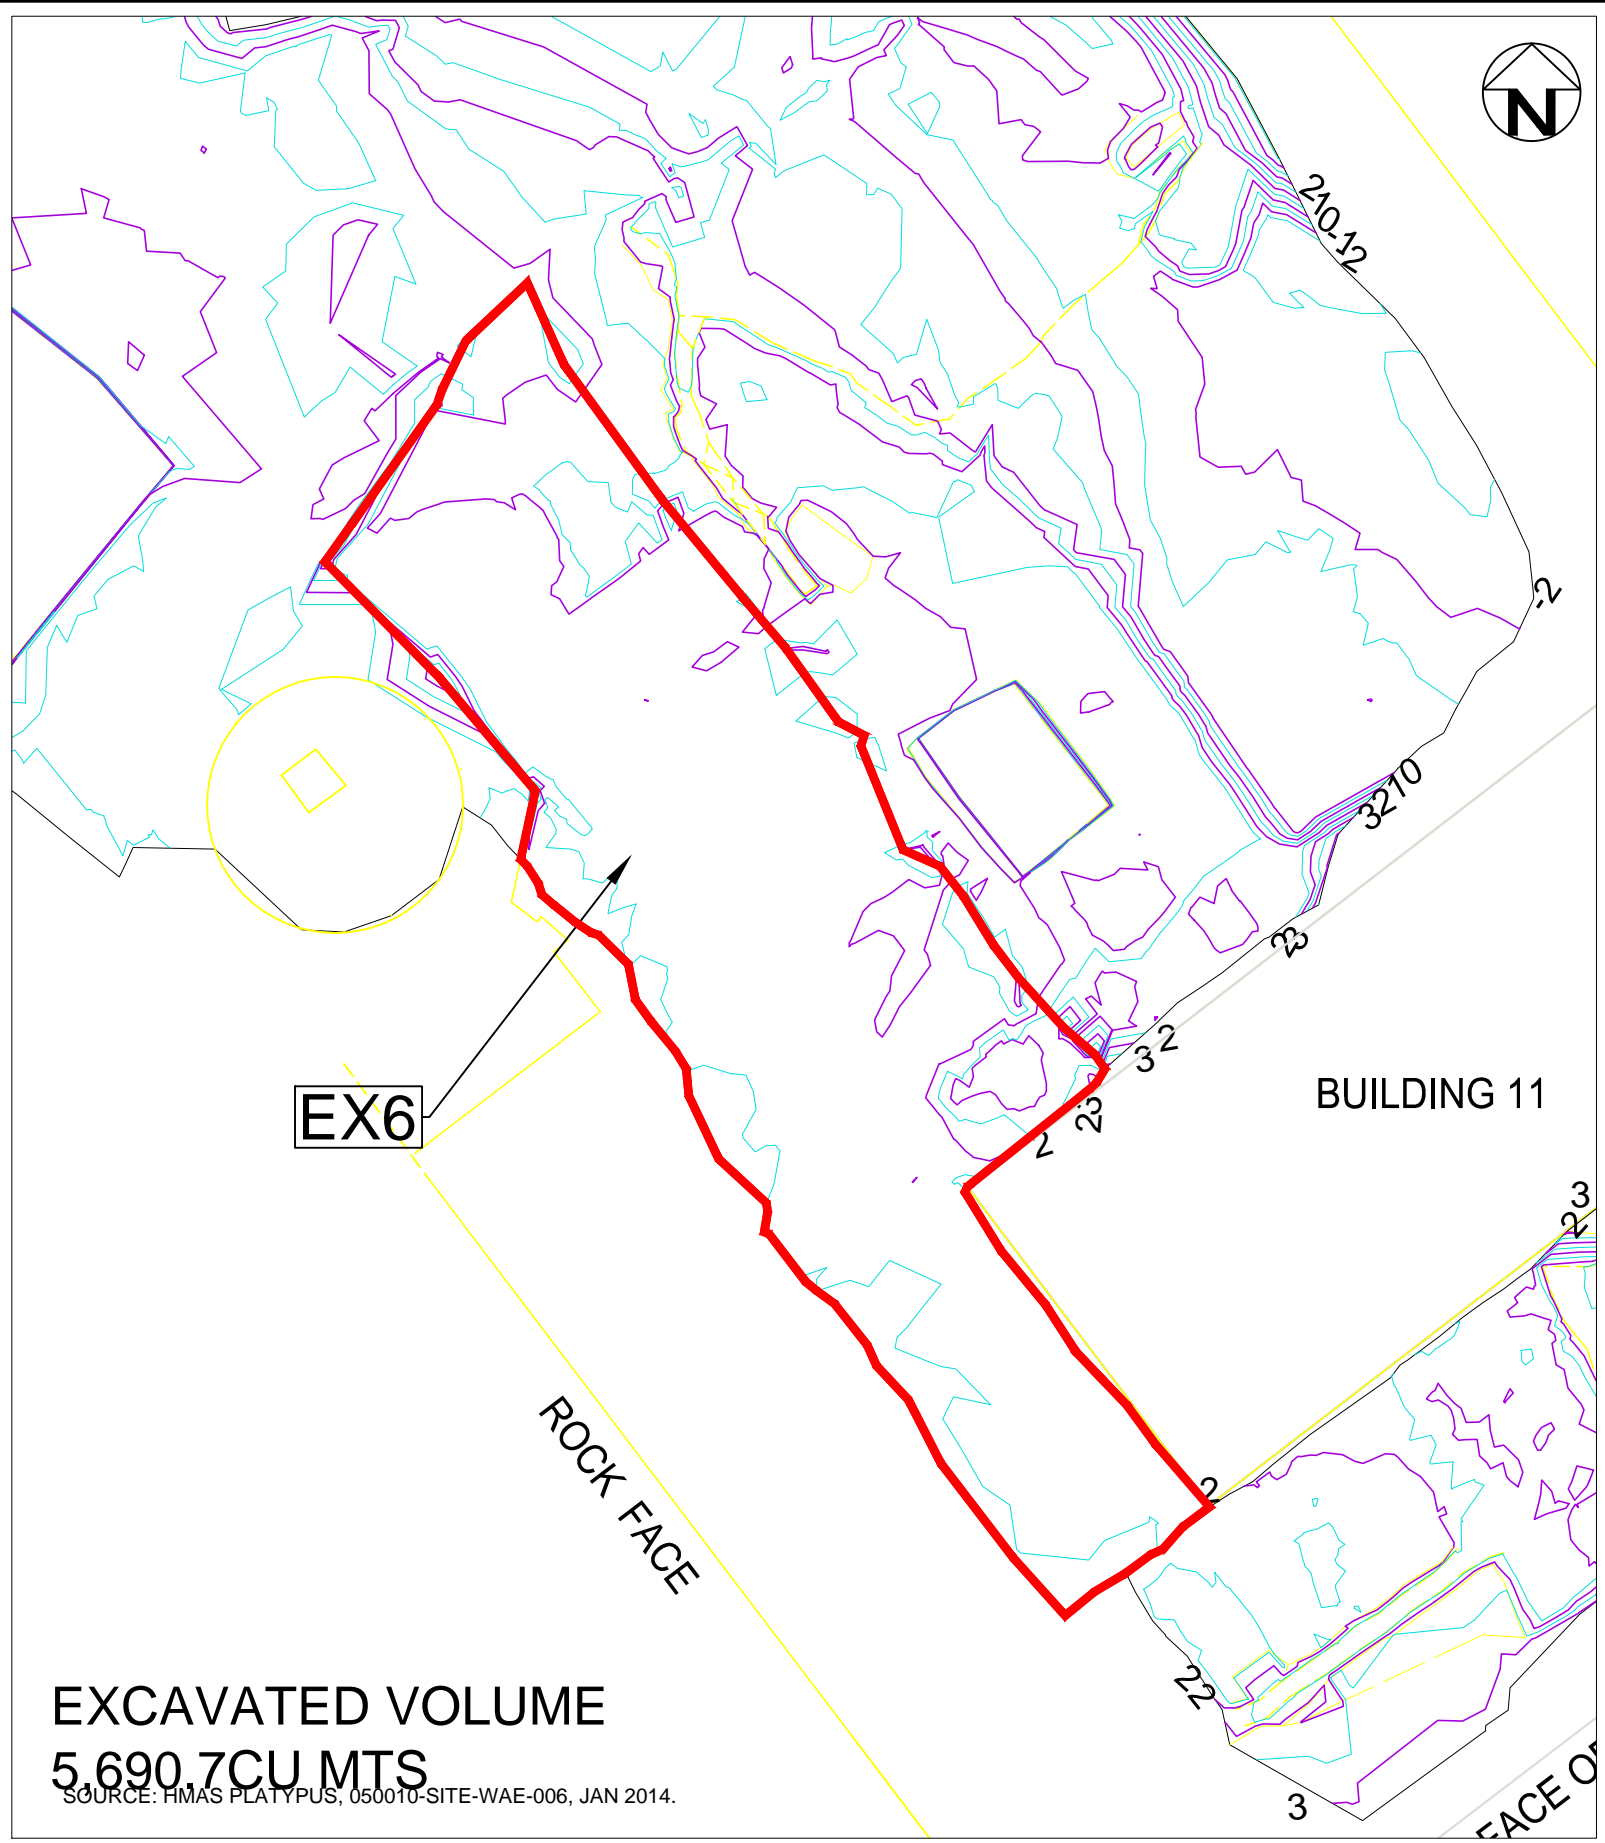
client:	THIESS SERVICES
project:	SITE VALIDATION, PLATYPUS REMEDIATION PROJECT, 118 HIGH STREET, NORTH SYDNEY, NEW SOUTH WALES
title:	REMEDIAION EXCAVATION 6
project no:	ENAUHOD04128AB-R00A
figure no:	FIGURE 11

- EXCAVATION BOUNDARY
- APPROXIMATE SITE BOUNDARY

**EXCAVATED VOLUME**  
**5,690.7CU MTS**  
SOURCE: HMAS PLATYPUS, 050010-SITE-WAE-006, JAN 2014.

- **Driveway Area between the Workshops (Building No.10) and the Submarine School (Building No.2)** (as shown in Figure 10 of Appendix A) – The driveway that extends from High Street in an L-shape to the southern boundary of the Northern Remediation Containment Area was subject to excavation to depths of 1.2 metres below the ground surface (m bgs) or to/into sandstone bedrock, whichever was first encountered. Whilst the excavation for the driveway from High Street down to between the RANTME Factory (Building No.1) and the Administration Building (Building No.3) was completed into bedrock in the base and walls, between the Workshops (Building No.10) and the Submarine School (Building No.2) there were areas of the driveway excavation where soils materials were retained at depths greater than 1.2 m bgs. In this area a marker liner comprised of orange HDPE plastic was installed along the base of the excavation prior to backfilling. This liner was installed to alert future users who may access depths greater than 1.2 m bgs that potentially contaminated materials are retained beneath the liner. In order to prevent undermining of the buildings on either side, the excavation along the roadway was only able to extend laterally to the edges of the buildings. During these works it was observed (reported in Validation Report) that the soil materials retained in the walls and beneath the buildings contained fragments of asbestos containing materials. No marker liner was installed along the face of the walls;

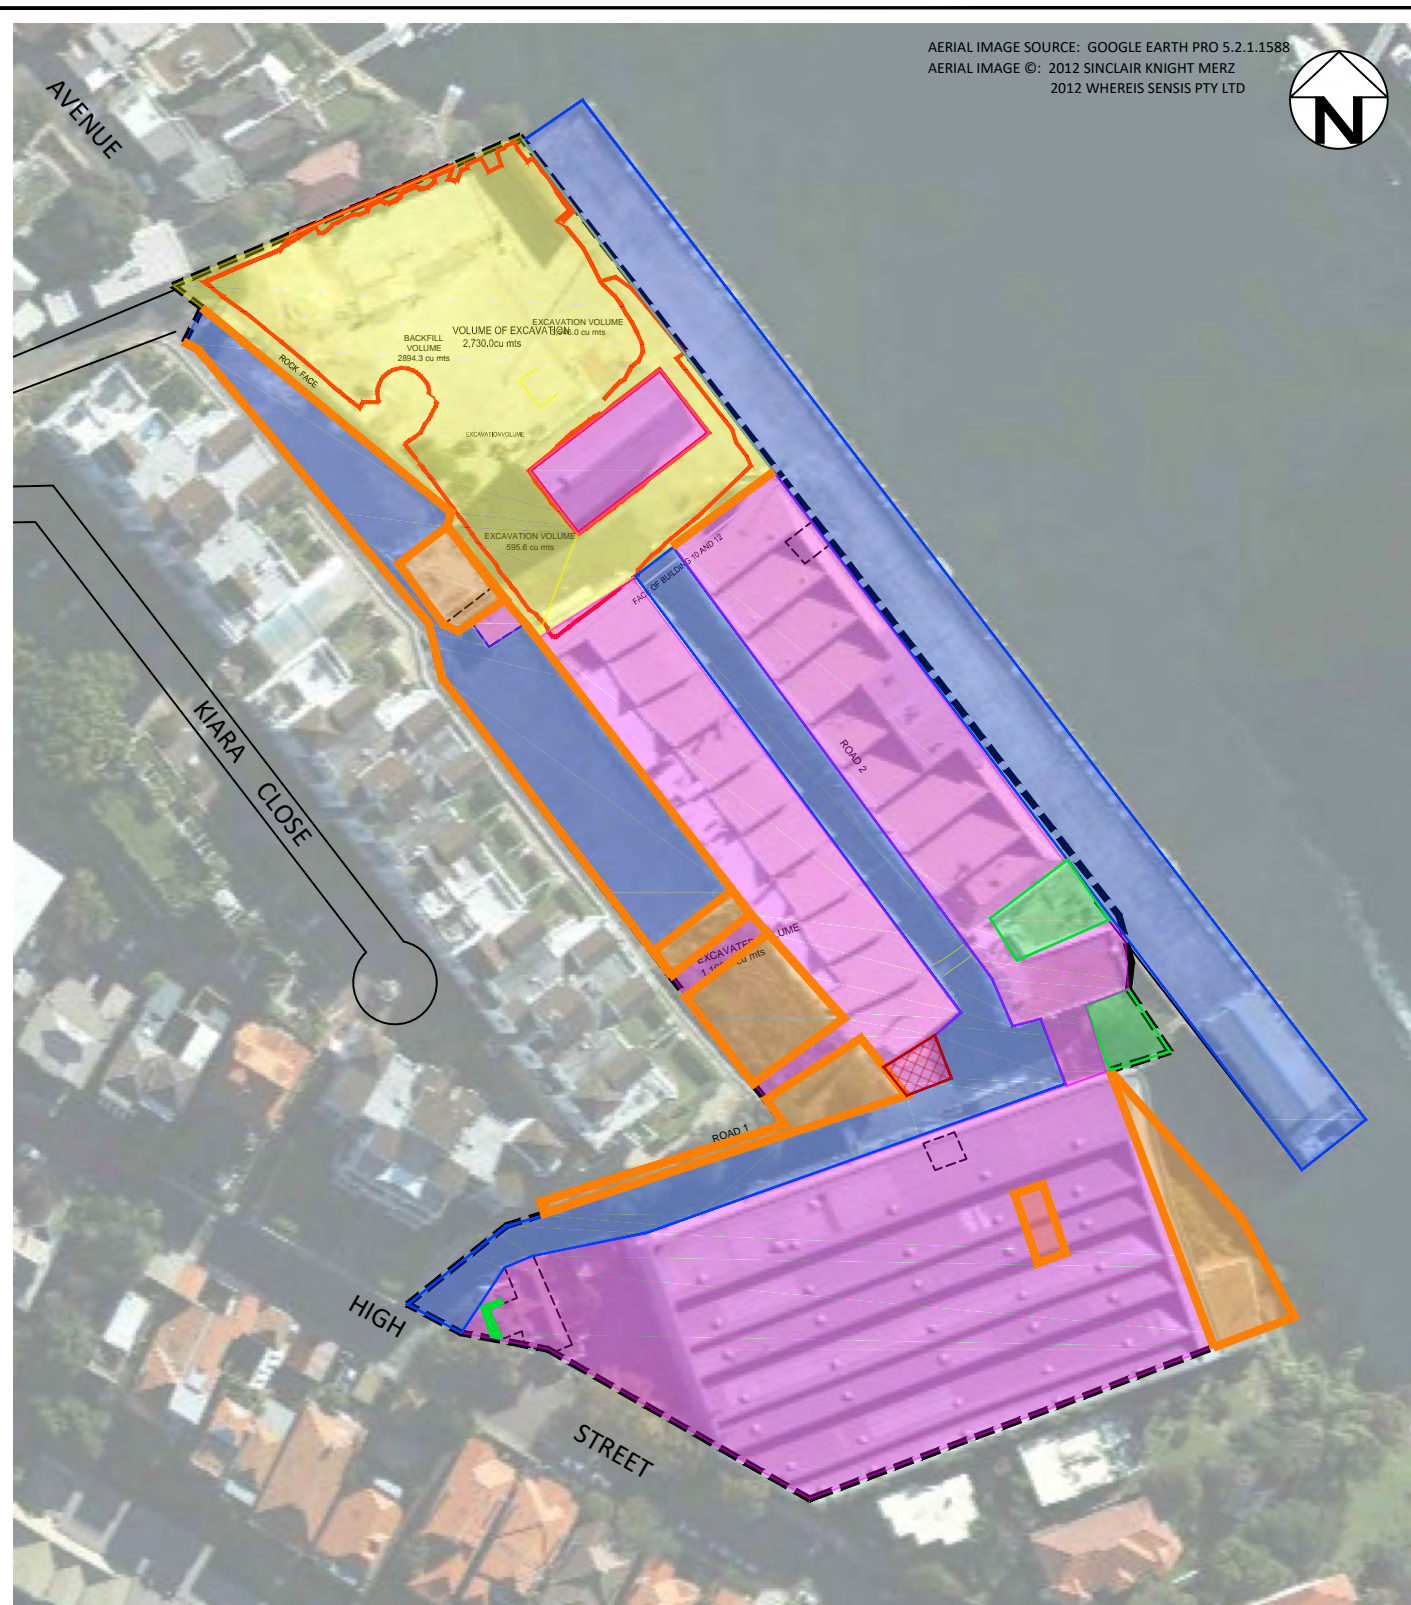
client:	THIESS SERVICES		
project:	SITE VALIDATION, PLATYPUS REMEDIATION PROJECT, 118 HIGH STREET, NORTH SYDNEY, NEW SOUTH WALES		
title:	IN-SITU CONTAINMENT		
project no:	ENAUHOD04128AB-R00A	figure no:	FIGURE 13
		rev.:	-

- APPROXIMATE SITE BOUNDARY
- ASPHALT SEALED
- CONCRETE FLOOR SLABS
- EXPOSED SANDSTONE SURFACES
- GRASS
- EXPOSED CAP
- SUBSTATION

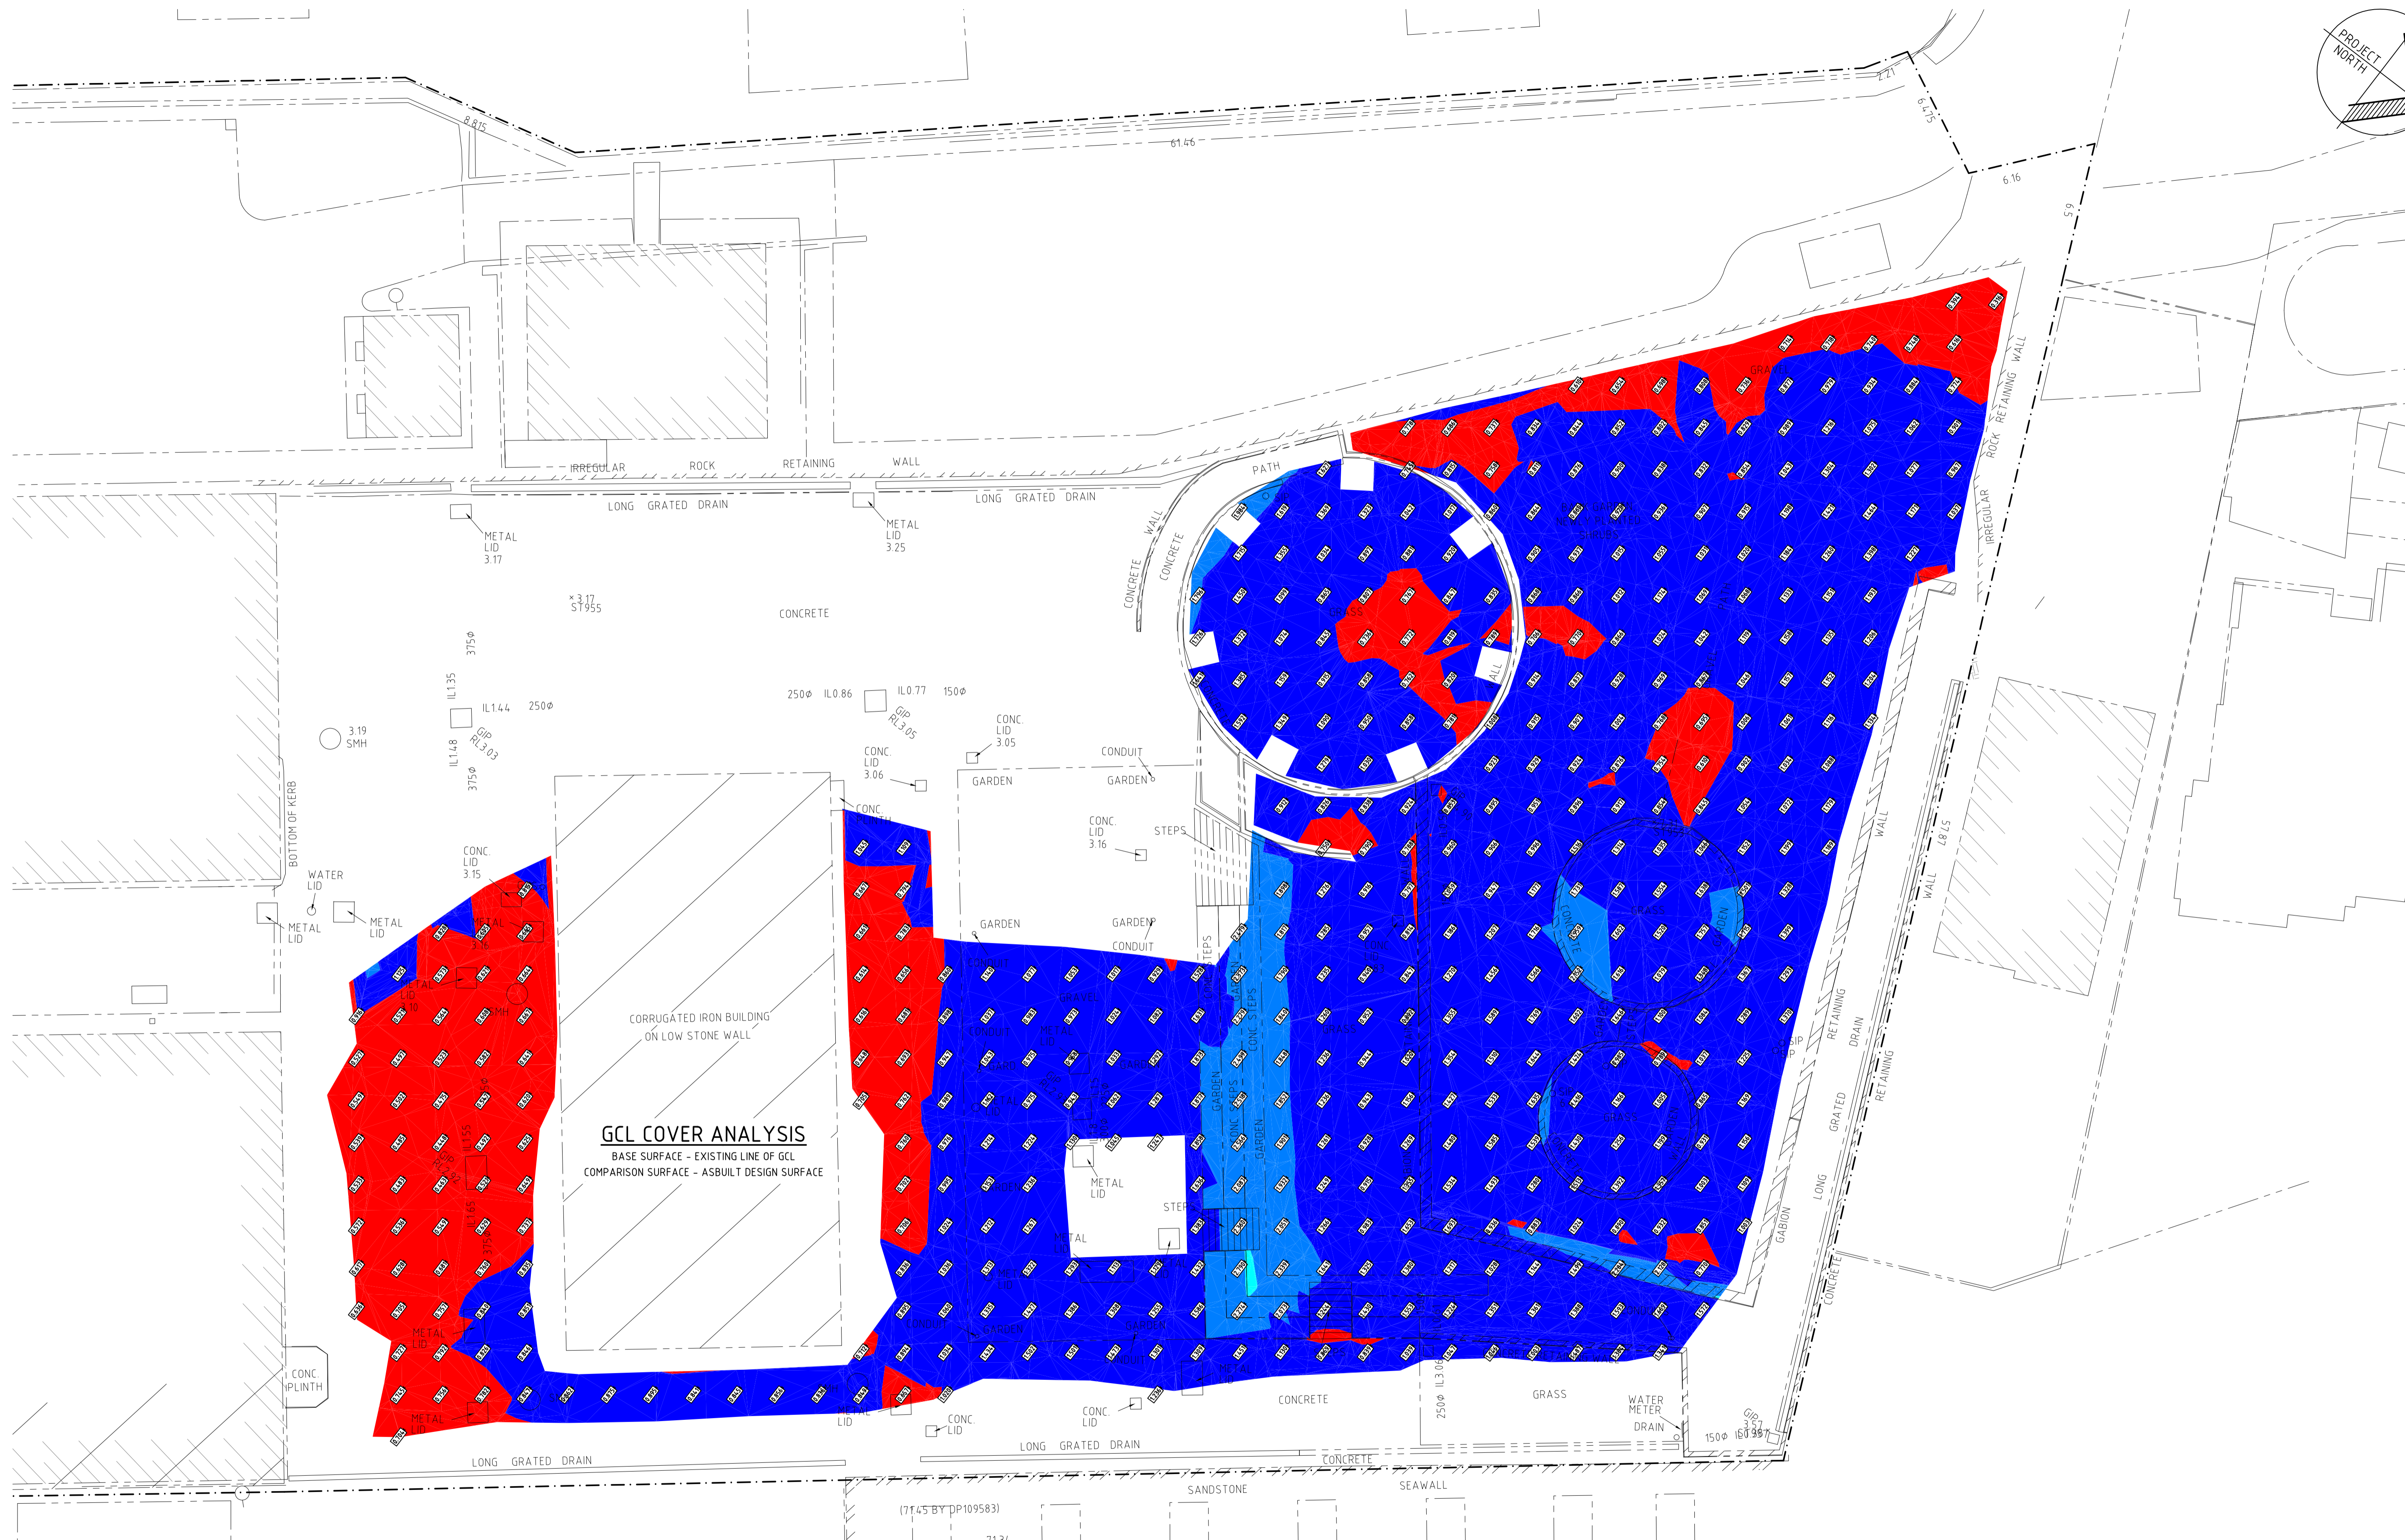
**AS BUILT GCL COVER ANALYSIS**  
 SCALE 1:150

**GCL COVER ANALYSIS**  
 BASE SURFACE - EXISTING LINE OF GCL  
 COMPARISON SURFACE - ASBUILT DESIGN SURFACE

- **Cap** – comprises the various materials used to establish the capping layer across the areas of the Site in which stabilised contaminated fill and soils were re-instated for retention;
- **Northern Remediation Area** – the northern section of the Site in which the former gasworks infrastructure was primarily located and that was the focus of the remediation works completed as shown on Figure 3 provided in Appendix A. The final layout and survey plan of this area is provided in Appendix B;
- **Northern Remediation Containment Area** – Area within the Northern Remediation Area in which stabilised contaminated fill and soils were backfilled, compacted and covered with a series of materials that comprise the cap the extent of which is shown on the survey plan provided in Appendix C.
