## FINAL REPORT

# Long-term Environmental Management Plan, Platypus Site High Street, North Sydney NSW

**10 May 2018**

**CONSARA Pty Ltd**  
ABN: 27 161 027 881  
ACN: 161 027 881  
Suite 2, Unit 6, 10 Rodborough Road Frenchs Forest NSW 2100  
PO Box 7360 Warringah Mall NSW 2100  
admin@consara.com.au

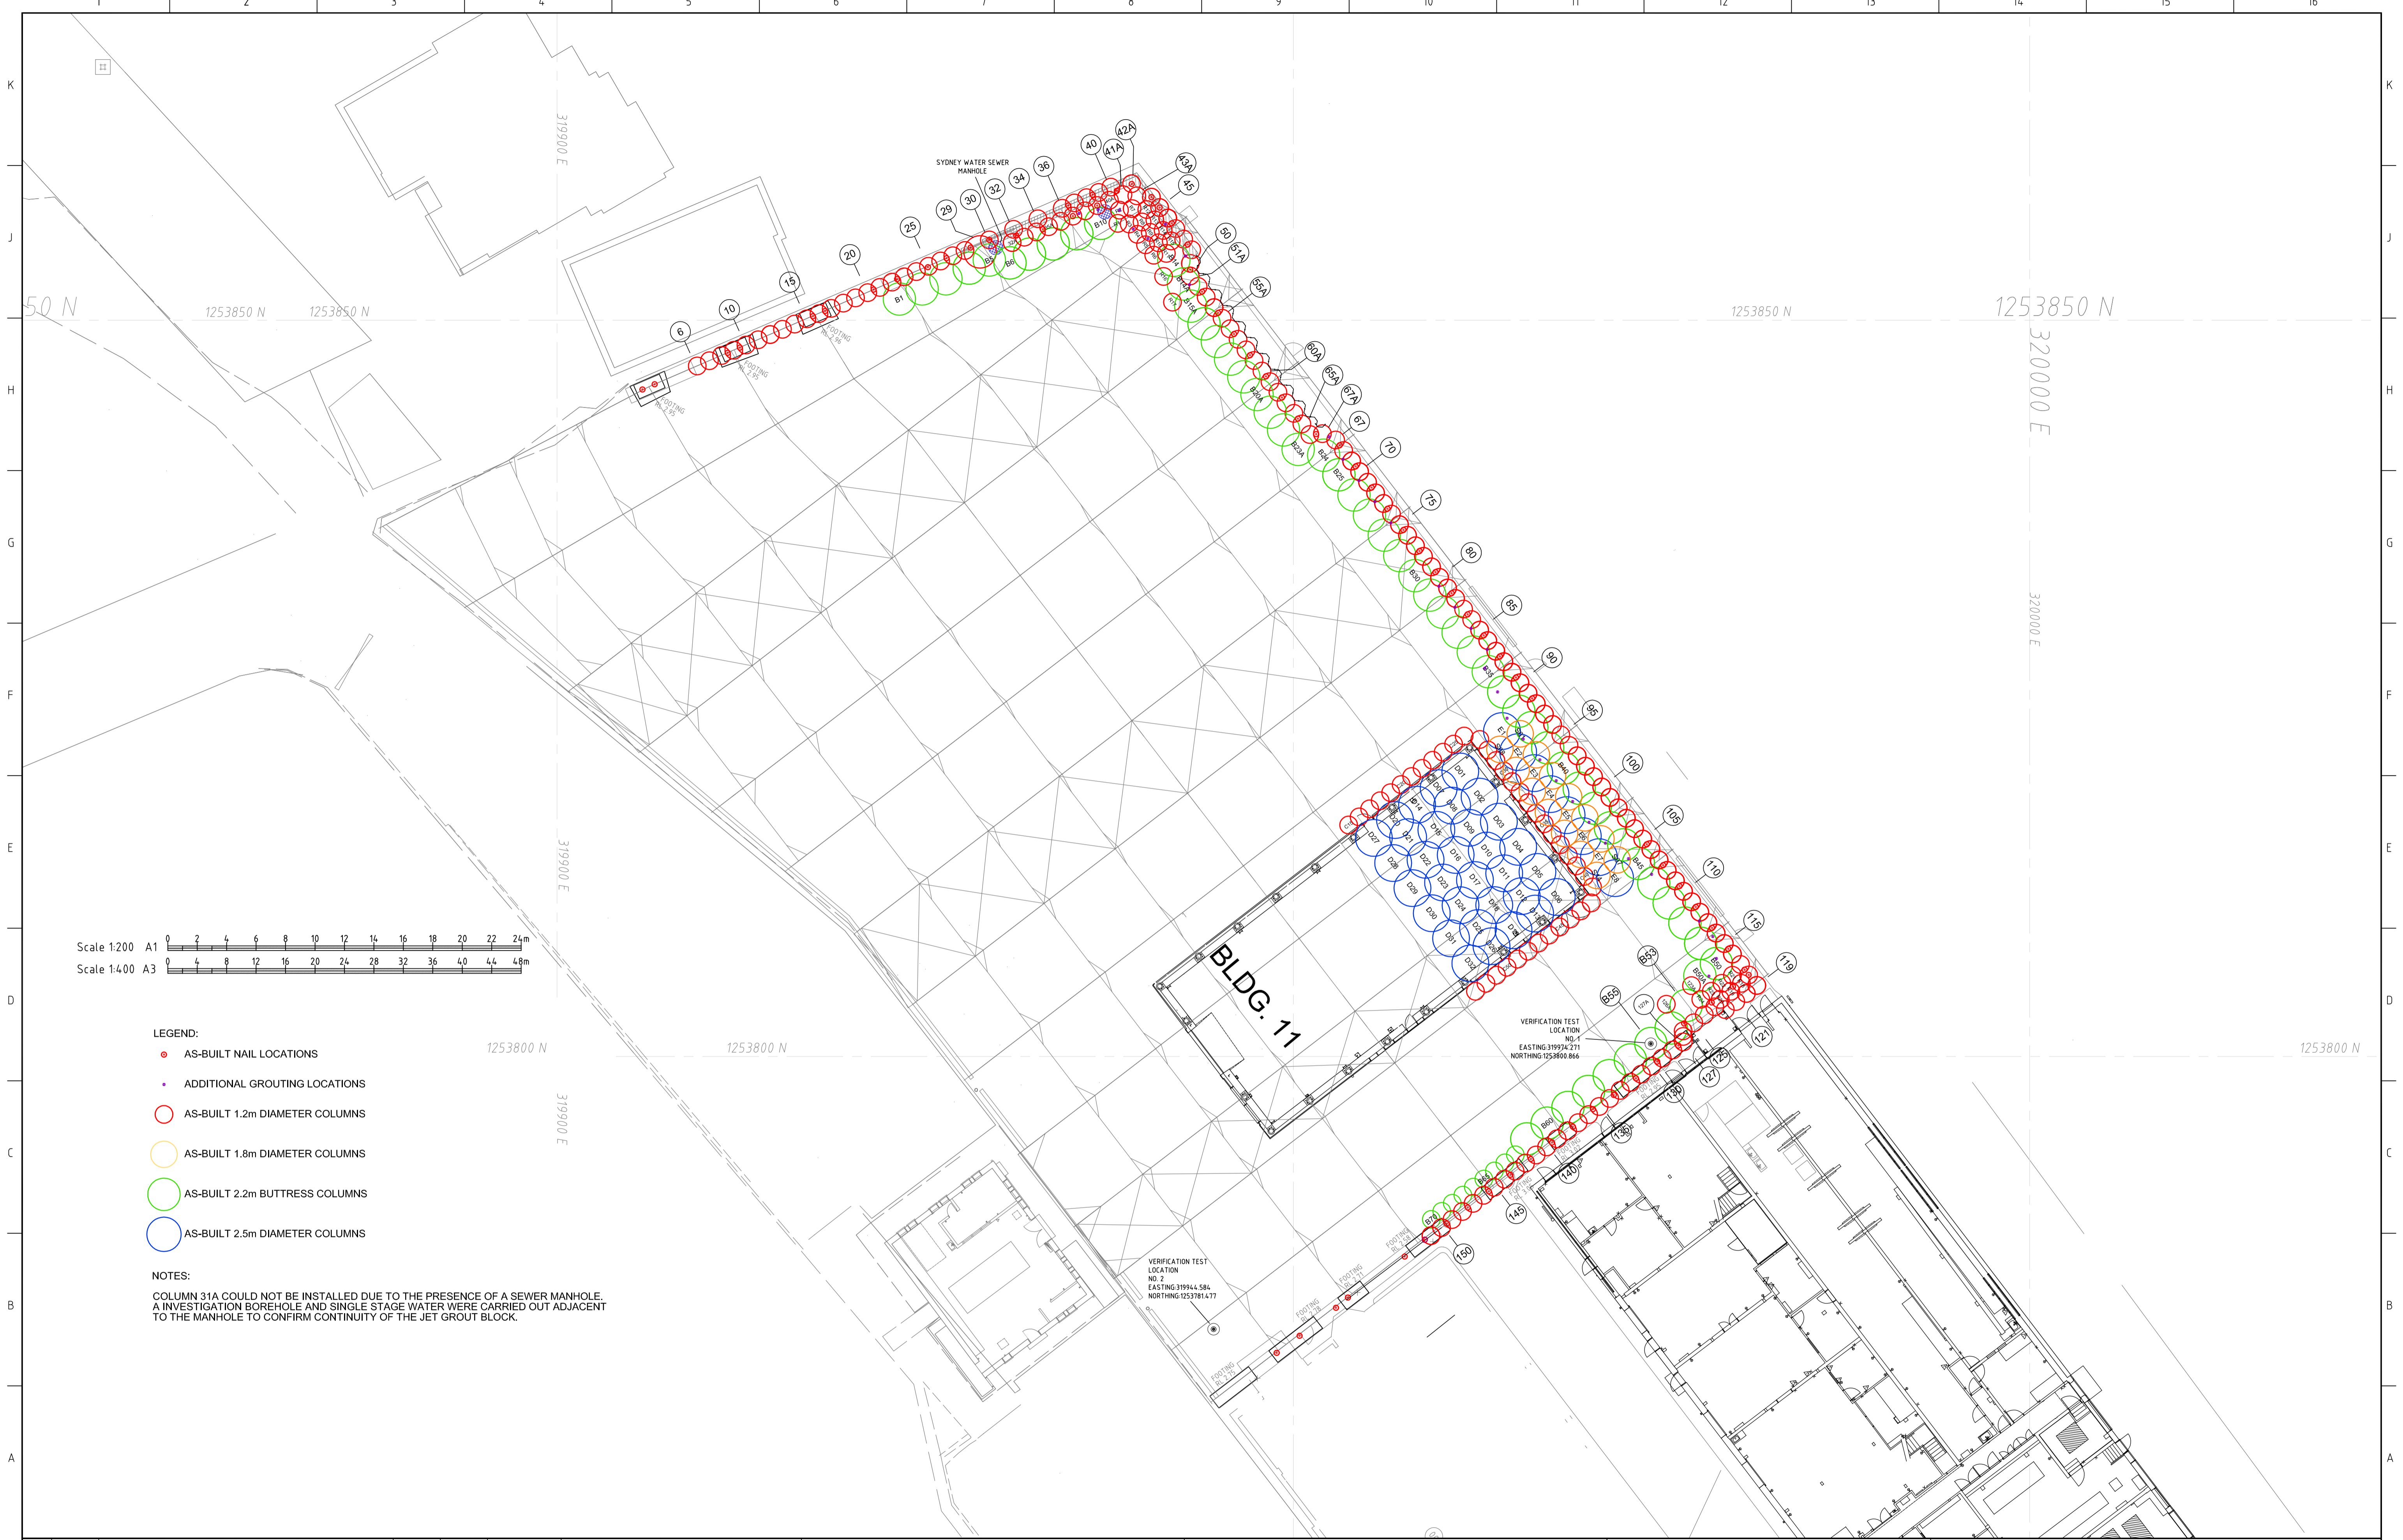
<b>HMAS PLATYPUS STAGE 2 REMEDIATION WORKS</b>		
DRAWING TITLE		
<b>AS BUILT COLUMN AND NAIL LOCATIONS</b>		
<b>NORTHERN SECTION</b>		
<b>PLAN VIEW</b>		
SCALE	DRG NO.	REV
A1 1:200	050010-JGW-WAE-002	G

- LEGEND:**
- AS-BUILT NAIL LOCATIONS
  - ADDITIONAL GROUTING LOCATIONS
  - AS-BUILT 1.2m DIAMETER COLUMNS
  - AS-BUILT 1.8m DIAMETER COLUMNS
  - AS-BUILT 2.2m BUTTRESS COLUMNS
  - AS-BUILT 2.5m DIAMETER COLUMNS

**NOTES:**  
 COLUMN 31A COULD NOT BE INSTALLED DUE TO THE PRESENCE OF A SEWER MANHOLE. AN INVESTIGATION BOREHOLE AND SINGLE STAGE WATER WERE CARRIED OUT ADJACENT TO THE MANHOLE TO CONFIRM CONTINUITY OF THE JET GROUT BLOCK.

- Other ancillary remediation works included installation of a jet-grout cut off wall along the lower eastern boundary of the Site (alignment shown in Appendix D), in-situ stabilisation of soil materials beneath the former retort house (Building No. 11 see Figure 2 in Appendix A and plans in Appendix D), containment of existing contaminated and potentially contaminated soils beneath existing buildings and paved surfaces and construction of a seepage collection system at the base of the cut sandstone walls on Site;

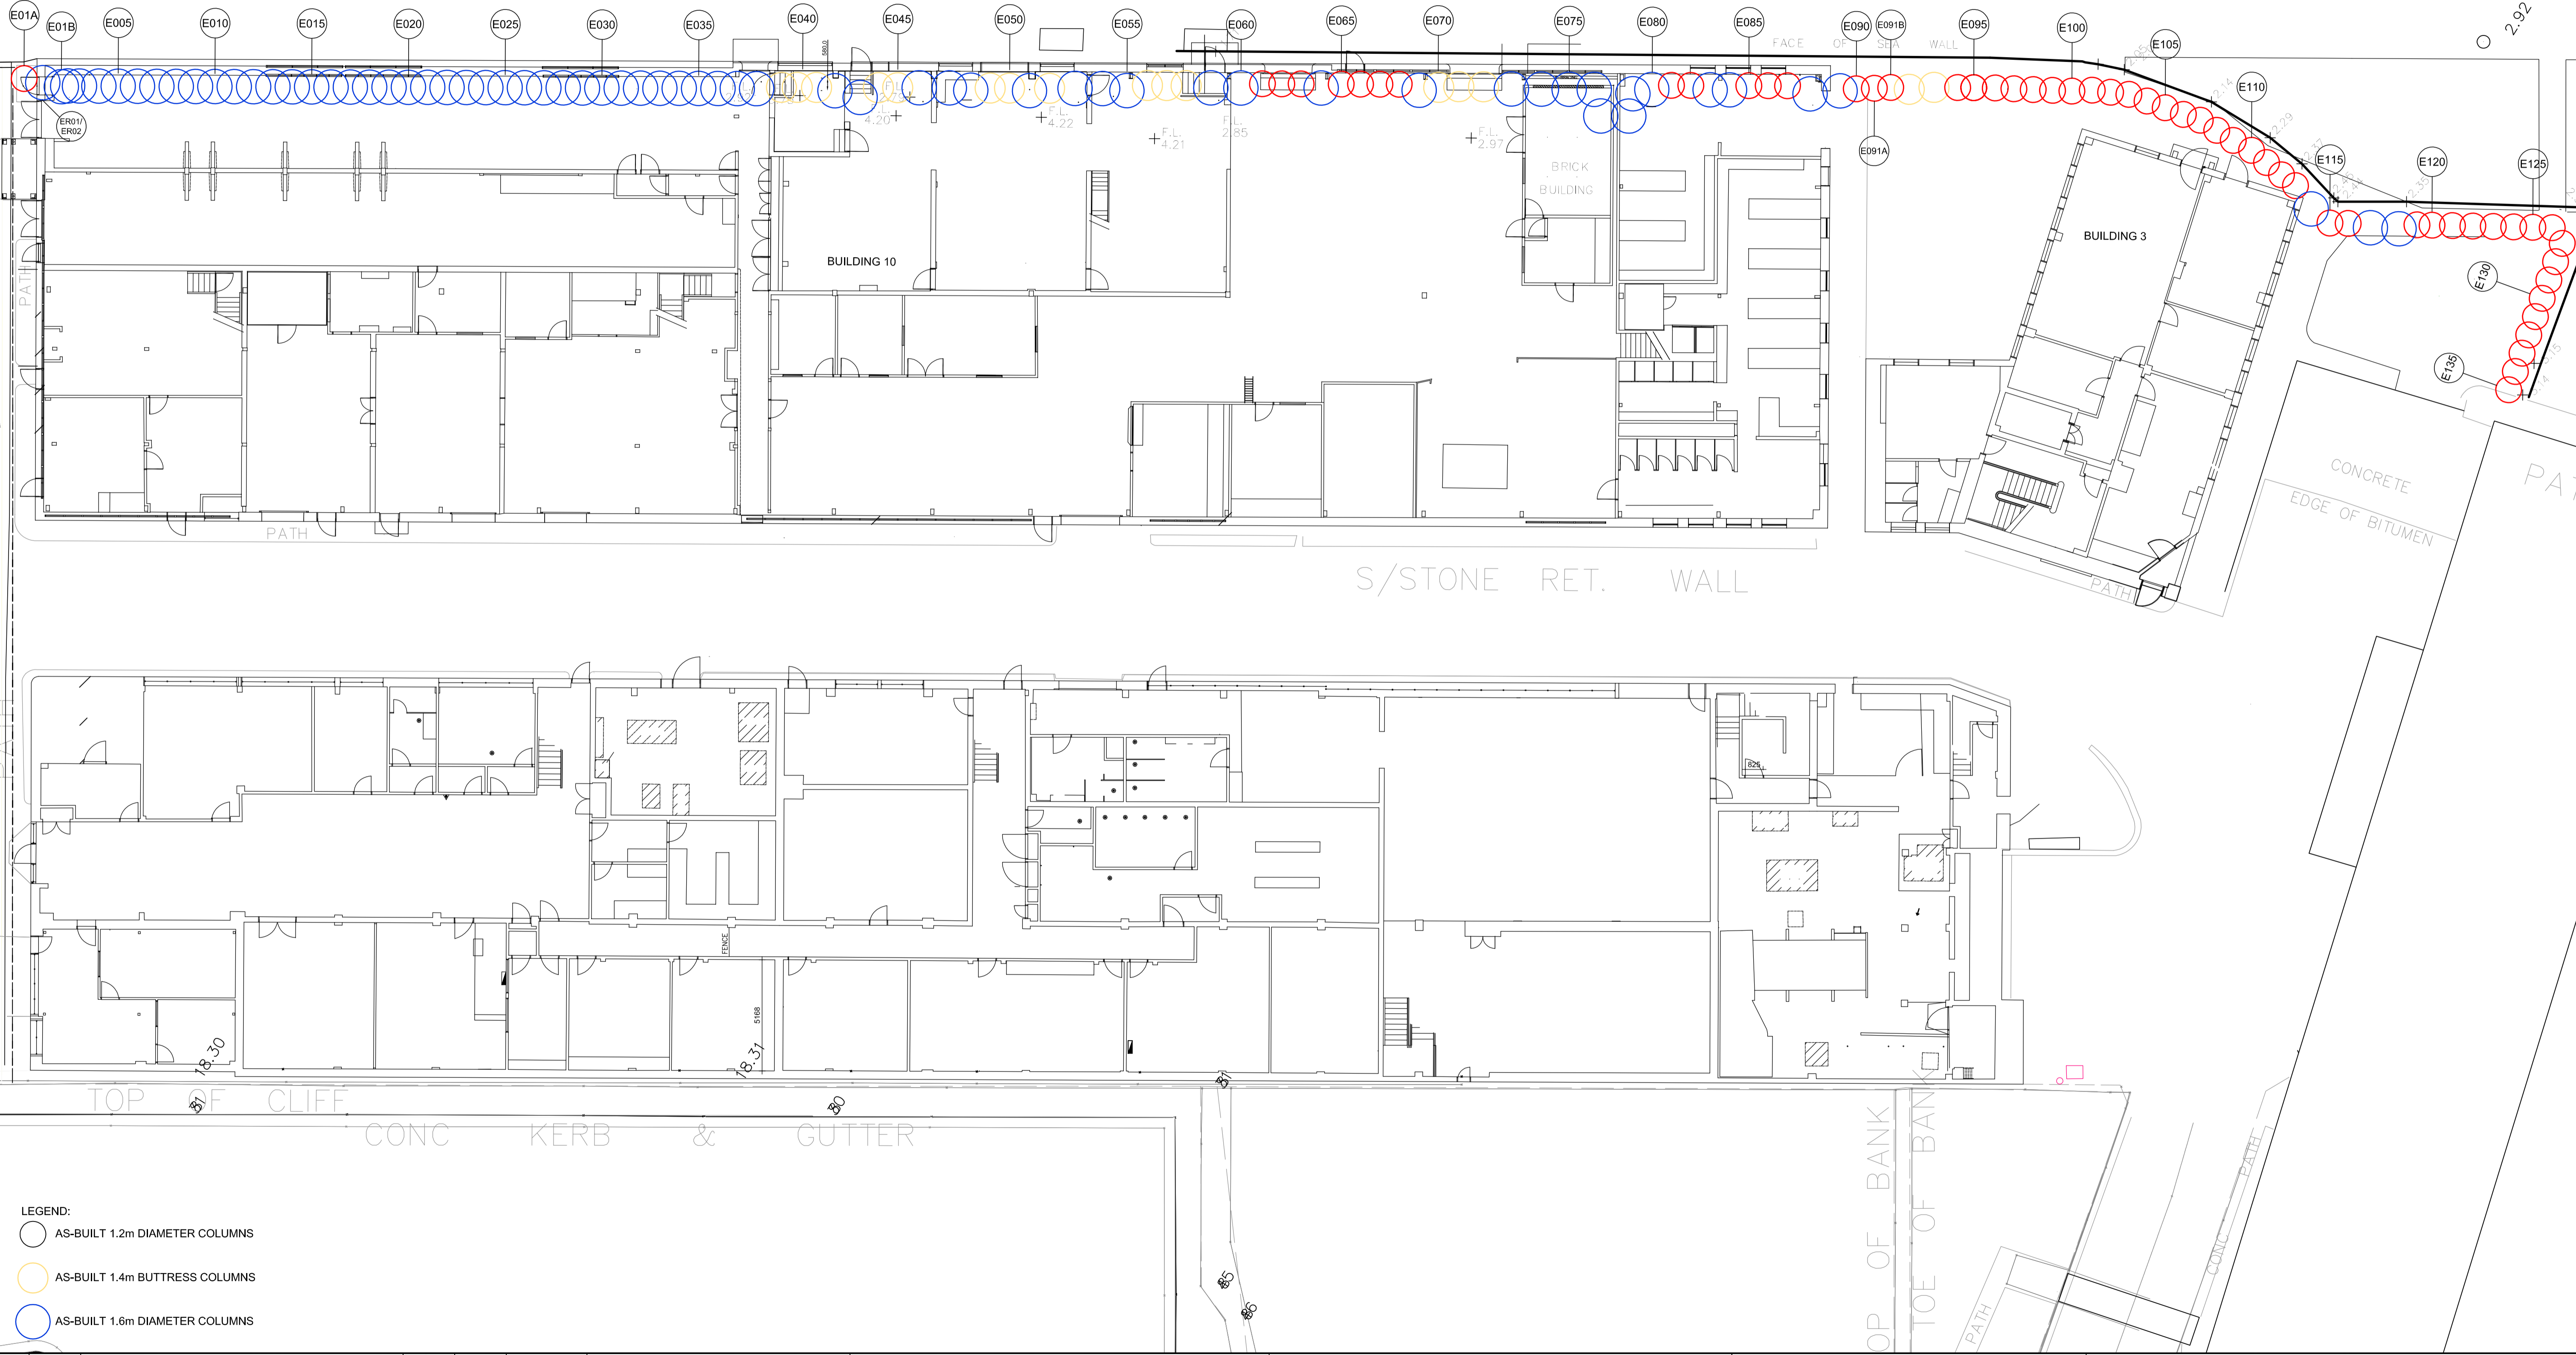
HMAS PLATYPUS STAGE 2 REMEDIATION WORKS		
DRAWING TITLE		
AS BUILT COLUMN LOCATIONS		
CENTRAL SECTION		
PLAN VIEW		
SCALE	DRG NO.	REV
A1 1:150	050010-JGW-WAE-003	A

1. Column diameters and positions shown are at slab level

- LEGEND:
- AS-BUILT 1.2m DIAMETER COLUMNS
  - AS-BUILT 1.4m BUTTRESS COLUMNS
  - AS-BUILT 1.6m DIAMETER COLUMNS

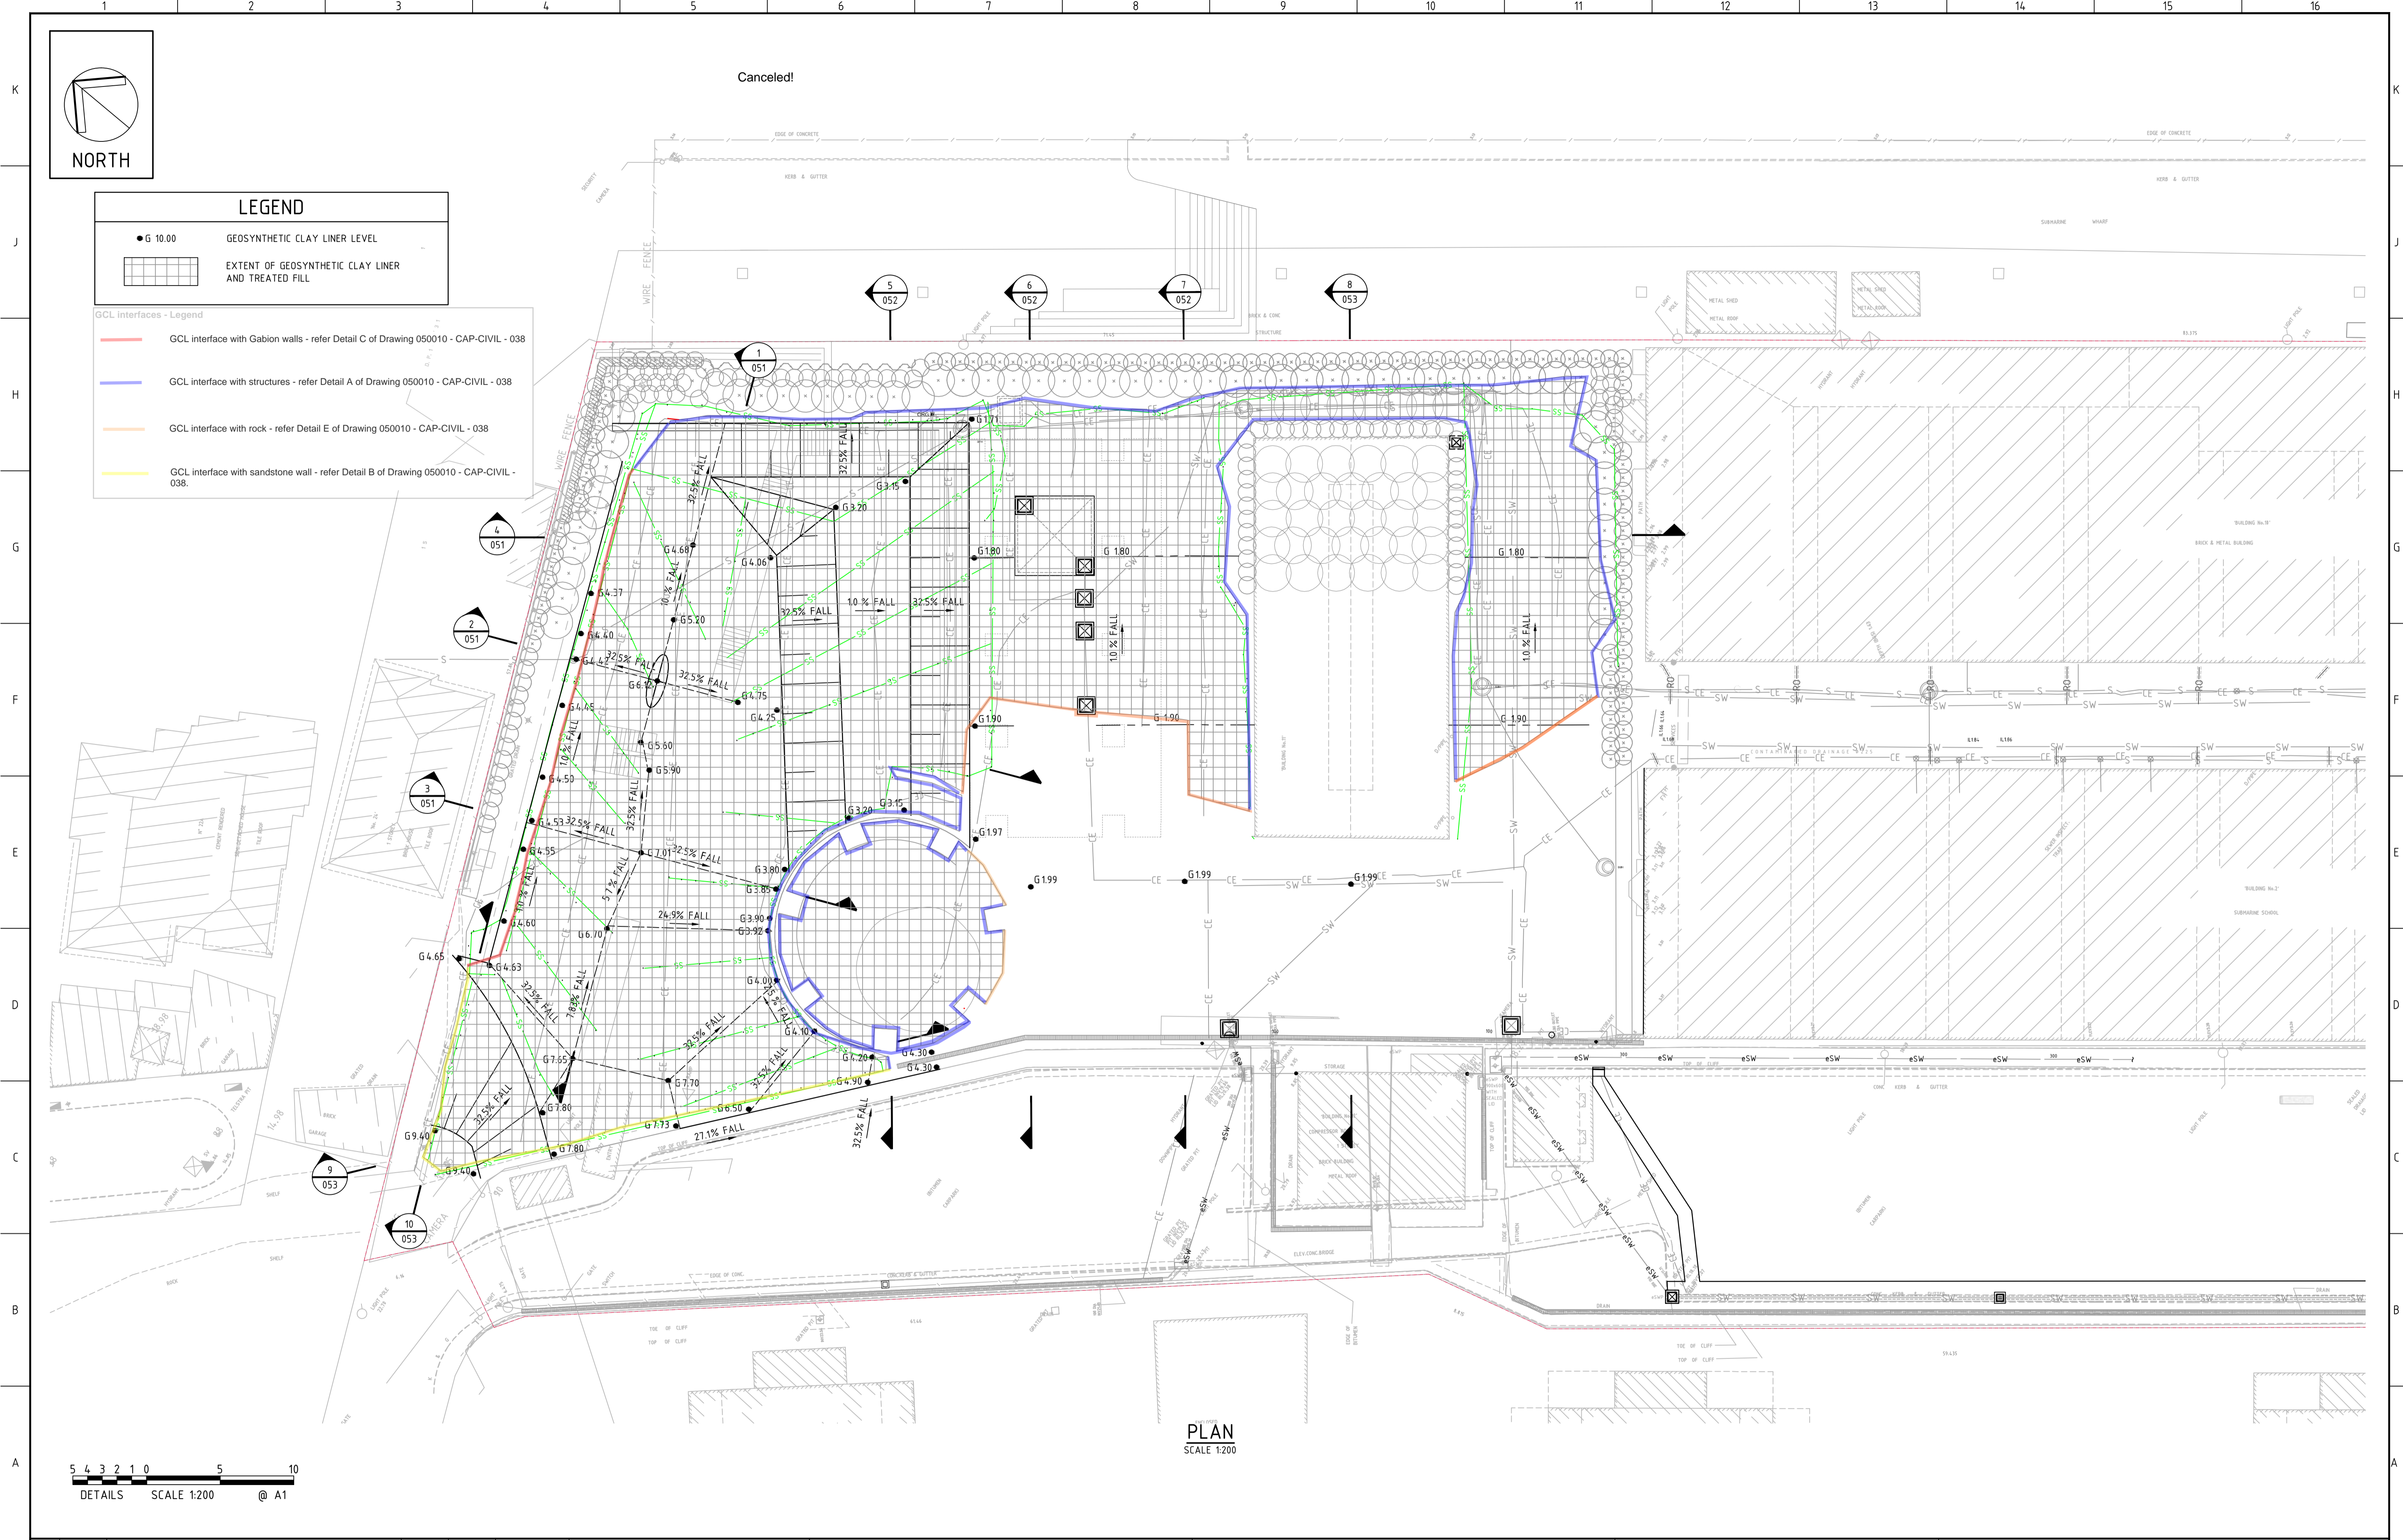
- G 10.00 GEOSYNTHETIC CLAY LINER LEVEL
  - [Grid Pattern] EXTENT OF GEOSYNTHETIC CLAY LINER AND TREATED FILL
- GCL Interfaces - Legend
- [Red Line] GCL interface with Gabion walls - refer Detail C of Drawing 050010 - CAP-CIVIL - 038
  - [Blue Line] GCL interface with structures - refer Detail A of Drawing 050010 - CAP-CIVIL - 038
  - [Orange Line] GCL interface with rock - refer Detail E of Drawing 050010 - CAP-CIVIL - 038
  - [Yellow Line] GCL interface with sandstone wall - refer Detail B of Drawing 050010 - CAP-CIVIL - 038.

The remediation works on the Northern Remediation Area, shown outlined in red on Figure 2 and 3 of Appendix A, resulted in the removal of all soil materials to bedrock. Whilst the most significantly contaminated materials were disposed off-site, the less contaminated materials were treated on the Site. This treatment served to stabilise the primary contaminants, PAHs and TPHs, in the soils. These stabilised soils were then reinstated into the deepest areas of the resultant excavation in compacted layers and were finished above the pre-existing surface levels to form the basis of the final landscaping works. A Cap comprised of various layers of materials was then placed over the stabilised soils. The extent of the retained stabilised materials is referred to as the Northern Remediation Containment Area as shown in plans provided in Appendix C and Appendix E. Details of the Cap are provided in detail below.

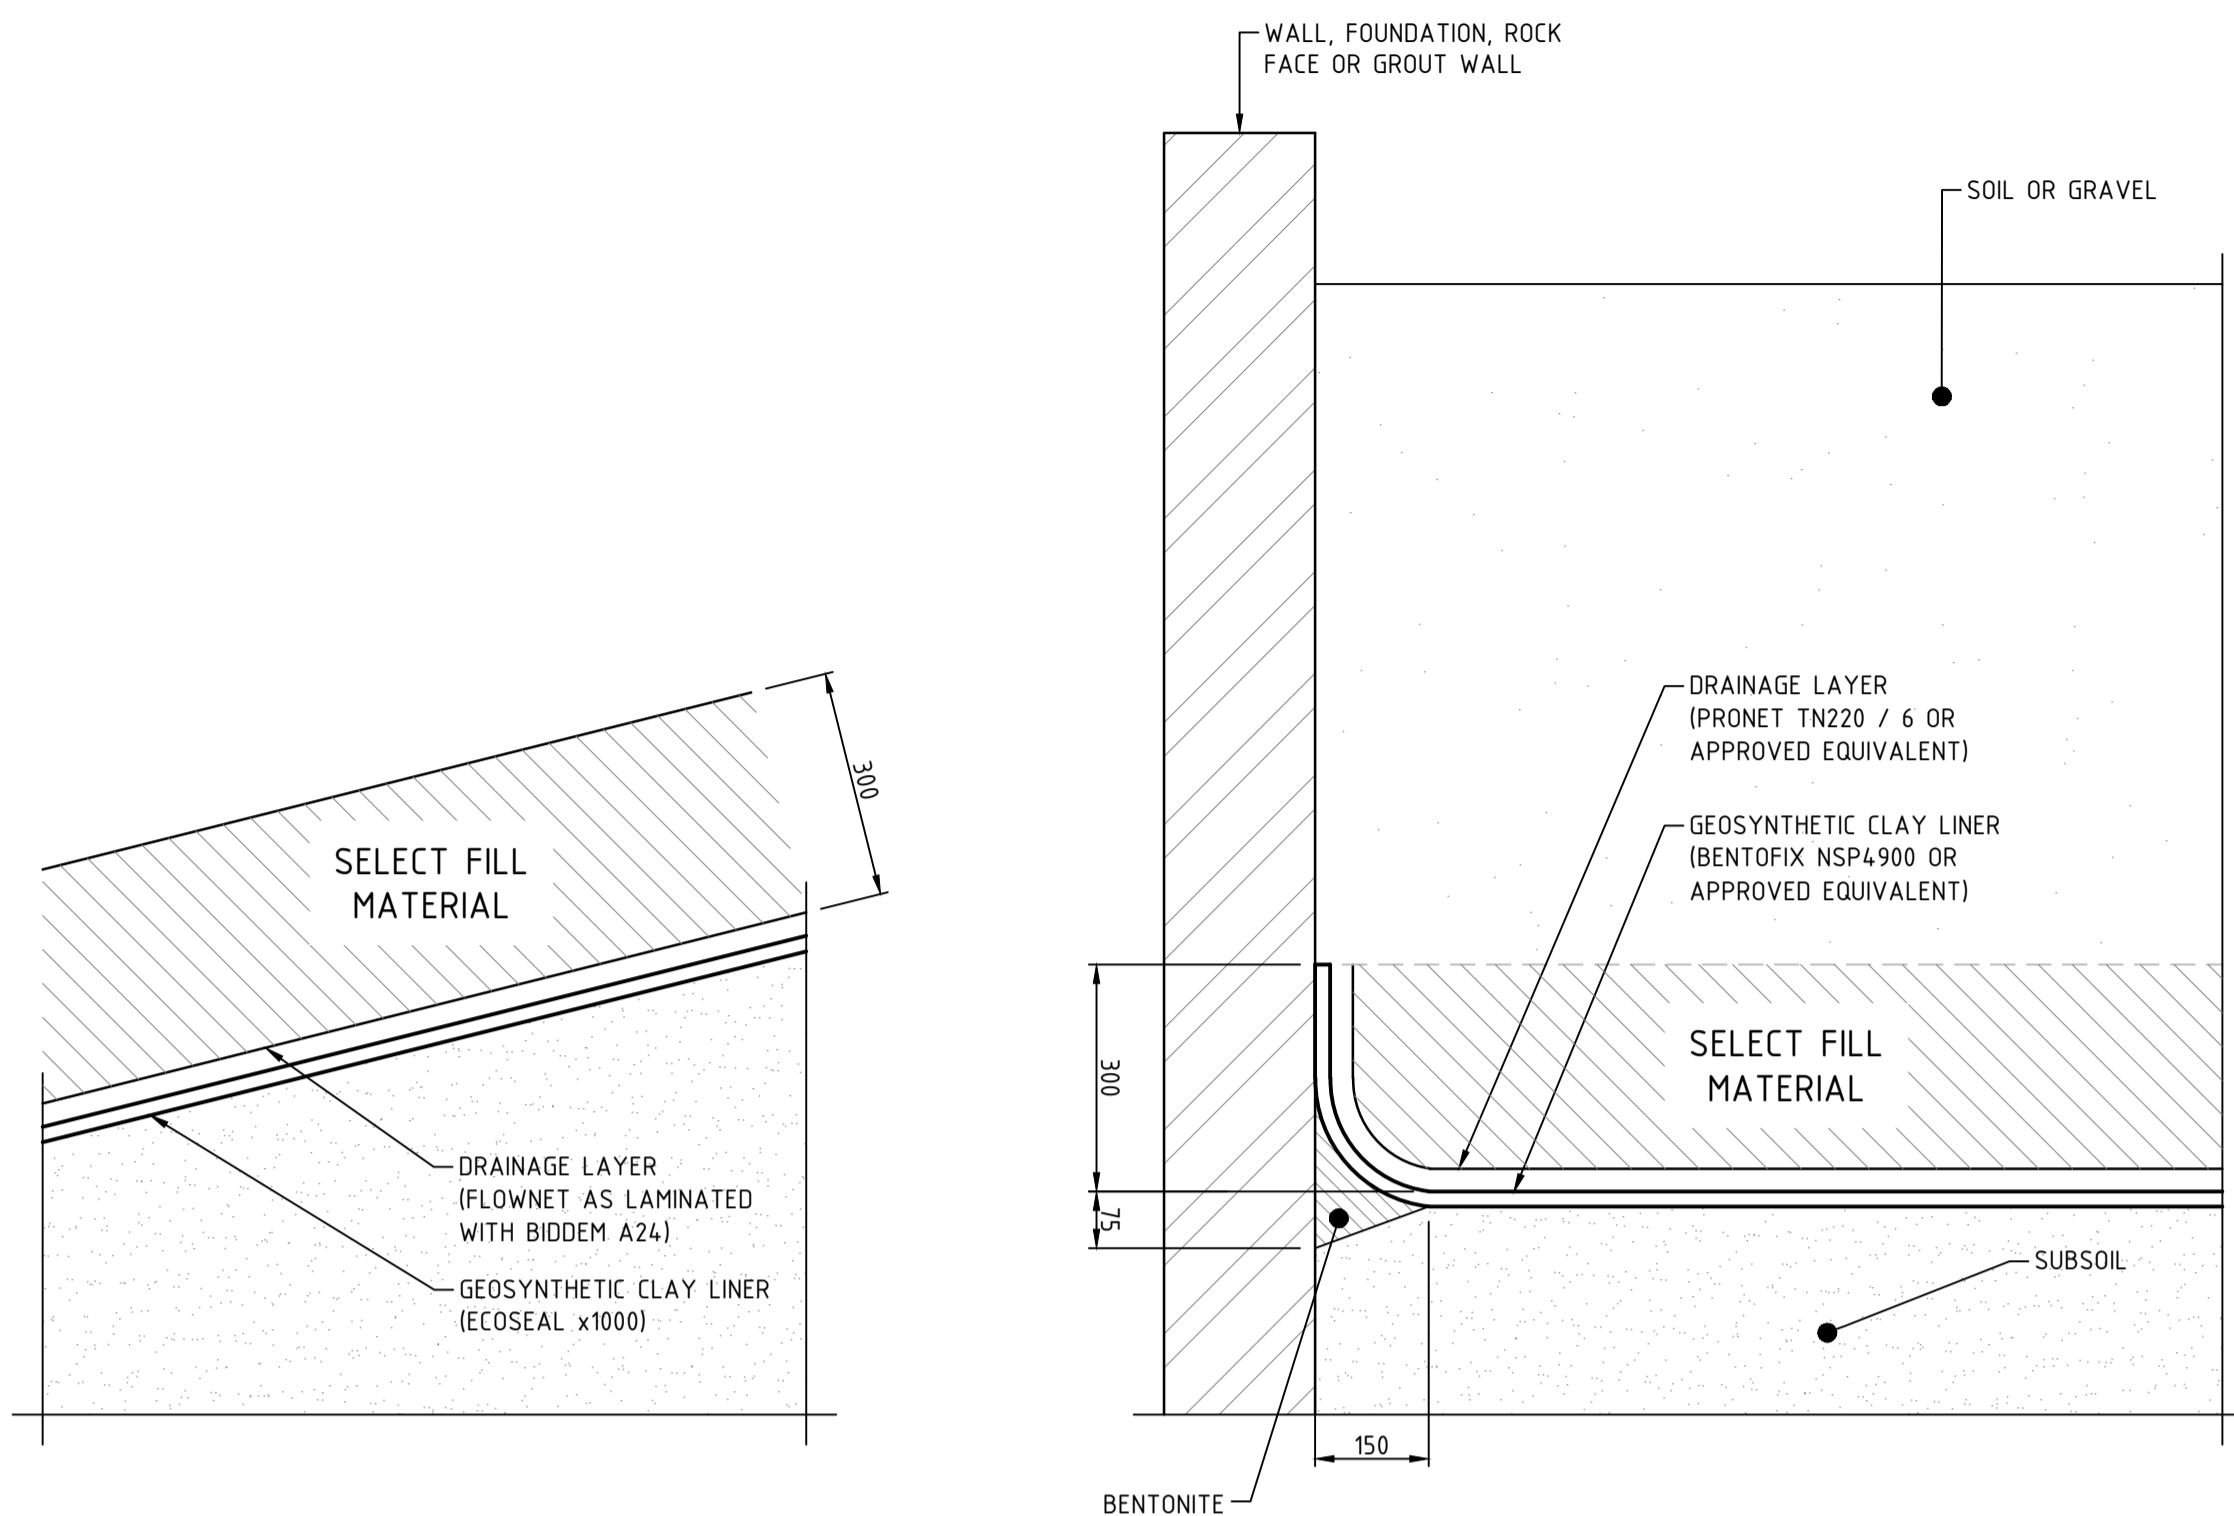
**GEOSYNTHETIC CLAY LINER**

**DETAIL**  
SCALE 1:10

**SEALING GEOSYNTHETIC CLAY LINER TO STRUCTURES**

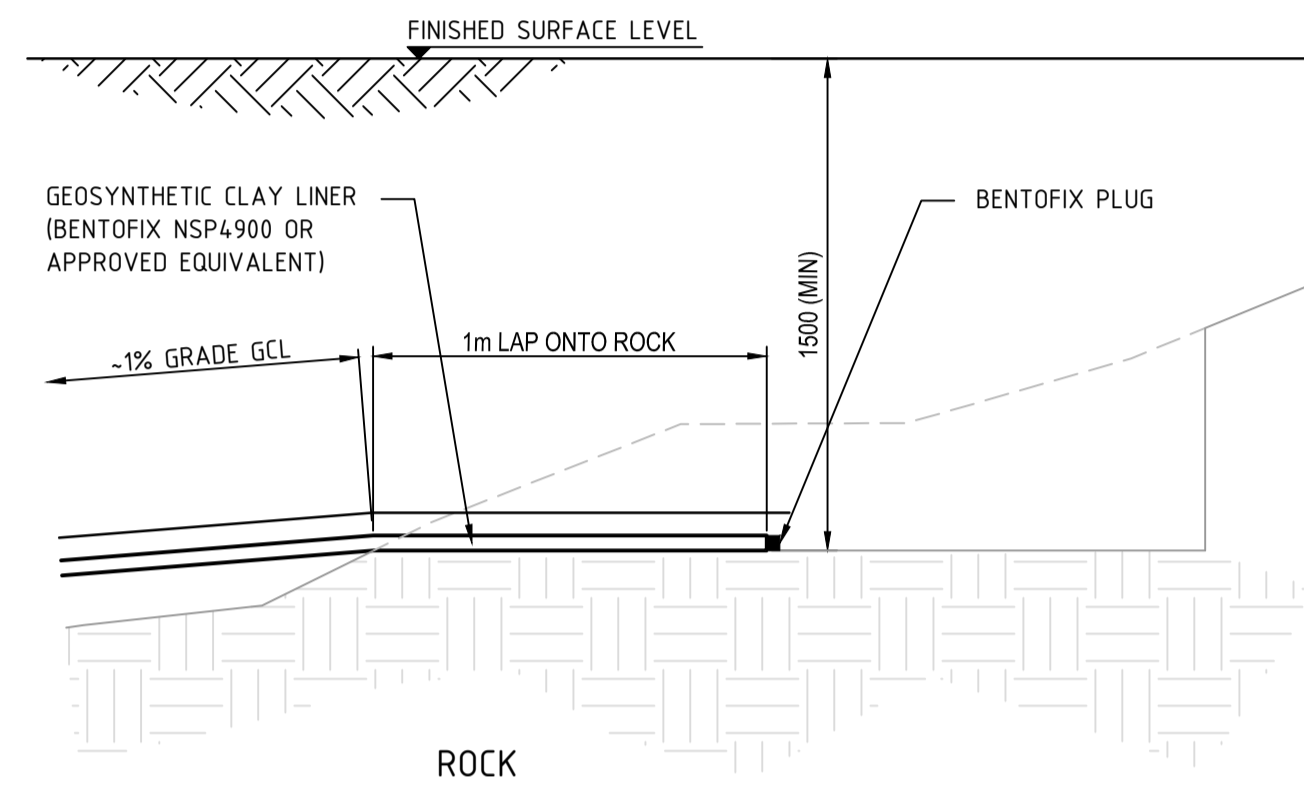
**DETAIL**  
SCALE 1:10

**ANCHORING TRENCH FOR GEOSYNTHETIC CLAY LINER**

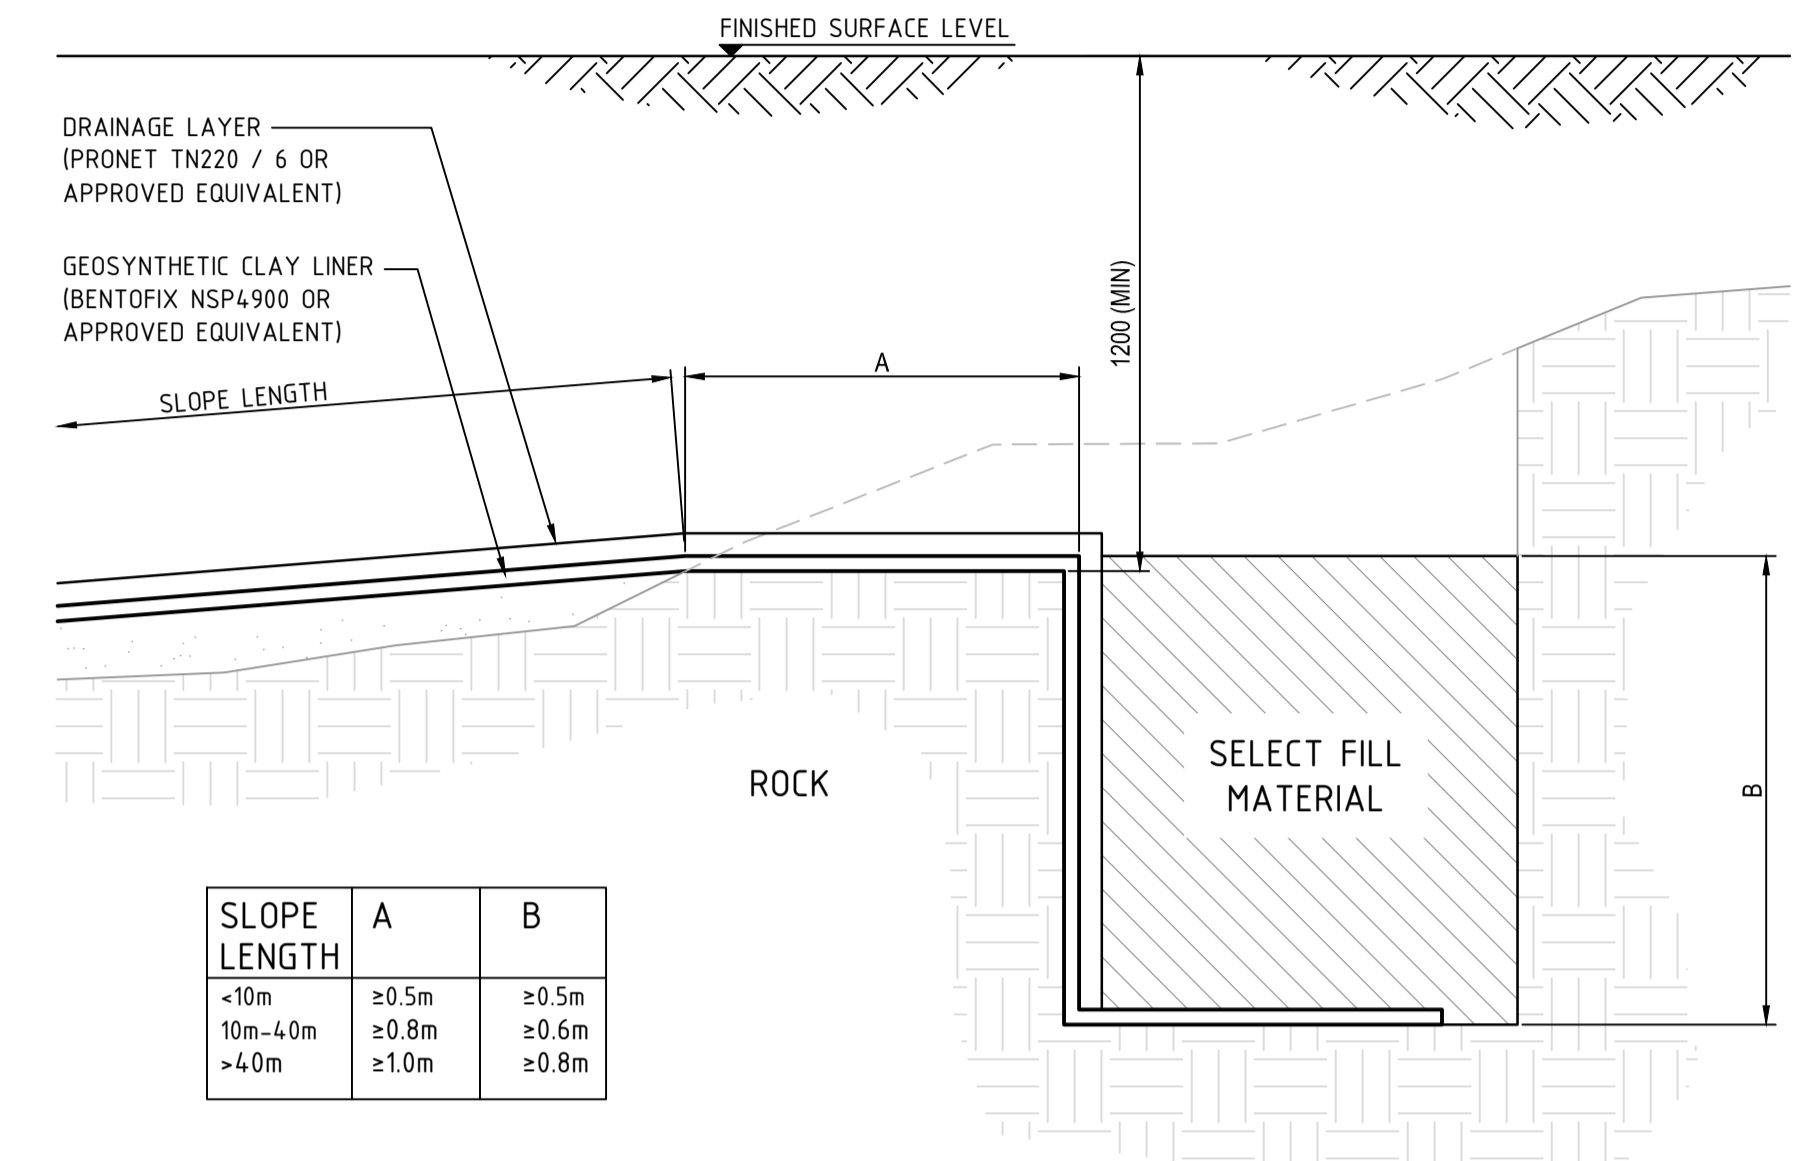
**DETAIL**  
SCALE 1:10

**ANCHORING TRENCH FOR GEOSYNTHETIC CLAY LINER**

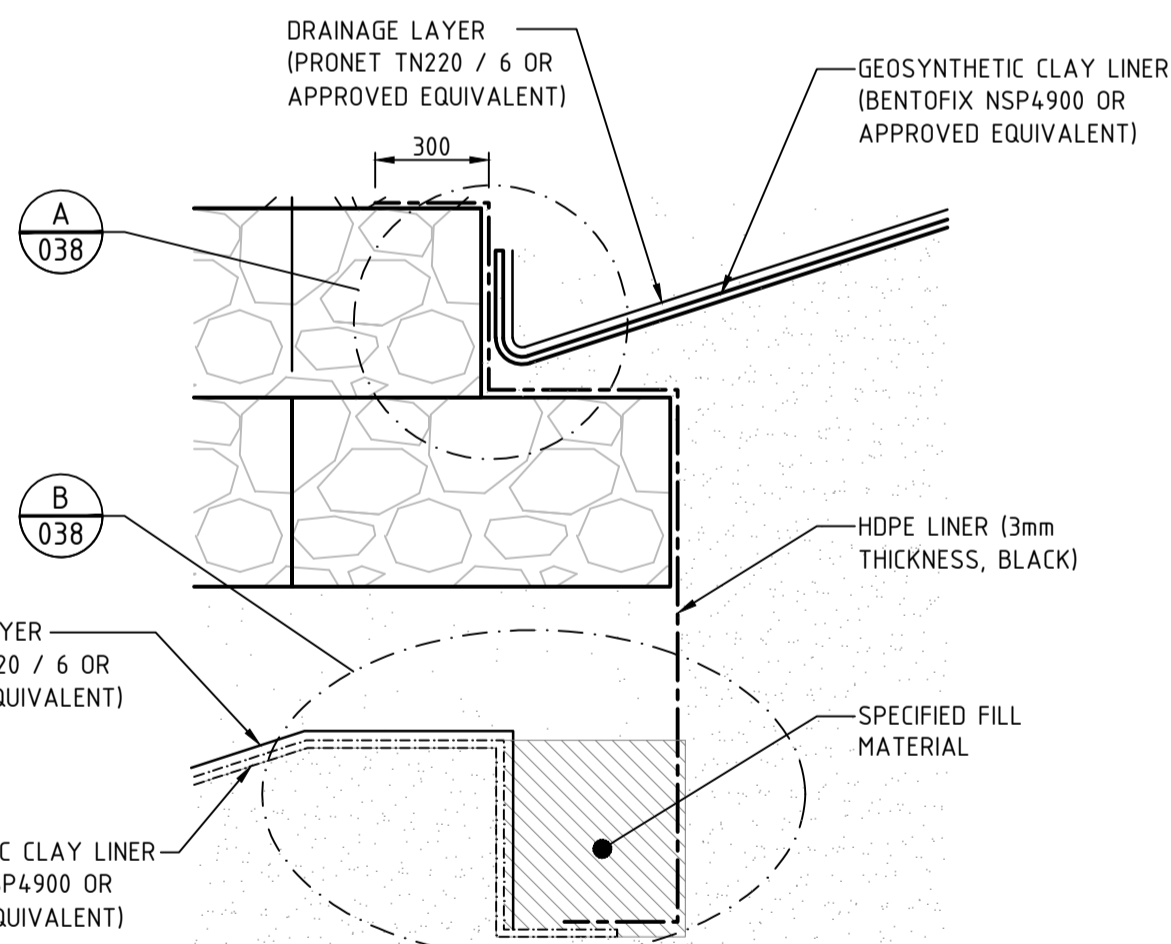
**DETAIL**  
SCALE 1:20

**GEOSYNTHETIC CLAY LINER AT GW4 GABION WALLS**

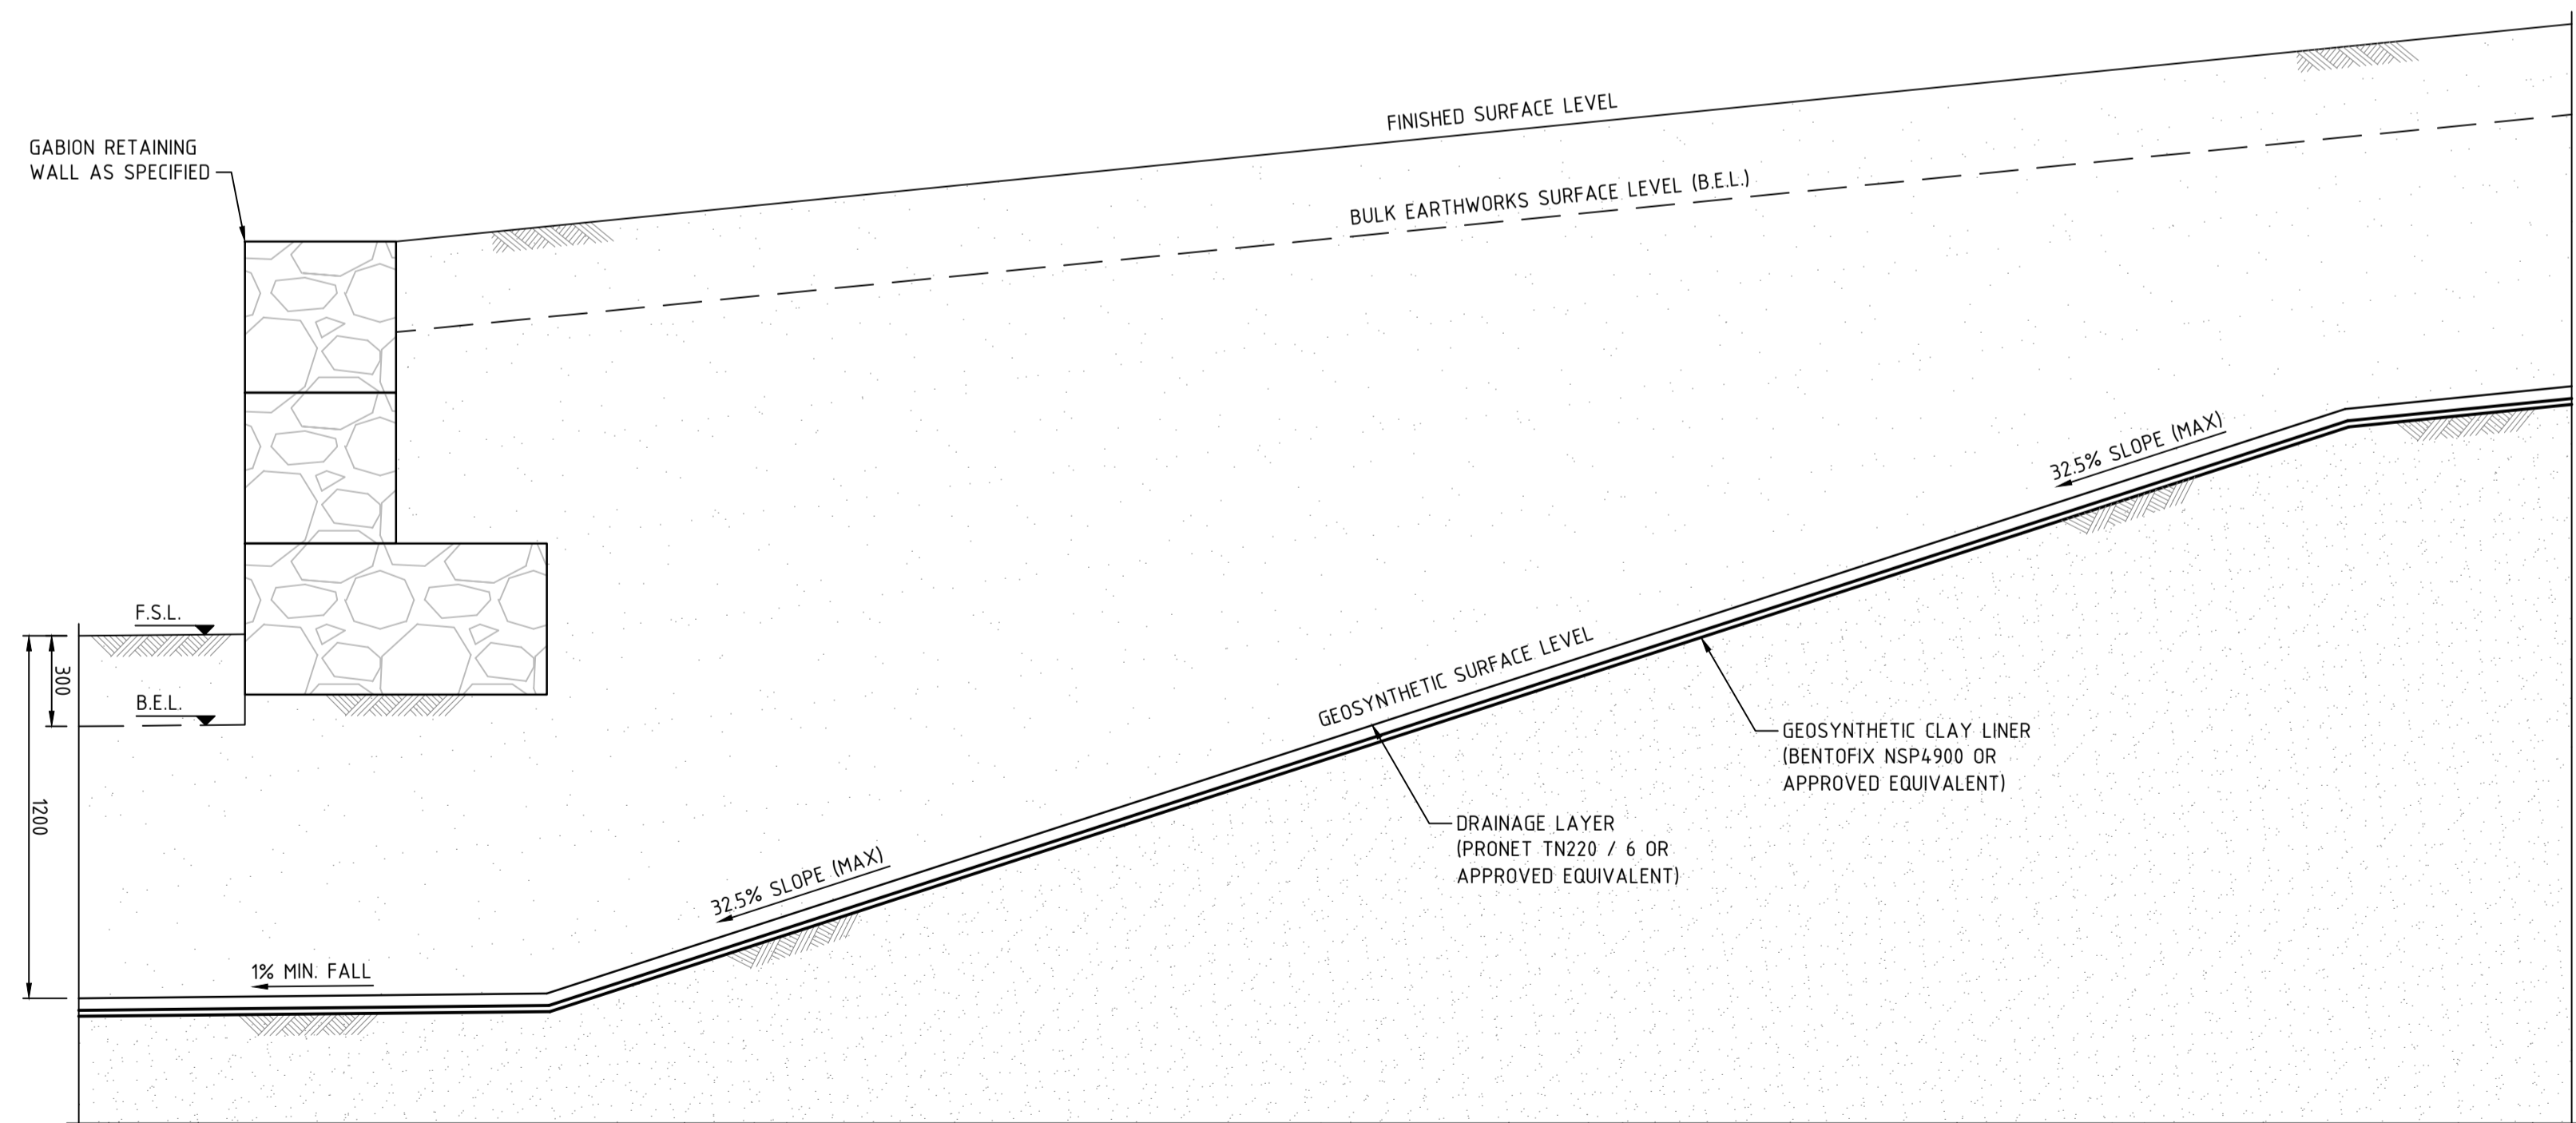
**GEOSYNTHETIC CLAY LINER UNDER RETAINING WALL - TYPICAL DETAIL**  
SCALE 1:20
