## FINAL REPORT

# Long-term Environmental Management Plan, Platypus Site High Street, North Sydney NSW

**10 May 2018**

**CONSARA Pty Ltd**  
ABN: 27 161 027 881  
ACN: 161 027 881  
Suite 2, Unit 6, 10 Rodborough Road Frenchs Forest NSW 2100  
PO Box 7360 Warringah Mall NSW 2100  
admin@consara.com.au

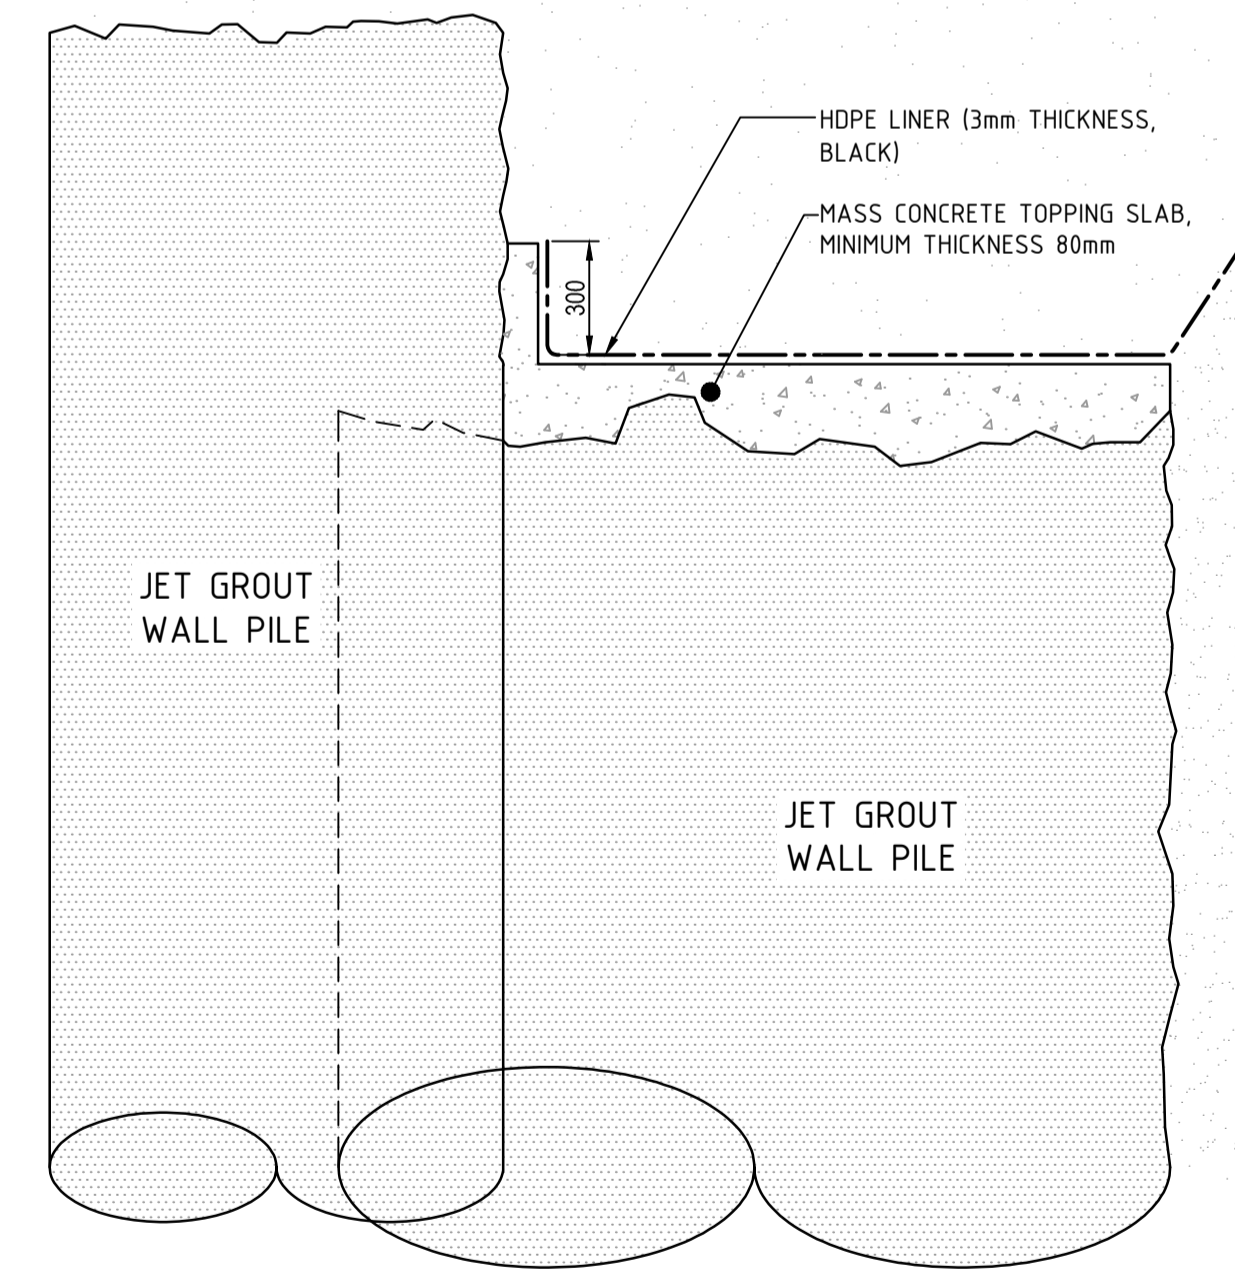
**DETAIL**  
SCALE 1:20

**SEALING HDPE LINER TO GROUT WALL**

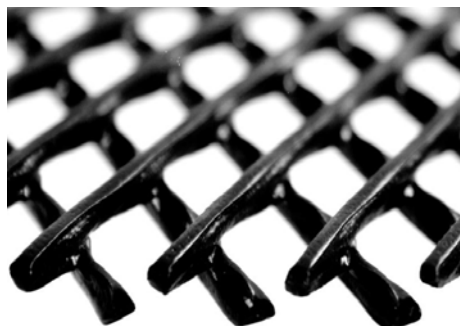
**PRODUCT DESCRIPTION:**

**INTERDRAIN M5** is a high-density polyethylene (HDPE) geonet. The geonet is made with 2 overcrossed strands at 60°, whose geometry create channels with a high flow capacity, also under pressure and at very low gradients.

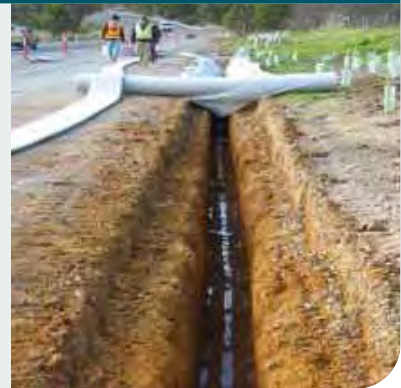
Removal of excess water from a structure whether it be a road, retaining wall or sports field is key to long term performance of the structure. **Megaflo**® is a unique composite drainage system with an unsurpassed infiltration rate and rigid flow path which ensures effective drainage under the most challenging conditions.

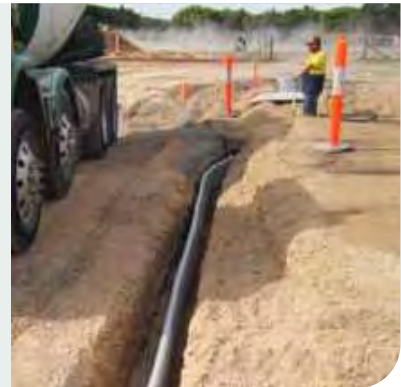
Rapid removal of excess water is a key consideration in roads and sports fields where excess water can result in significant damage to the pavement or limit the playability of the sports surface. The long flat shape of **Megaflo**® incorporates a high open area for inflow of water - allowing rapid response time well in excess of conventional drainage systems.

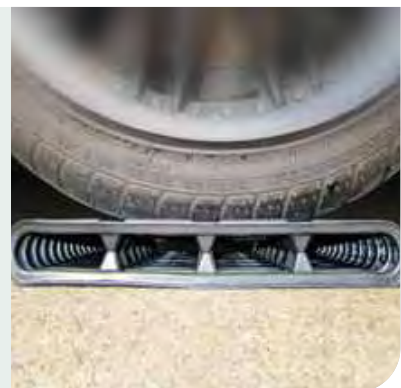
Vertically installing the **Megaflo**® drainage panel utilises the ribbed structure to provide higher strength under traffic loads. The properties of high compressive modulus, longitudinal stiffness and structural rigidity aids the mechanical performance of **Megaflo**®, ensuring the long term hydraulic flow capacity of the drain. High structural strength allows for a minimum cover depth of 100mm, recommended for **Megaflo**® in most applications. **Megaflo**® typically requires less backfill in comparison to a traditional trench which results in cost savings and faster installation.

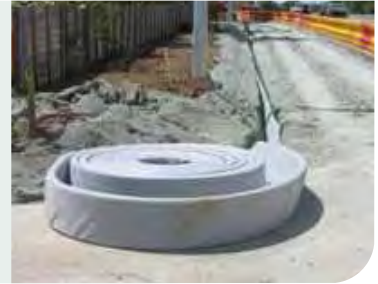
### ROADSIDE EDGE DRAINS

**Megaflor**® provides faster and higher inflow capacity due to its high trench installation profile and earlier interception of pavement infiltration. **Megaflor**® has a high compressive modulus and structural rigidity (preventing deflection under normal service loads), due to its elongated ribbed profile incorporating internal support.

Simple installation techniques provide installation savings compared to a traditional round pipe drainage system.

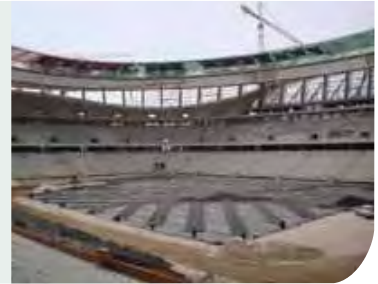
### SPORTS FIELDS

Sports field surfaces endure high traffic, which if not drained adequately, results in costly and time consuming maintenance. Adequate drainage requires the fast and effective removal of water after a storm.

The use of narrow width **Megaflor**® flat panel drain ensures minimal disruption of the existing sports surface with a simple, cost effective installation process.

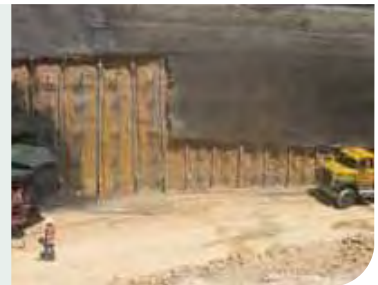
### RETAINING WALLS

**Megaflor**® provides reliable drainage in specialist construction applications such as retaining walls, shotcrete walls and tunnels.

The **Megaflor**® drainage system can be utilised vertically or horizontally to remove excess water, preventing the build up of water pressures induced on the structure.

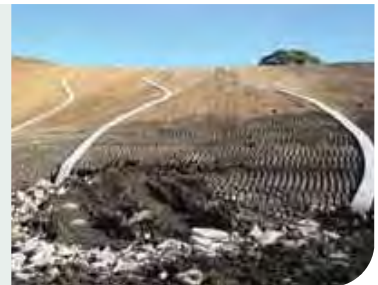
### LANDFILL

Landfill leachate and gas collection systems are an integral part of landfill design for lining and capping systems.

The high compressive strength of **Megaflor**® under normal and inclined loads makes it the ideal product for a range of landfill drainage applications.

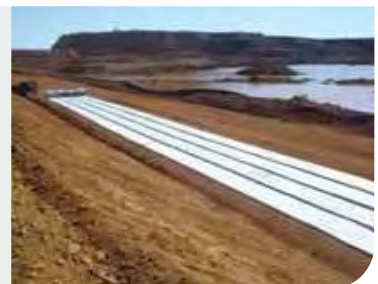
### MINING

**Megaflor**® is ideally suited for use as collector drains in mining applications. Its high compressive modulus and structural rigidity prevents deflection and the loss of flow capacity under high load or localised settlement.

**Megaflor**® Ultra is available for the rapid drainage of tailing dams.

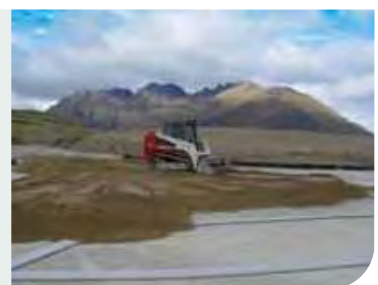
The trenchless option of **Megaflor**® laid directly onto the subgrade results in significant savings in man-hours and material compared to traditional round pipe.

Regardless of the subgrade soil type, all golf courses can benefit from improved drainage using **Megaflor**®.

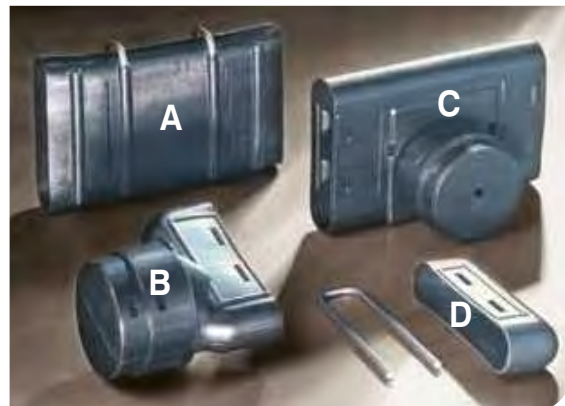
- **Megaflo®** couplers are a high strength, secure means to join continuous sections of **Megaflo®**, inserted beneath the geotextile.
- Connecting to 100mm diameter round pipe is easily achieved using either the **Megaflo®** side outlet or **Megaflo®** end outlet where required.
- **Megaflo®** end caps can be fitted to terminations to prevent backfill ingress into the system. Other fittings are available for connecting **Megaflo®** in various arrangements depending on the application.

Fittings are available to suit all Megaflo® sizes:

A	Joiner Coupling	C	Side Outlet
B	End Outlet	D	End Cap

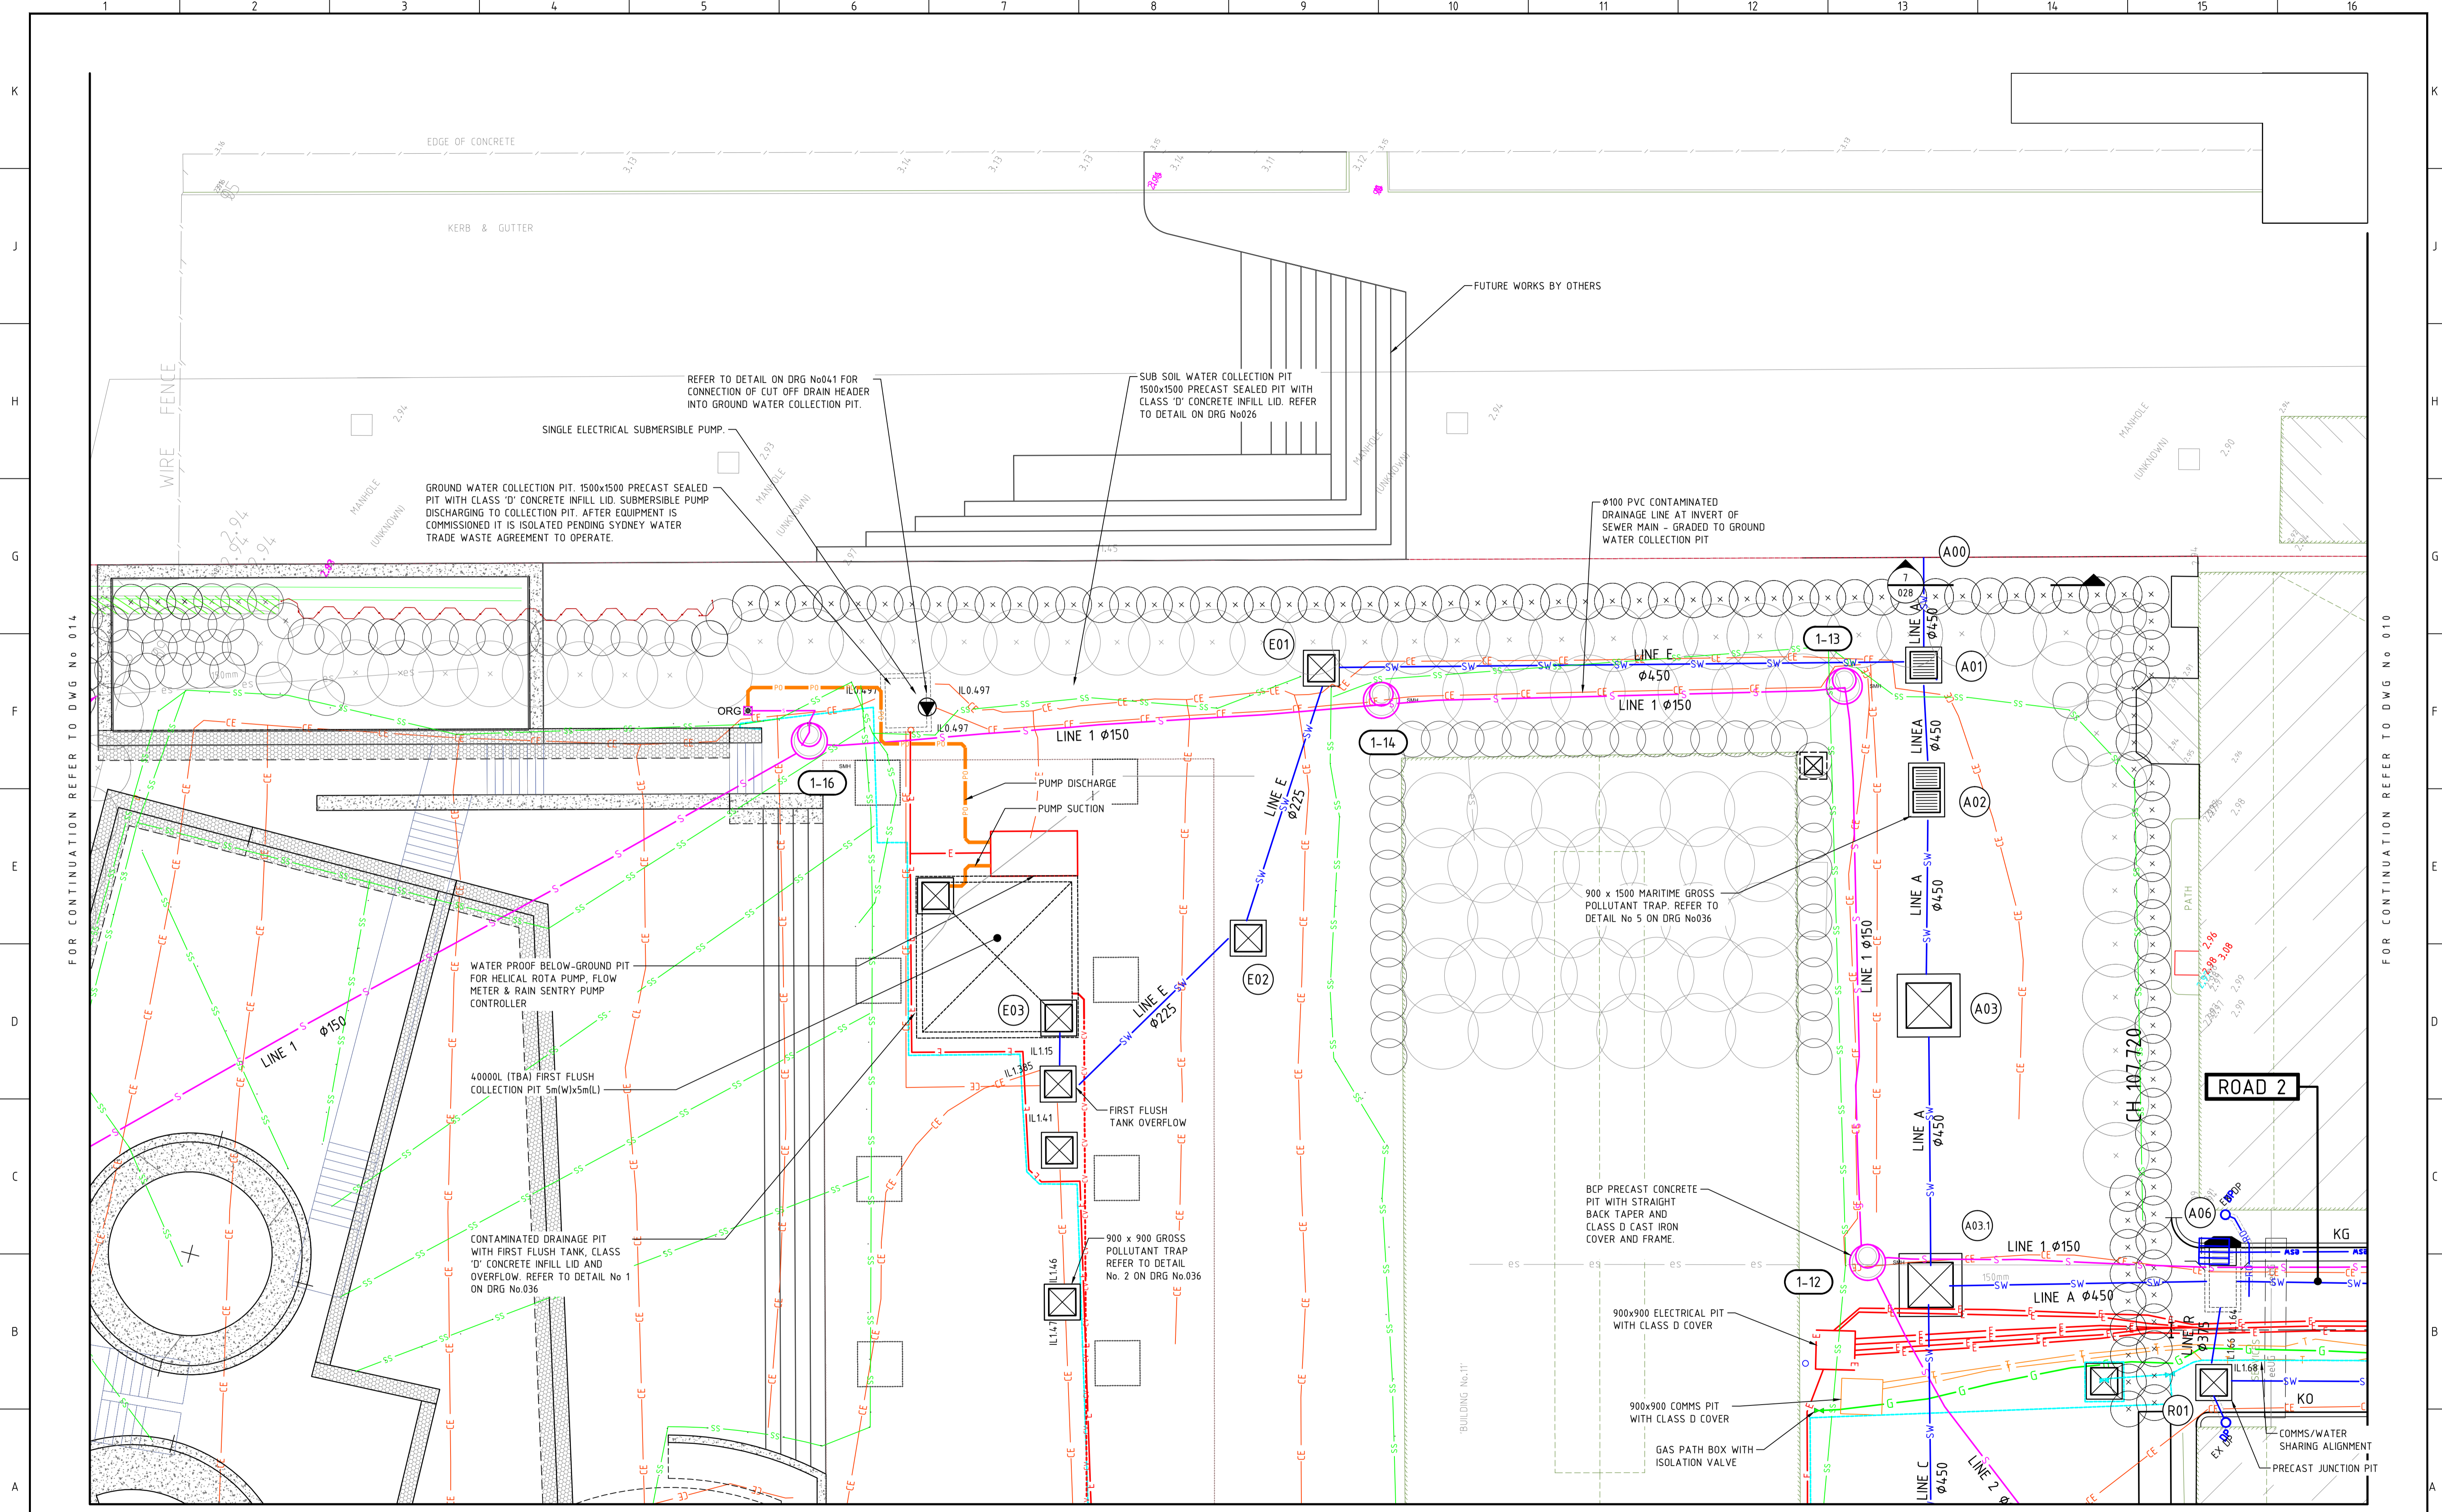
HMAS PLATYPUS STAGE 2 REMEDIATION WORKS		
DRAWING TITLE		
SITWORKS PLAN		
SHEET 4 OF 7		
SCALE	DRG NO.	REV
A1 1:100	050010-CAP-CIVIL-011	WAE

FOR CONTINUATION REFER TO DWG No 014

FOR CONTINUATION REFER TO DWG No 010

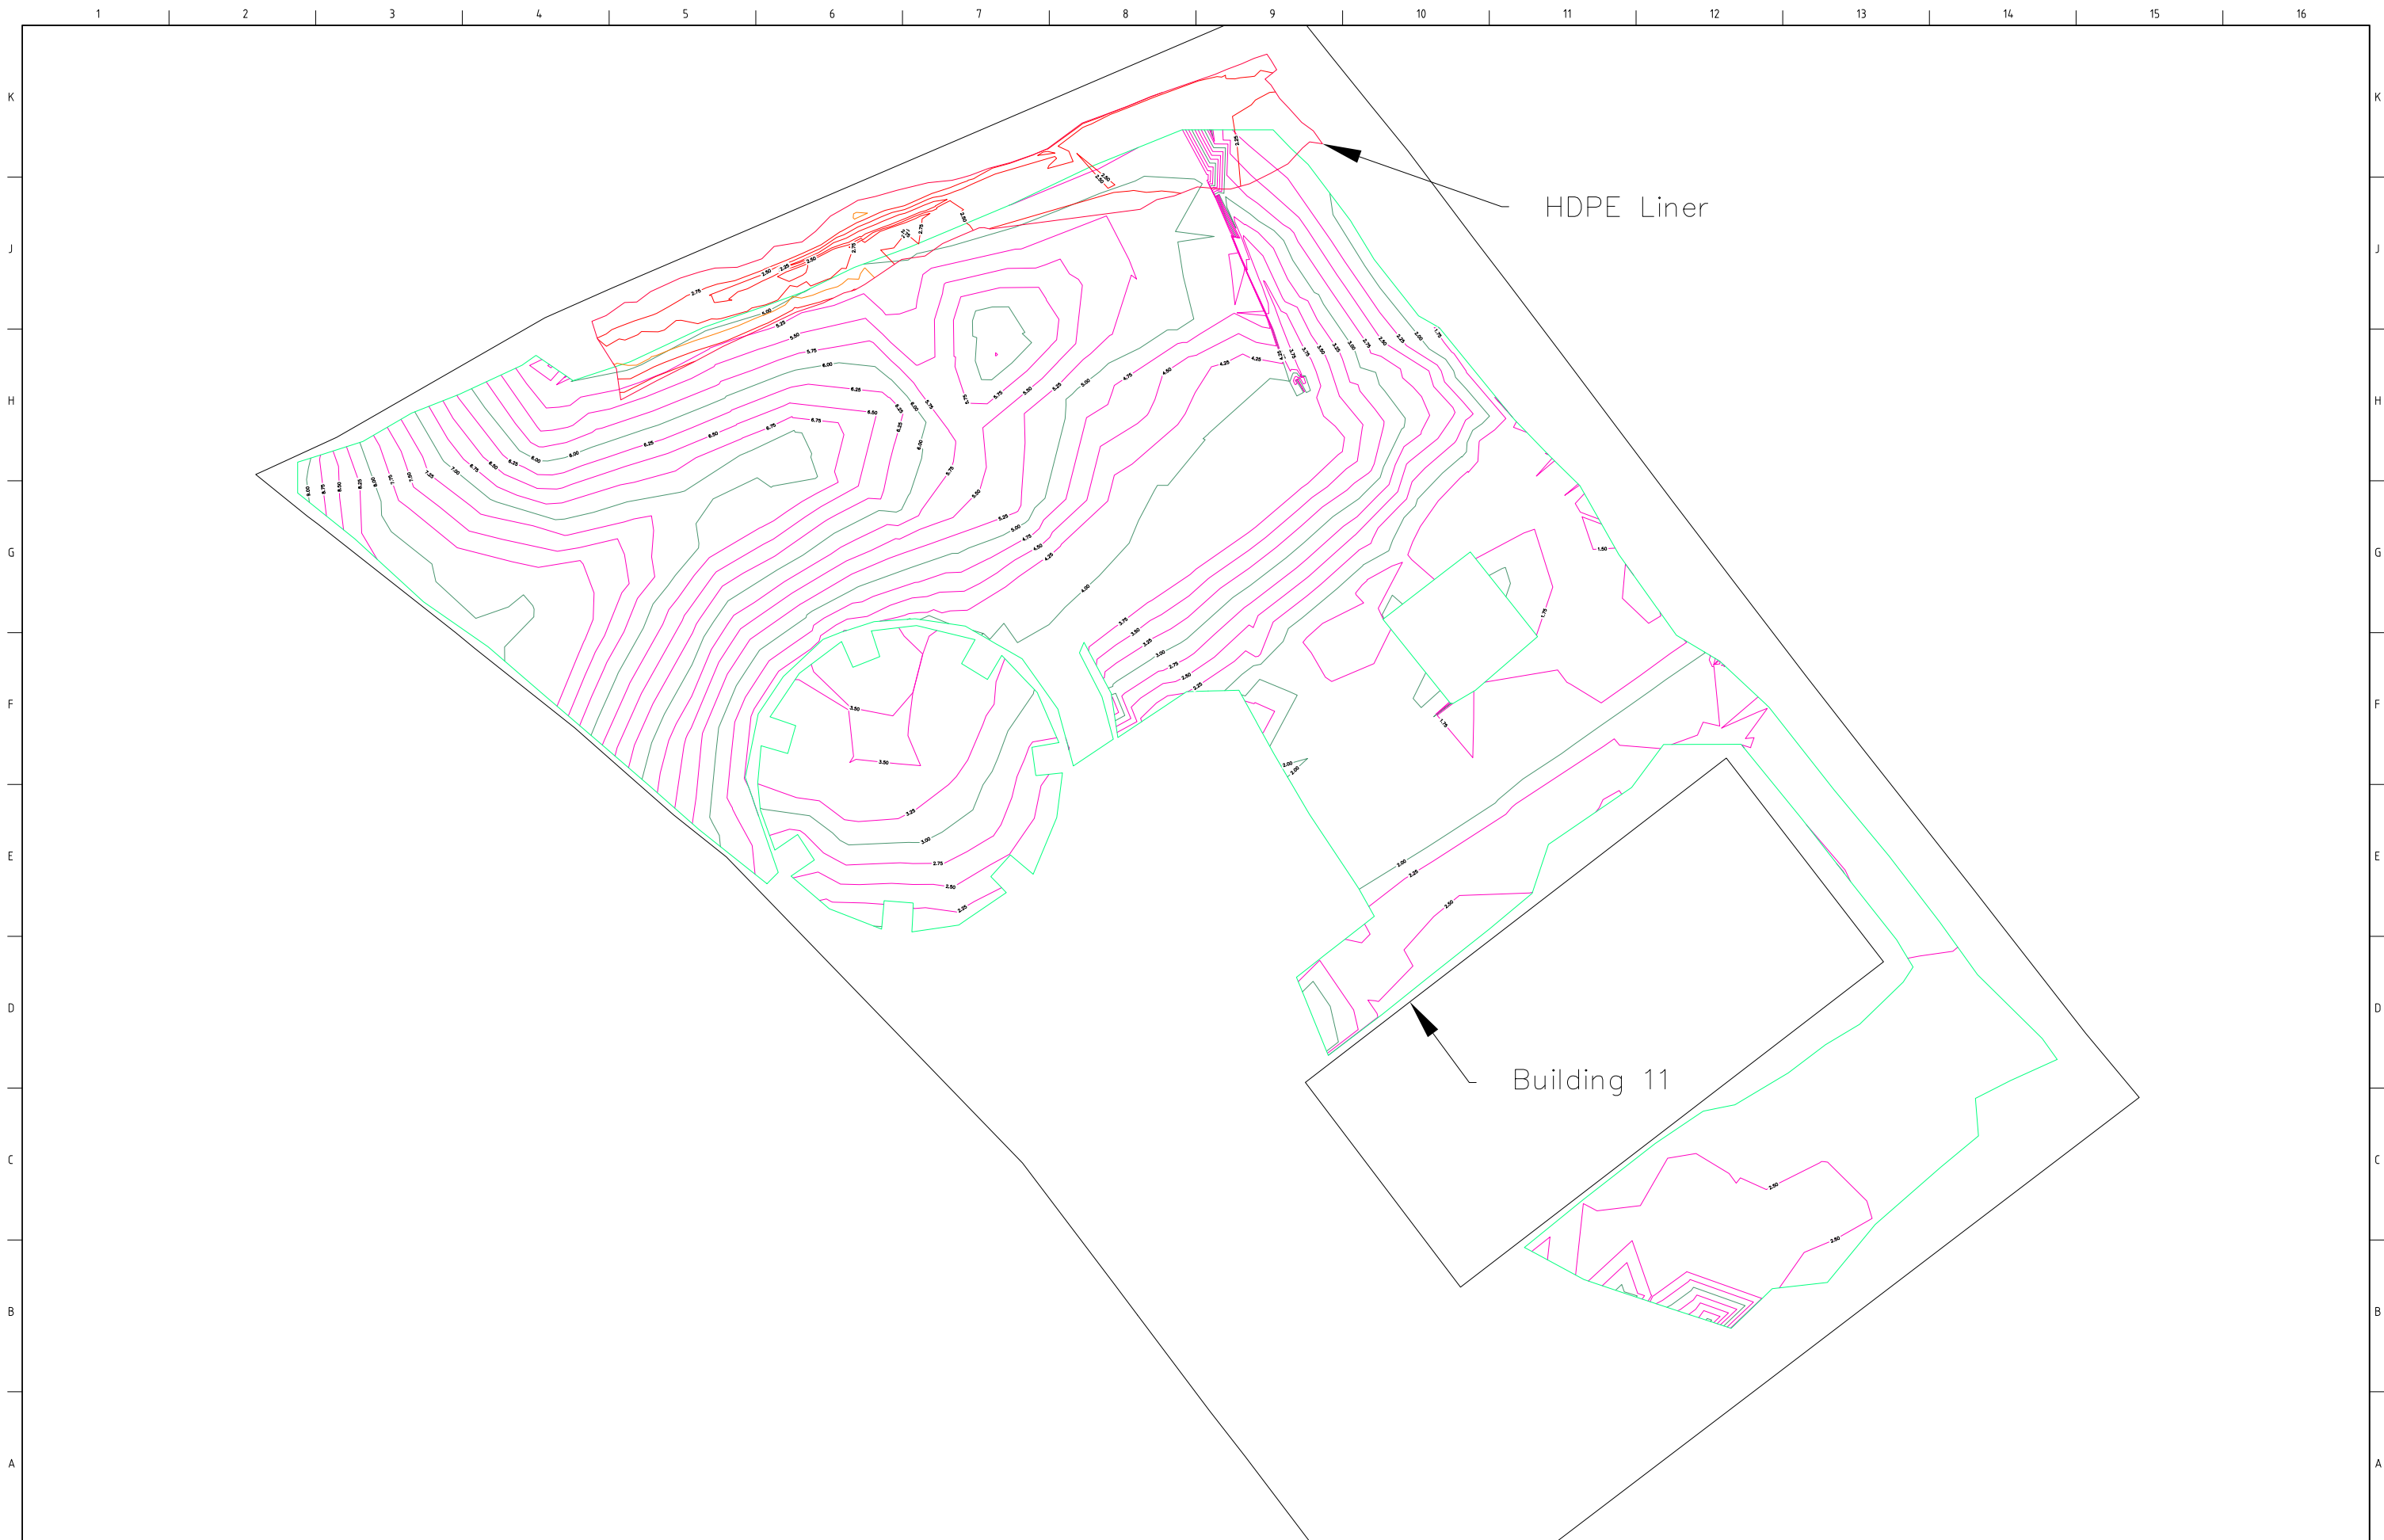
HMAS PLATYPUS STAGE 2 REMEDIATION WORKS		
DRAWING TITLE		
GEOSYNTHETIC CLAY LINER		
AS BUILT		
SCALE	DRG NO.	REV
A1 1:150	050010-CAP-WAE-010	B

REV	DATE	DESCRIPTION	BY	APP'D	REVIEWED
B	4.11.2014	HDPE LINER SURFACE ADDED	SHB	SHB	BW
A	20.10.2014	ISSUED FOR REVIEW	SHB	SHB	BW

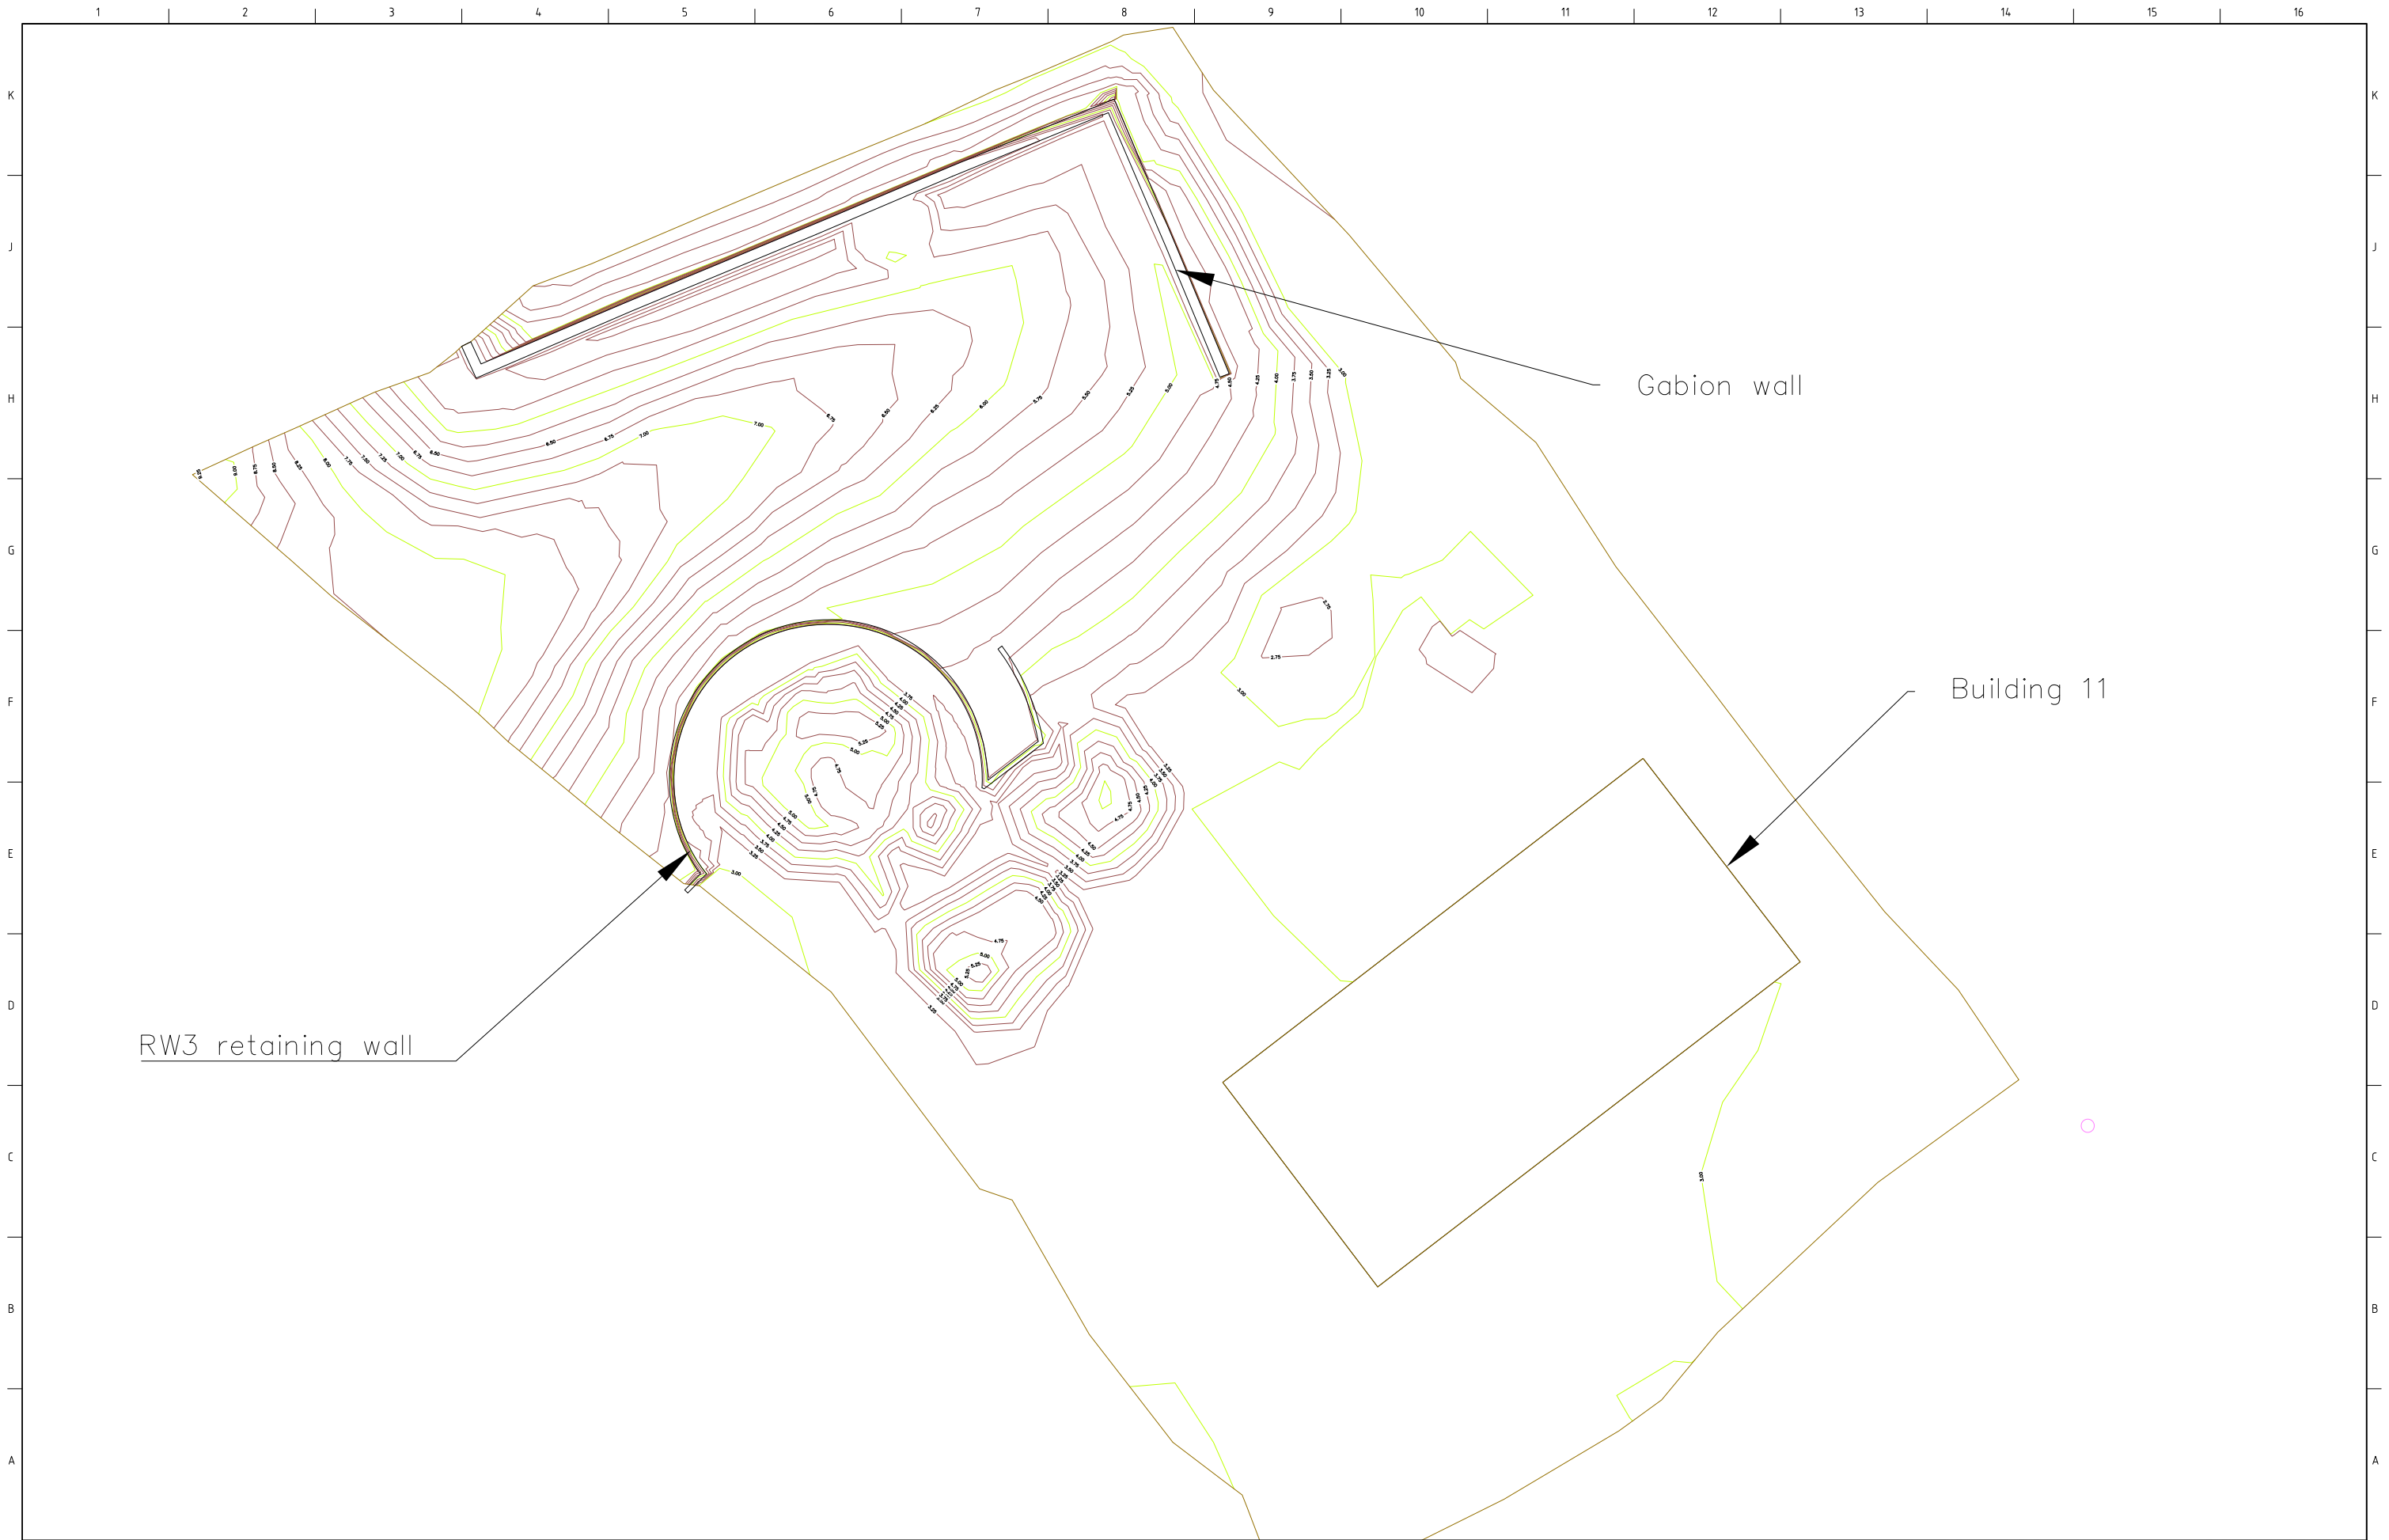
HMAS PLATYPUS STAGE 2 REMEDIATION WORKS		
DRAWING TITLE		
FINAL CAPPING SURFACE		
AS BUILT		
SCALE	DRG NO.	REV
A1 1:150	050010-CAP-WAE-011	A

RW3 retaining wall

Gabion wall

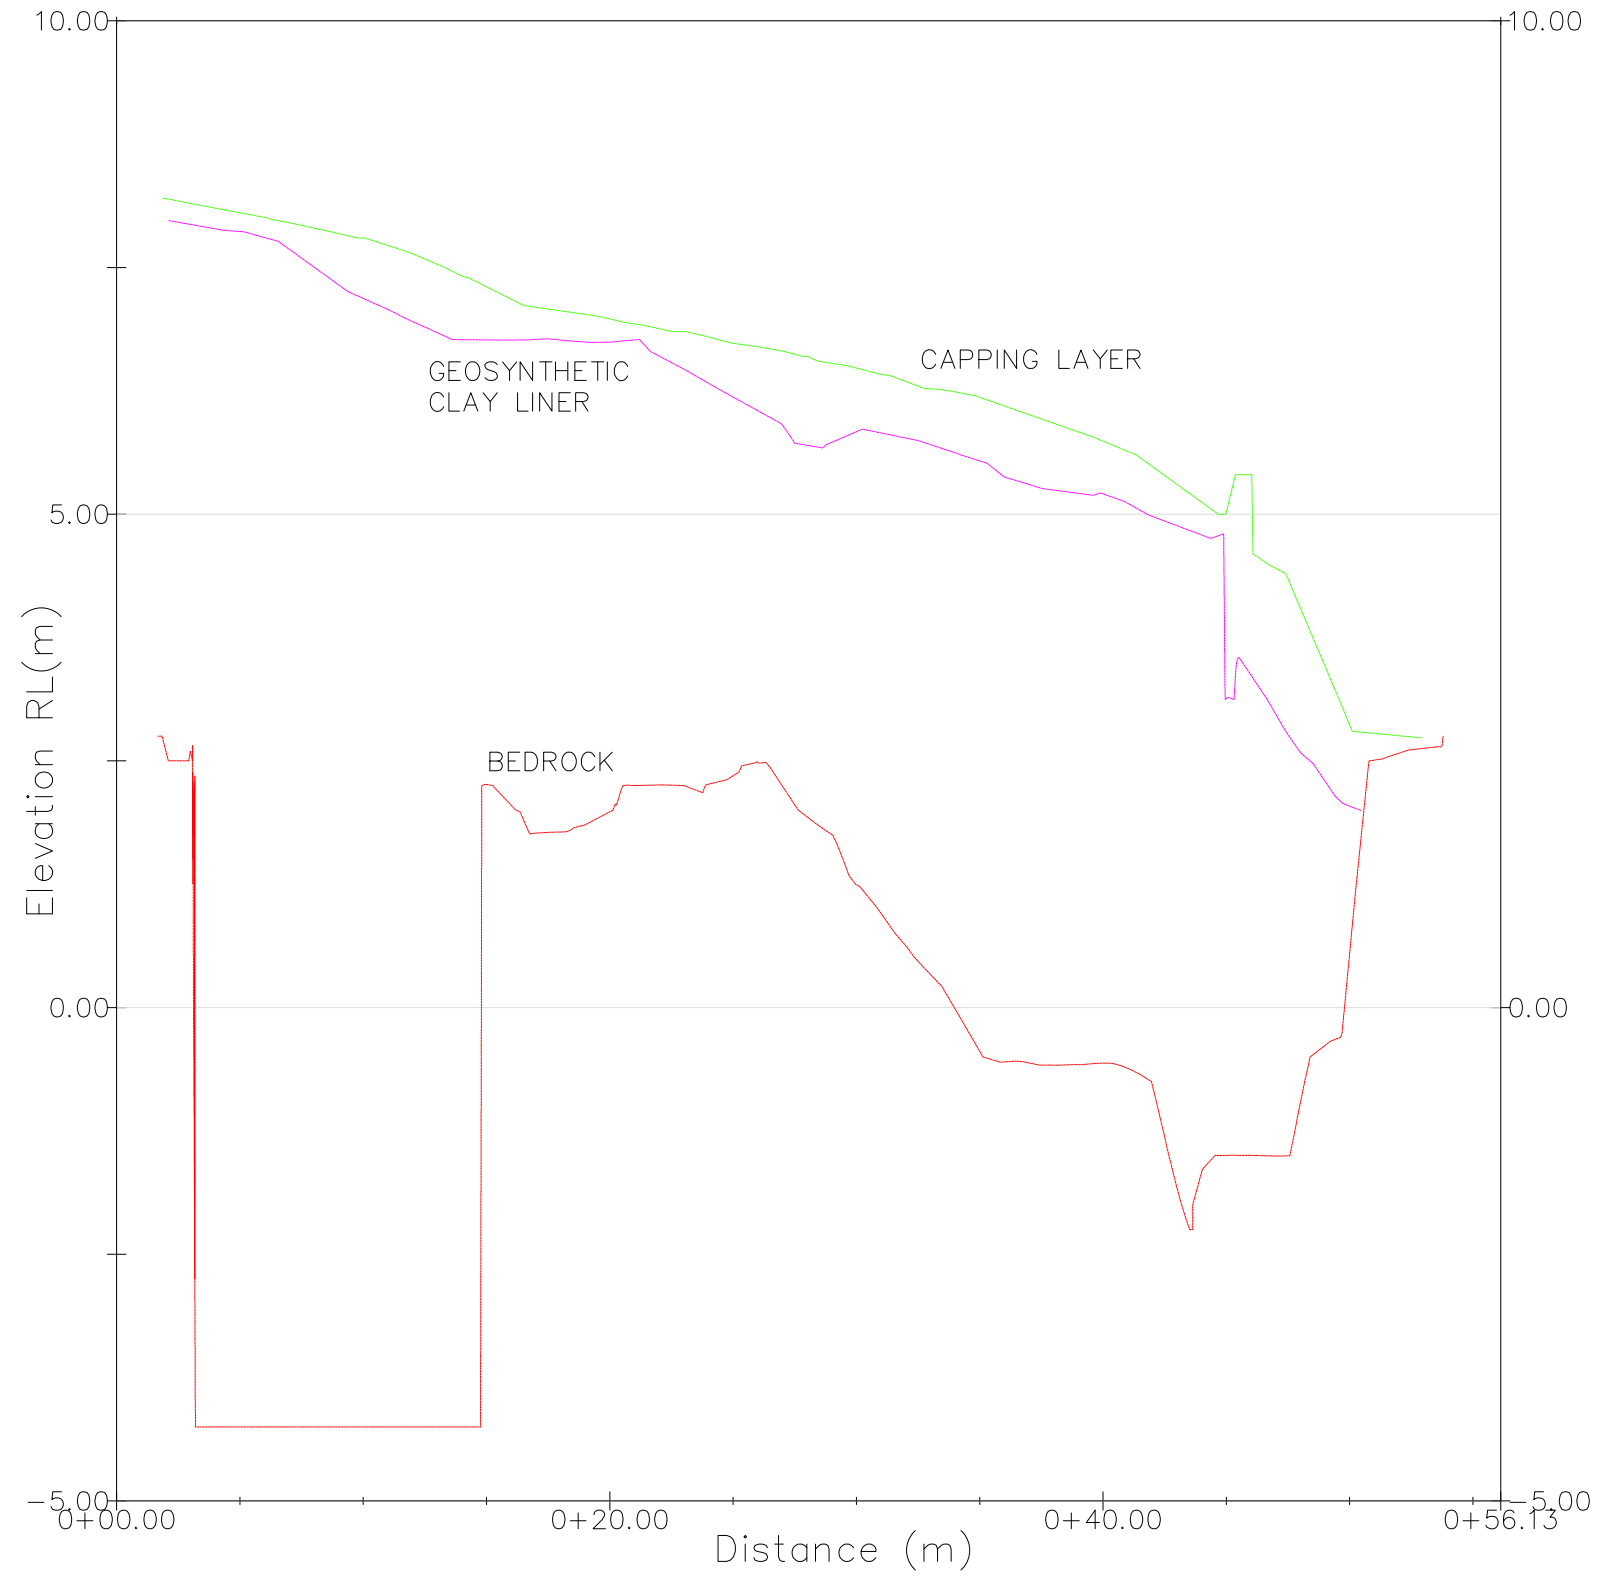
<b>HMAS PLATYPUS STAGE 2 REMEDIATION WORKS</b> DRAWING TITLE <b>CONTAINMENT CELL TYPICAL CROSS SECTION AS BUILT</b>		
SCALE	DRG NO.	REV
A1 1:150	050010-CAP-WAE-013	A

# Typical Cross Section
